## Arborist Report: Tukwila Village

Site visit : September 13, 2011

Report date: September 16, 2011

Re: Tukwila Village, International Blvd & S. 144<sup>th</sup> Street, Tukwila, WA  
Site visit: 9/13/11

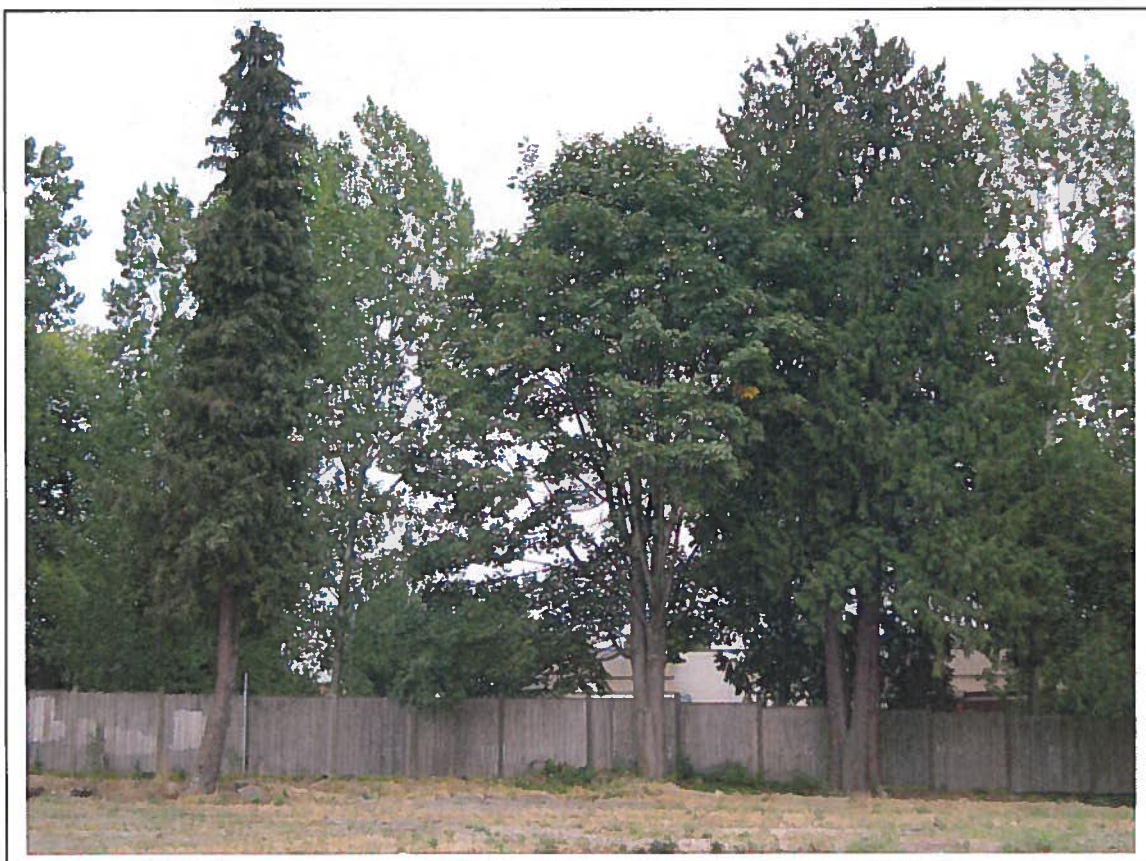
- North trees, north of the matchline, #1-18, 45-47: These are all unaesthetic and in marginal health. The exception is fir #18, which somehow escaped damage during the construction of the adjacent apartment building to the east.
- East trees, #19-24: These are benefiting from the irrigation from the adjacent library's lawn and are the most vigorous on the site. See the photo on page 5.

Trees near the east property line fence, north of S. 144<sup>th</sup>, are the healthiest because they receive irrigation from the adjacent library property.  
From the left the on site trees are #19 Lawson cypress, #20 Bigleaf maple, and #21 Western red cedar.

**East:** The best trees on the site are near the east property line, adjacent to the irrigated King County Library lawn. I recommend saving maple #20 and cedar #21, and protect them as a group at their dripline radii. Fir #18 is also worth saving if the design will allow it.

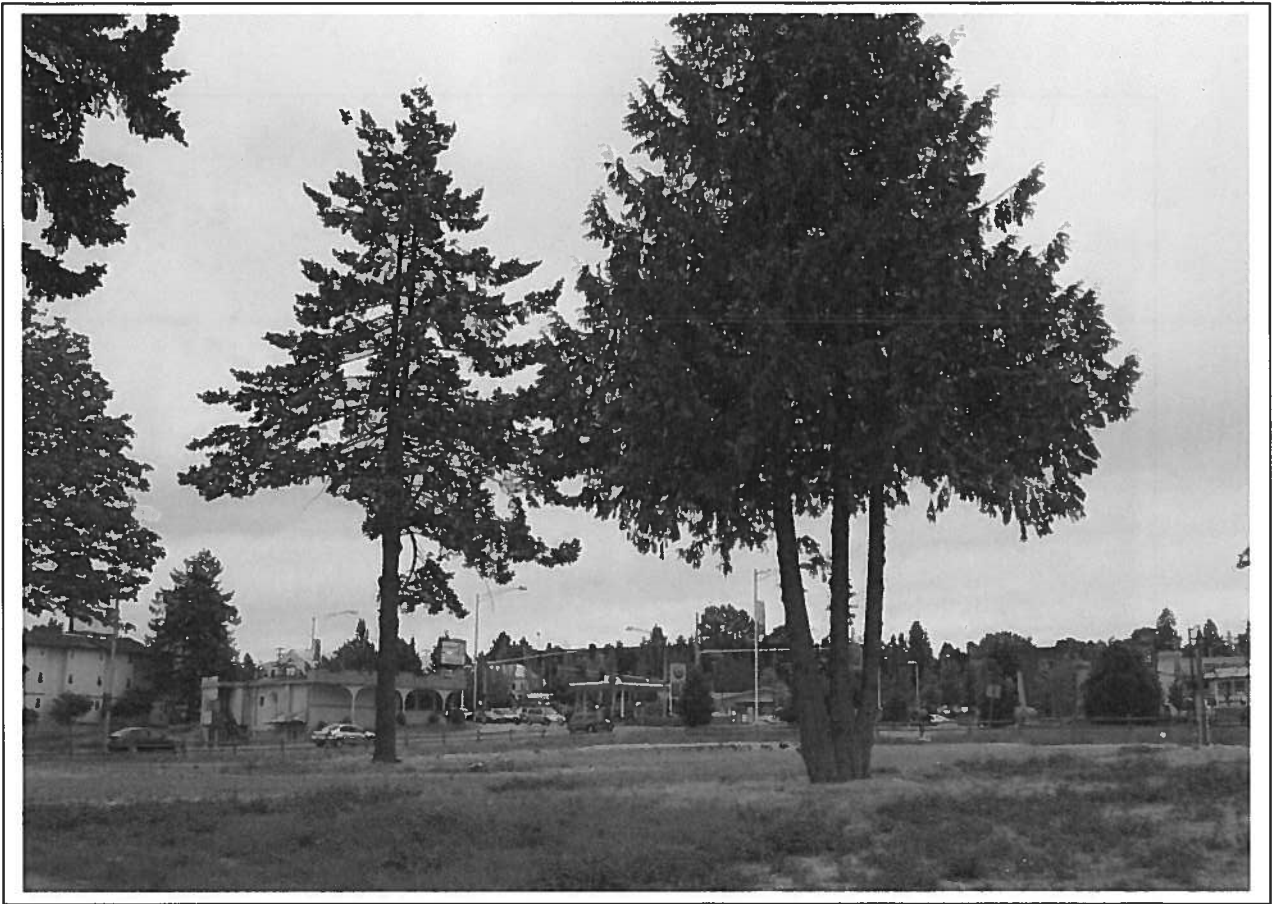
- North of S. 144<sup>th</sup> St.: The trees are dying or very stressed from wounds, excess pruning, and drought. See the photo on page 6. The exception is Coast redwood #32; even with graffiti on the trunk it stands out as a superior tree. It can grow to 200 feet and live 300 years. This species is tolerant of disturbance.

The left tree is Doug fir #41. It's dying because of damage from the asphalt poured over the roots. The right tree is Western red cedar #42 which has been excessively pruned. Many of the on site trees suffered extreme limbing and are unaesthetic. The tree in the distance, to the left of the salmon-colored building, is Coast redwood #35. It's in good health and should be retained assuming there's enough space for its roots and canopy.

**Central/southwest:** The two Coast redwoods #32 and #35 are worth saving if they will have enough space to grow. These are very young trees.
