Arborist Report: Tukwila Village

Site visit : September 13, 2011

Tina Cohen, I.S.A. Certified Arborist #PN0245A
Northwest Arborvitae

Report date: September 16, 2011

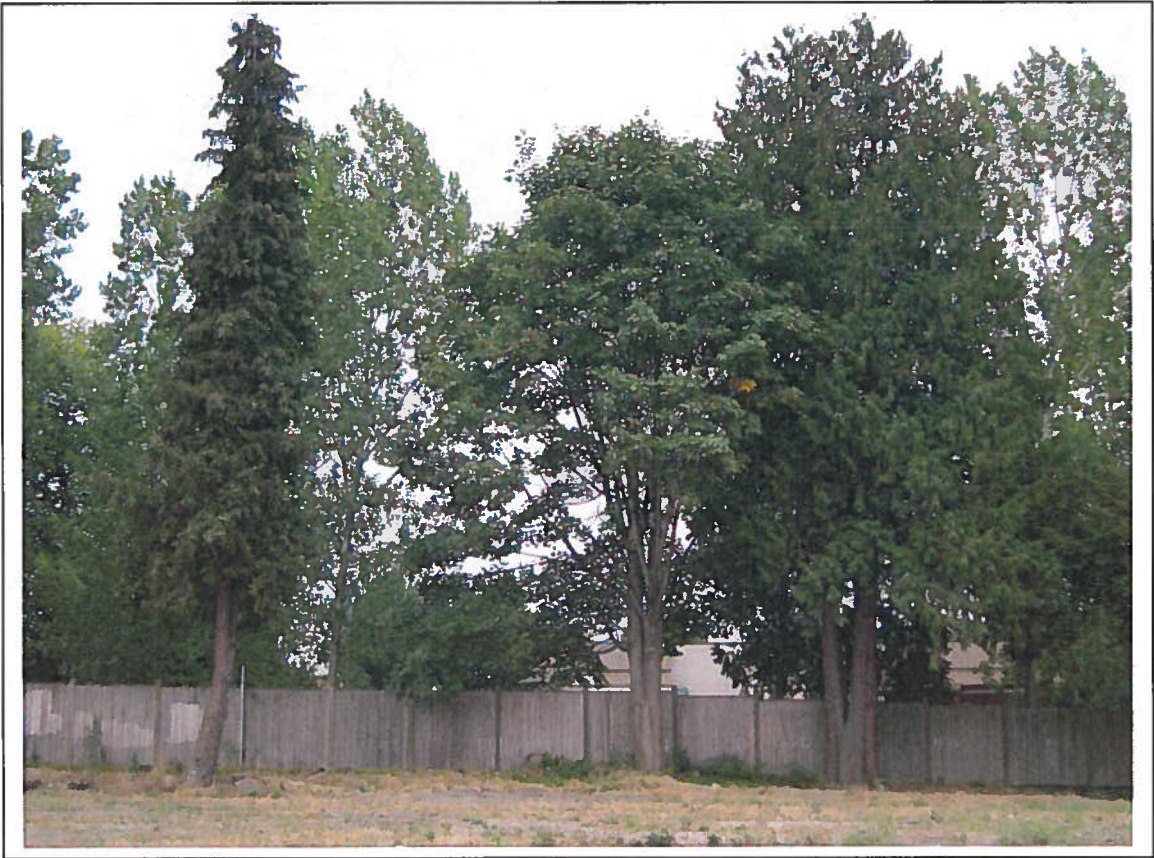
- North trees, north of the matchline, #1-18, 45-47: These are all unaesthetic and in marginal health. The exception is fir #18, which somehow escaped damage during the construction of the adjacent apartment building to the east.
- East trees, #19-24: These are benefiting from the irrigation from the adjacent library's lawn and are the most vigorous on the site. See the photo on page 5.

Trees near the east property line fence, north of S. 144th, are the healthiest because they receive irrigation from the adjacent library property.
From the left the on site trees are #19 Lawson cypress, #20 Bigleaf maple, and #21 Western red cedar.

East: The best trees on the site are near the east property line, adjacent to the irrigated King County Library lawn. I recommend saving maple #20 and cedar #21, and protect them as a group at their dripline radii. Fir #18 is also worth saving if the design will allow it.

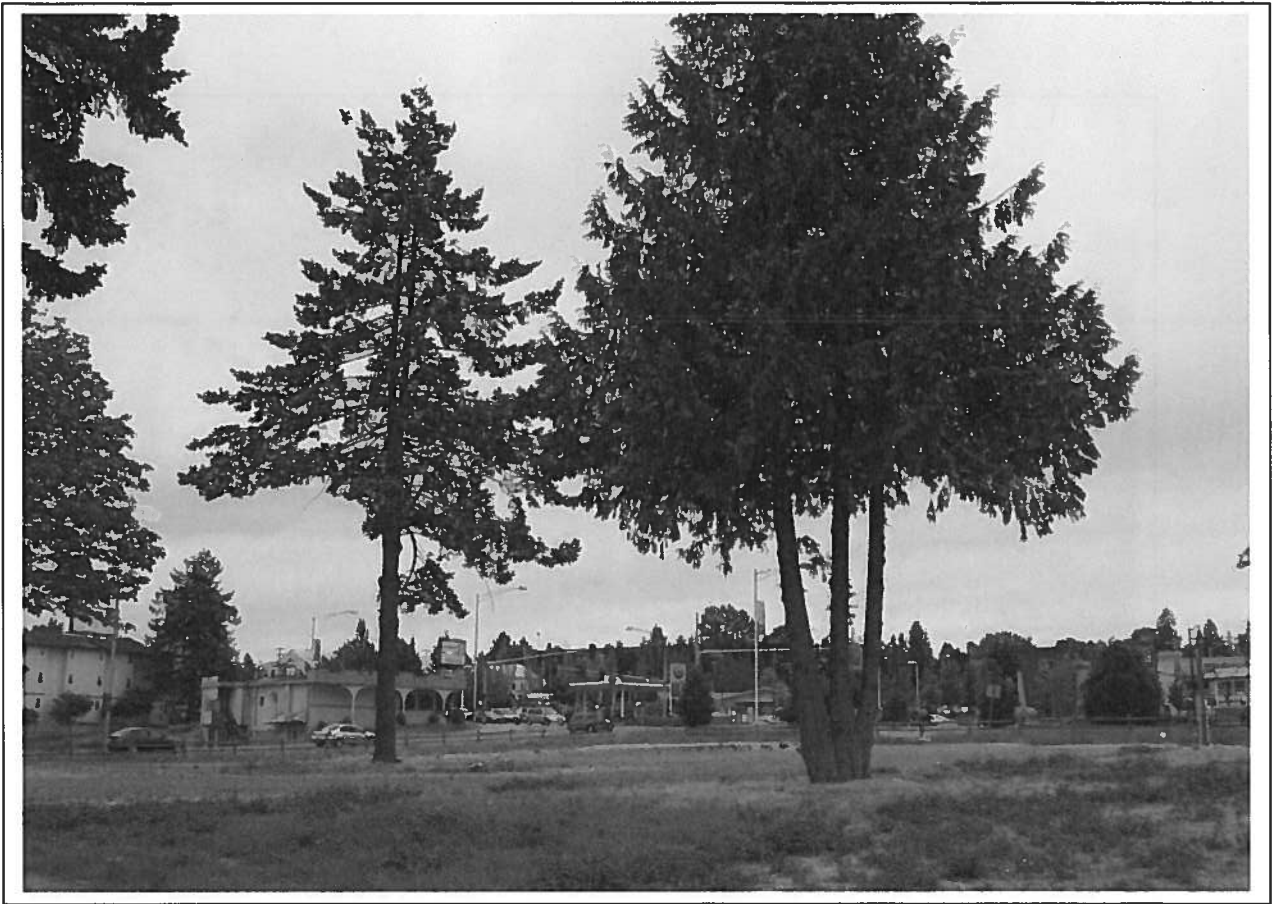
- North of S. 144th St.: The trees are dying or very stressed from wounds, excess pruning, and drought. See the photo on page 6. The exception is Coast redwood #32; even with graffiti on the trunk it stands out as a superior tree. It can grow to 200 feet and live 300 years. This species is tolerant of disturbance.

The left tree is Doug fir #41. It's dying because of damage from the asphalt poured over the roots. The right tree is Western red cedar #42 which has been excessively pruned. Many of the on site trees suffered extreme limbing and are unaesthetic. The tree in the distance, to the left of the salmon-colored building, is Coast redwood #35. It's in good health and should be retained assuming there's enough space for its roots and canopy.
