**Tina Cohen, Certified Arborist**

June 20, 2017

Site: Tukwila Village, International Blvd at S. 144<sup>th</sup> Street, Tukwila, WA  
Site visit: June 1, 2017

**Arborist Services: Coast Redwood Damage & Recommendations**

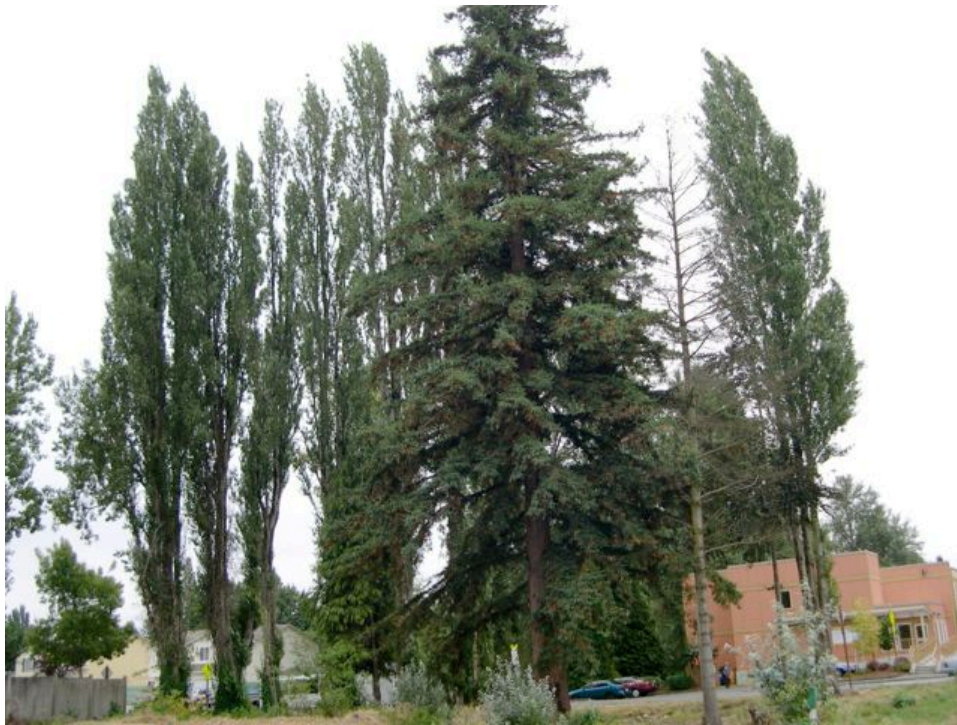
The tree is healthy but not vigorous. The canopy appears thin, although not significantly different compared with photos from 2015. However compared with the 2011 photo from the original inventory the canopy is more sparse and stressed looking. This is likely the response to root loss and/or summer drought.

Above: Photo from 9/13/2011 shows #32 Coast redwood in a flat, wet grassy area. The photo was taken standing northwest of the tree.

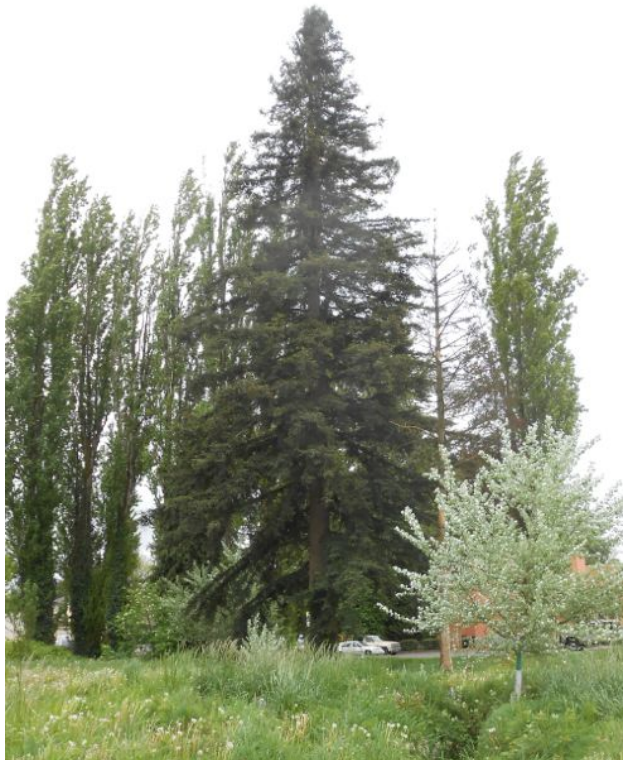
Above: The redwood on 4/28/2015 from the same angle.

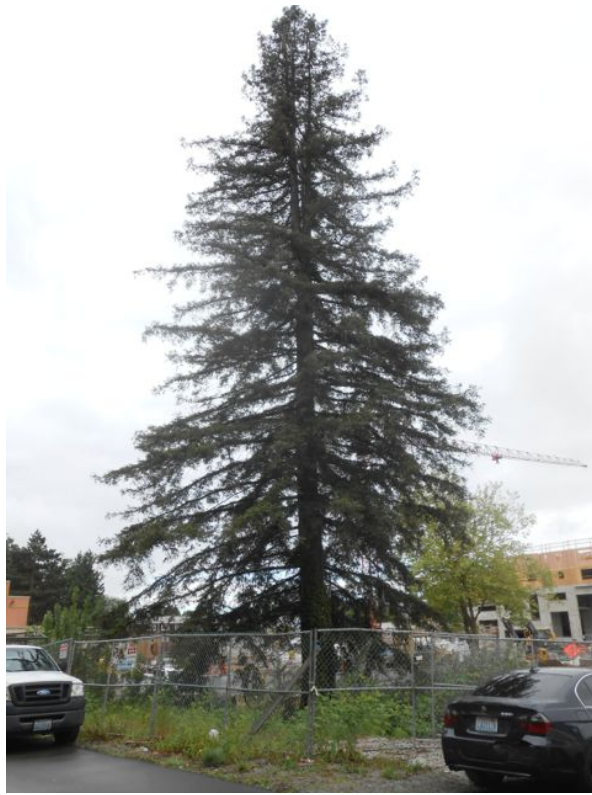
As a rule of thumb with conifers, the roots extend double the radius of the dripline. Much of the surrounding area has been filled so most of the rootzone is now below the original grade. The roots are restricted by significant amount of added compacted soil, an estimated 5 feet or more above the original grade. The fill has not impacted the trunk.

Above: The same tree 6/1/2017. The grade has been raised on all sides. Other trees were removed.

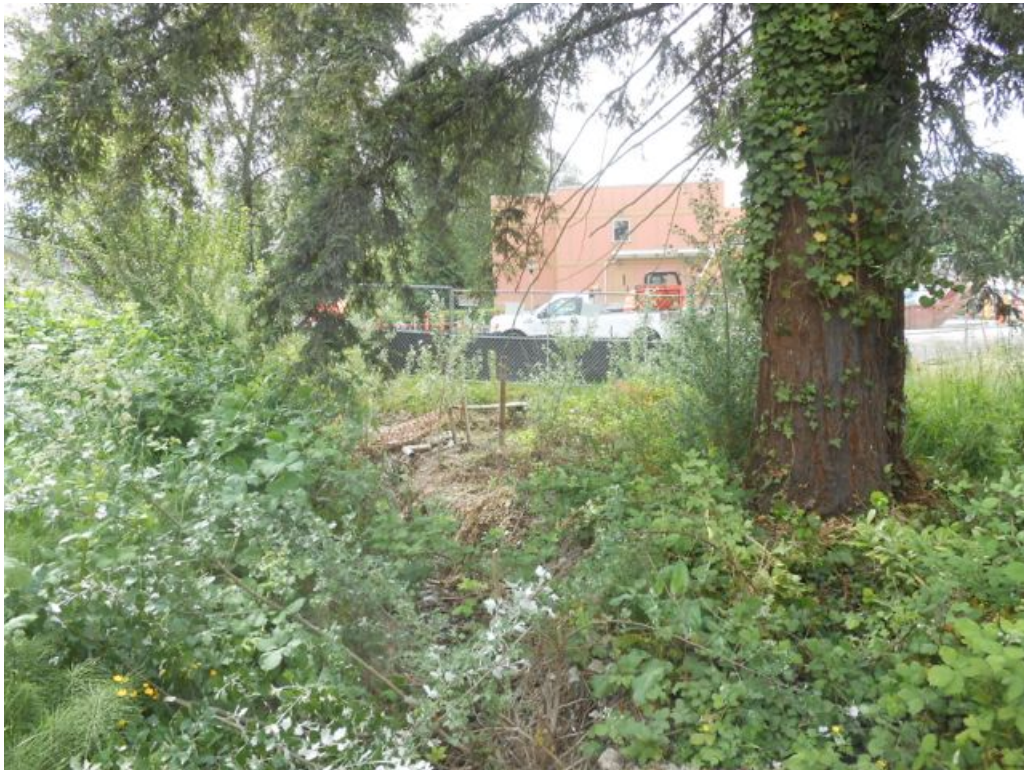
- The contractor either disregarded or did not receive the tree protection specifications listed in my 2015 report. The site plans that I reviewed did not show the Tree Protection Zone.
- In the field, the tree protection fence was located significantly closer than specified.
- The City inspector failed to include tree protection in the approval process.
- The grade change was much more excessive than indicated to me in 2015.
- The north portion of the existing drainage swale has already been filled and compacted.

Above: 6/1/2017. The existing drainage swale can be seen to the left, east of the trunk. Note the orange protection fence adjacent to the swale. The portion of the swale to the north has already been filled.

**Use permeable fill in the existing swale:** The project engineer and landscape architect shall specify a draining, permeable fill such as a mix of soil, and drain rock mixed with round sand. The fill must drain. Compacted fill will further damage the roots.

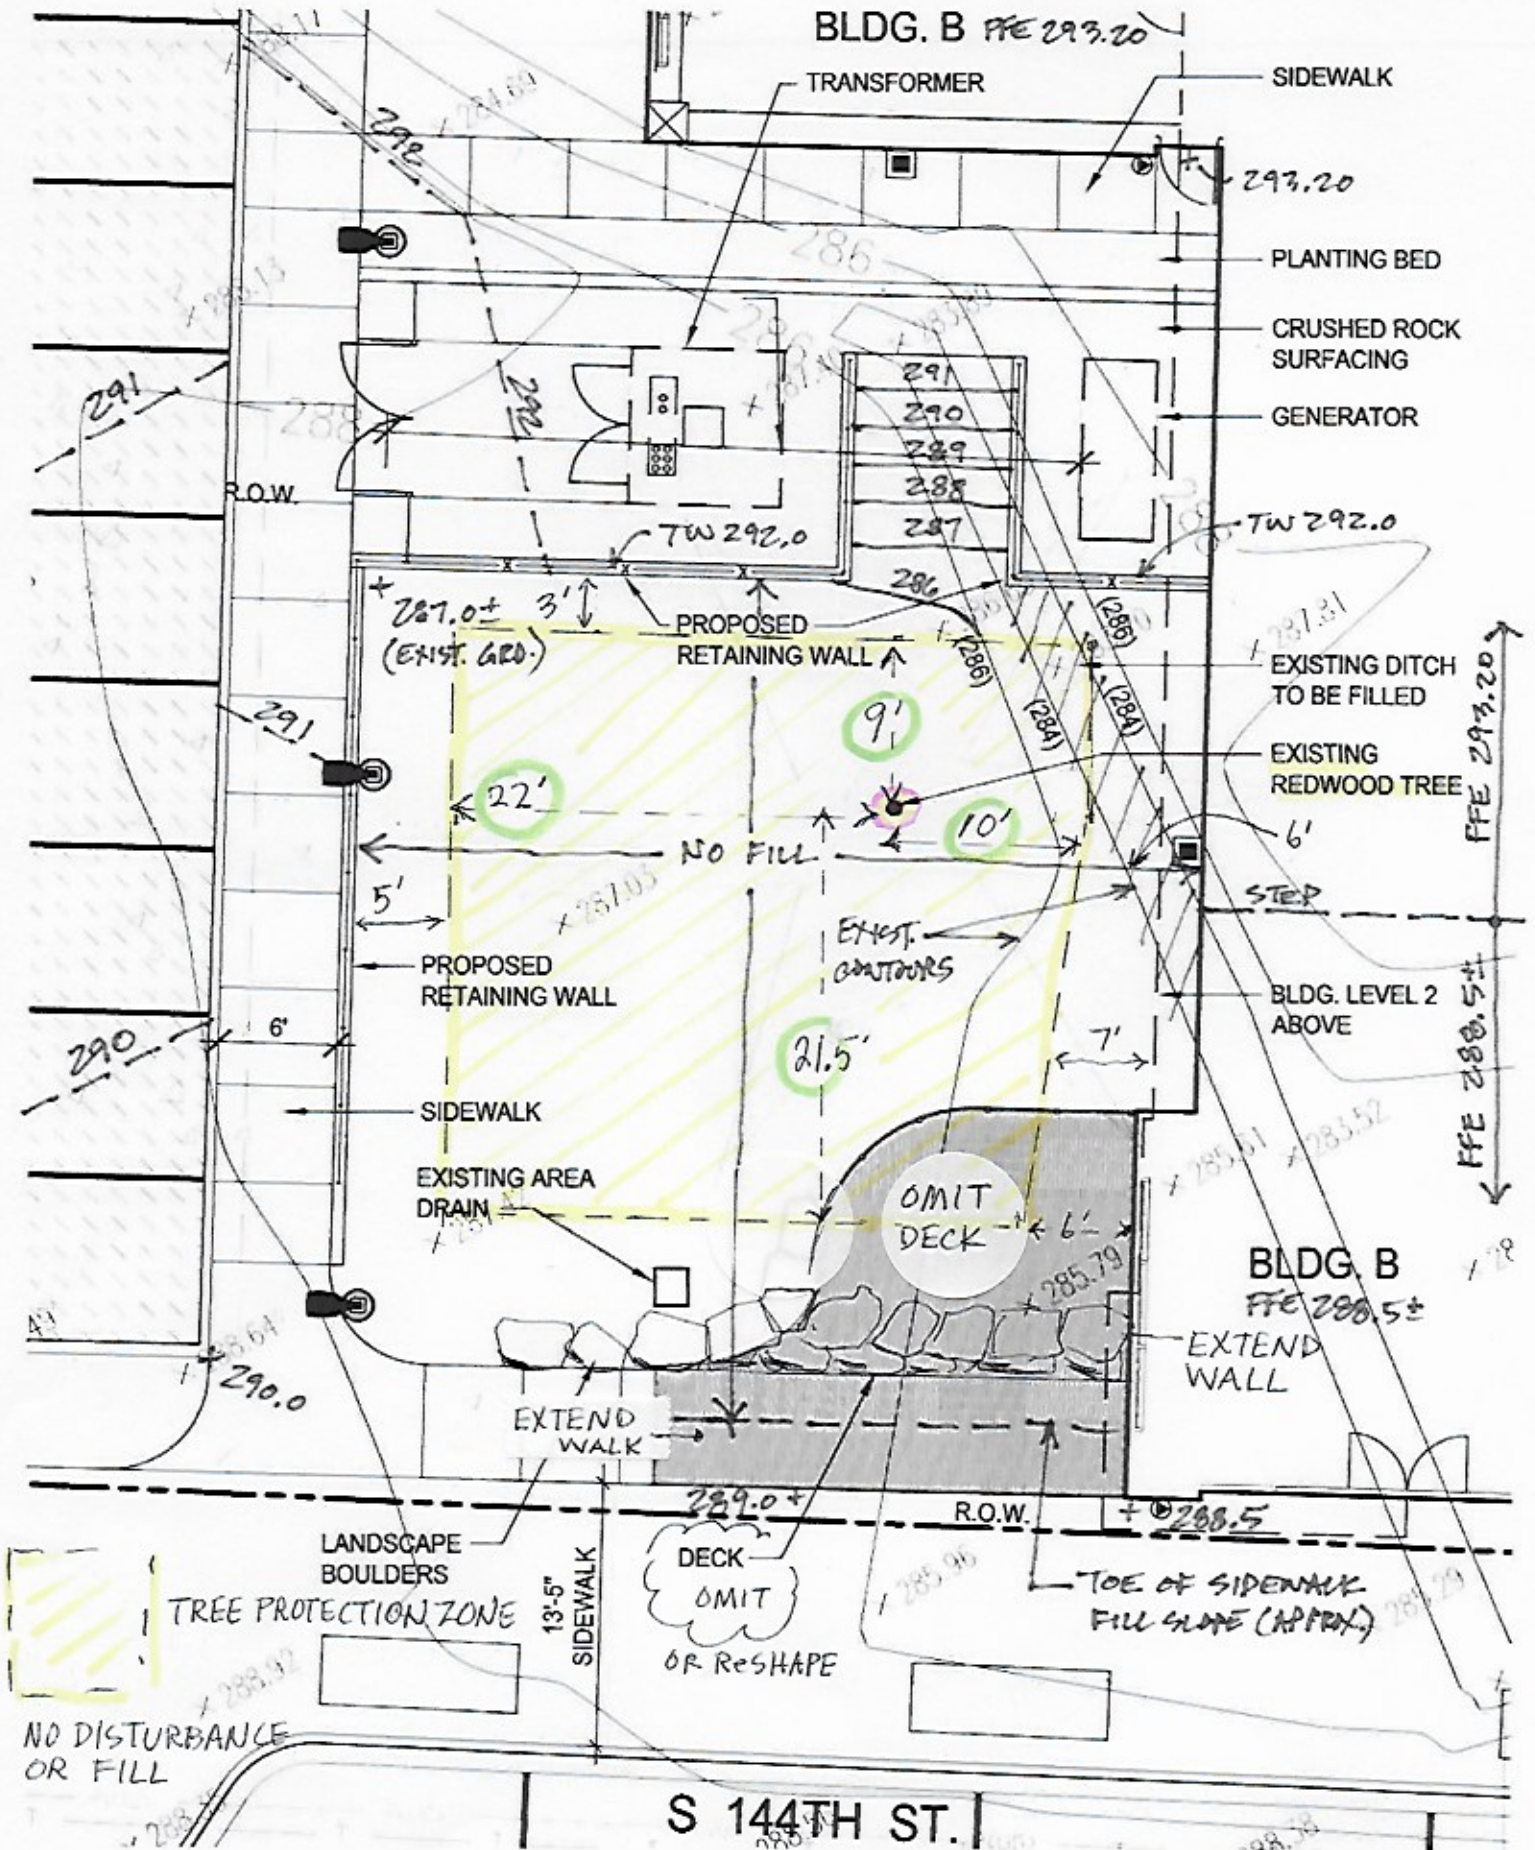
By: The LA Studio, LLC  
 Date: June 19, 2017

NOTES ADDED  
 BY TINA COHEN  
 6-20-2017

The post construction prognosis is fair. Retain the tree and be vigilant about not further impacting the roots. The Tree Protection Zone (fence location) is shown on the attached plan. There can be no incursion into this area. I recommend omitting the proposed deck.

'Tree Protection' requires the placement of a temporary fence around the tree at a specified distance throughout the project. The fence and explanation should be shown on all construction plans: There can be NO grading, excavation, storage of materials or any trespass within the Tree Protection Zone

(TPZ). If needed, temporary incursions must be first approved by the project arborist. Please the attached site plan.
