TO: **Transportation and Infrastructure Committee**
FROM: **Robin Tischmak, Acting Public Works Director** RRT
BY: **Steve Carstens, Senior Program Manager**
CC: **Mayor Ekberg**
DATE: **January 19, 2018**
SUBJECT: **Ordinance for Truck Only Speed Reduction 42nd Ave S**
Posting Load Limits on 42nd Ave S in Allentown
Bridge Load Rating Review and Update

August 2017

2.2 Tier 2 - Structural Assessment – Piers 2 and 3 Column Damages

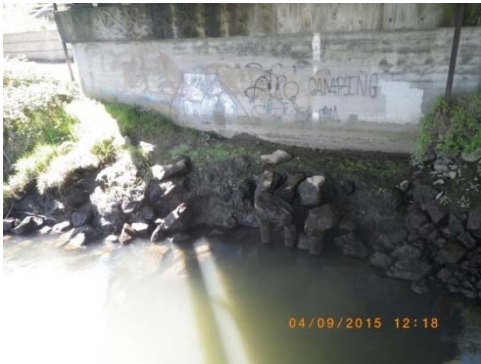
The bridge is located within the City of Tukwila on a sharp bend of the Duwamish River that produces turbulent high velocity flows at the truss abutments. These frequent flows

have caused scour damage at the bridge abutments and at the north approach roadway. Because the bridge foundation depths are unknown and there is active scour, the City has implemented a scour Plan of Action (POA) for high flow events. Additionally, existing riprap at Pier 2 is either washing away or is falling into a scour hole developing on the river side of the pier. The bridge is the only access for the BNSF intermodal yard located at the end of South 124th Street as other

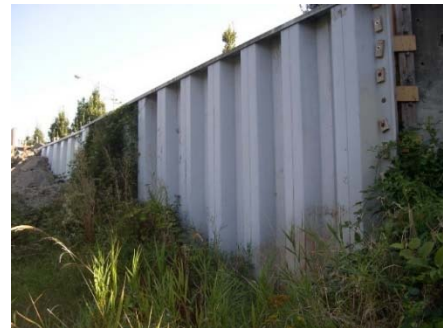
The City of Tukwila has struggled for years to maintain the bridge. Maintenance projects include a major paint project in the mid-1990’s and a significant project to rebuild the north bridge approach after erosion, caused by scour, threatened the existing roadway. This problem is currently resurfacing even after the City installed a sheet pile wall to protect the approach. A dramatic illustration is the sinking of the north approach guardrail posts with a section of the rail currently at almost ground level. There is also the ongoing problem of keeping the bridge clean enough to perform valid inspections. Cleaning the bridge adds significant cost to the

already expensive fracture critical inspections as well as adding equipment scheduling complications.

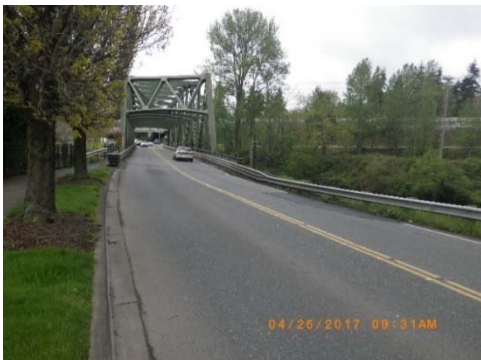
In addition to the substructure problems, the deck and floor system are in distress as evidenced by significant loud floor system creaking and deck panel banging under traffic. These problems have been reported by bridge inspectors and Tukwila

Maintenance for years. These noises cannot be associated with specific damage at this point but are worrisome in a fracture critical bridge subjected to extreme fatigue stresses by the heavy truck traffic.

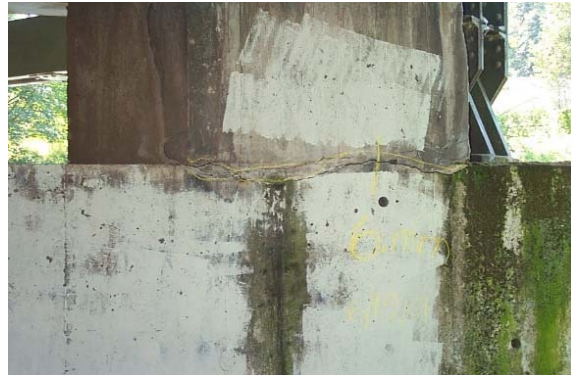
Next, seismic forces were analyzed and were shown to be large enough to yield the interface of the short columns and the piers wall as the forces are transferred through the semi rigid link caused by the frozen bearings. This condition is accentuated at the obtuse corner (i.e. Column Plinth 3A at northwest corner of the Pier 3).

The existing bridge design, which includes an extreme skew of 38°, puts these columns at additional risk from seismic events as well as from normal temperature and traffic forces as torque forces are developed and added to the high shear forces.

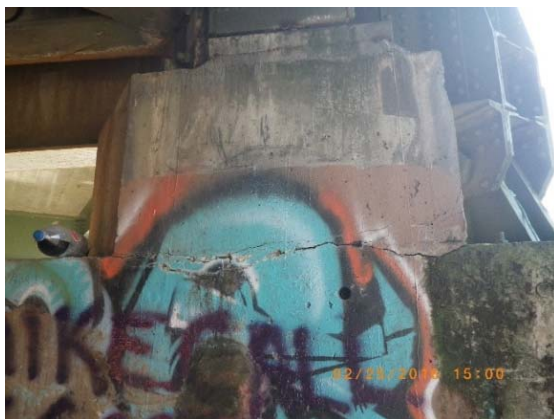
The interface cracking has been documented since 2001 (upper photo) and the cracks are currently opening and starting to spall. In addition, there has been documented evidence for many years of the deterioration of the reinforcing steel as evidenced by rusty leaching. These problems may have been initiated during the April 29, 1965 South Sound Earthquake and were likely compounded by the February 28, 2001 Nisqually earthquake. However, the damage

is aggravated daily by the constant truck traffic and seasonally due to normal temperature

forces. This constant cyclical bombardment of Column 3A make it a failure risk for Span 3.

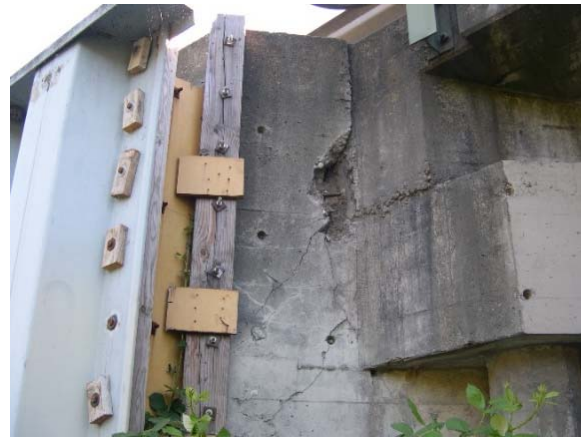
Since the rocker bearings located on the plinths are all completely frozen, there is a semi-rigid link allowing these high magnitude forces to be transmitted through Span 3 to the North Abutment, Pier 4. Again, due to the bridge's large skew, a concentration of force is toward the northwest side of the abutment as illustrated by the damage at this location. This concentration of force may play a role in the continued settlement issues of the north bridge approach roadway at the steel sheet pile wall repair mentioned above.
