INFORMATIONAL MEMORANDUM

TO: Transportation and Infrastructure Committee
FROM: Henry Hash, Public Works Director *HH*
BY: Ryan Larson, Senior Program Manager
CC: Mayor Ekberg
DATE: February 23, 2018
SUBJECT: Tukwila 205 Levee Certification
Project No. 91341203, Contract No. 14-164
Tukwila Levee Rehabilitation

LEVEE REHABILITATION REQUEST FORM

Flood Protection Facility Inspection

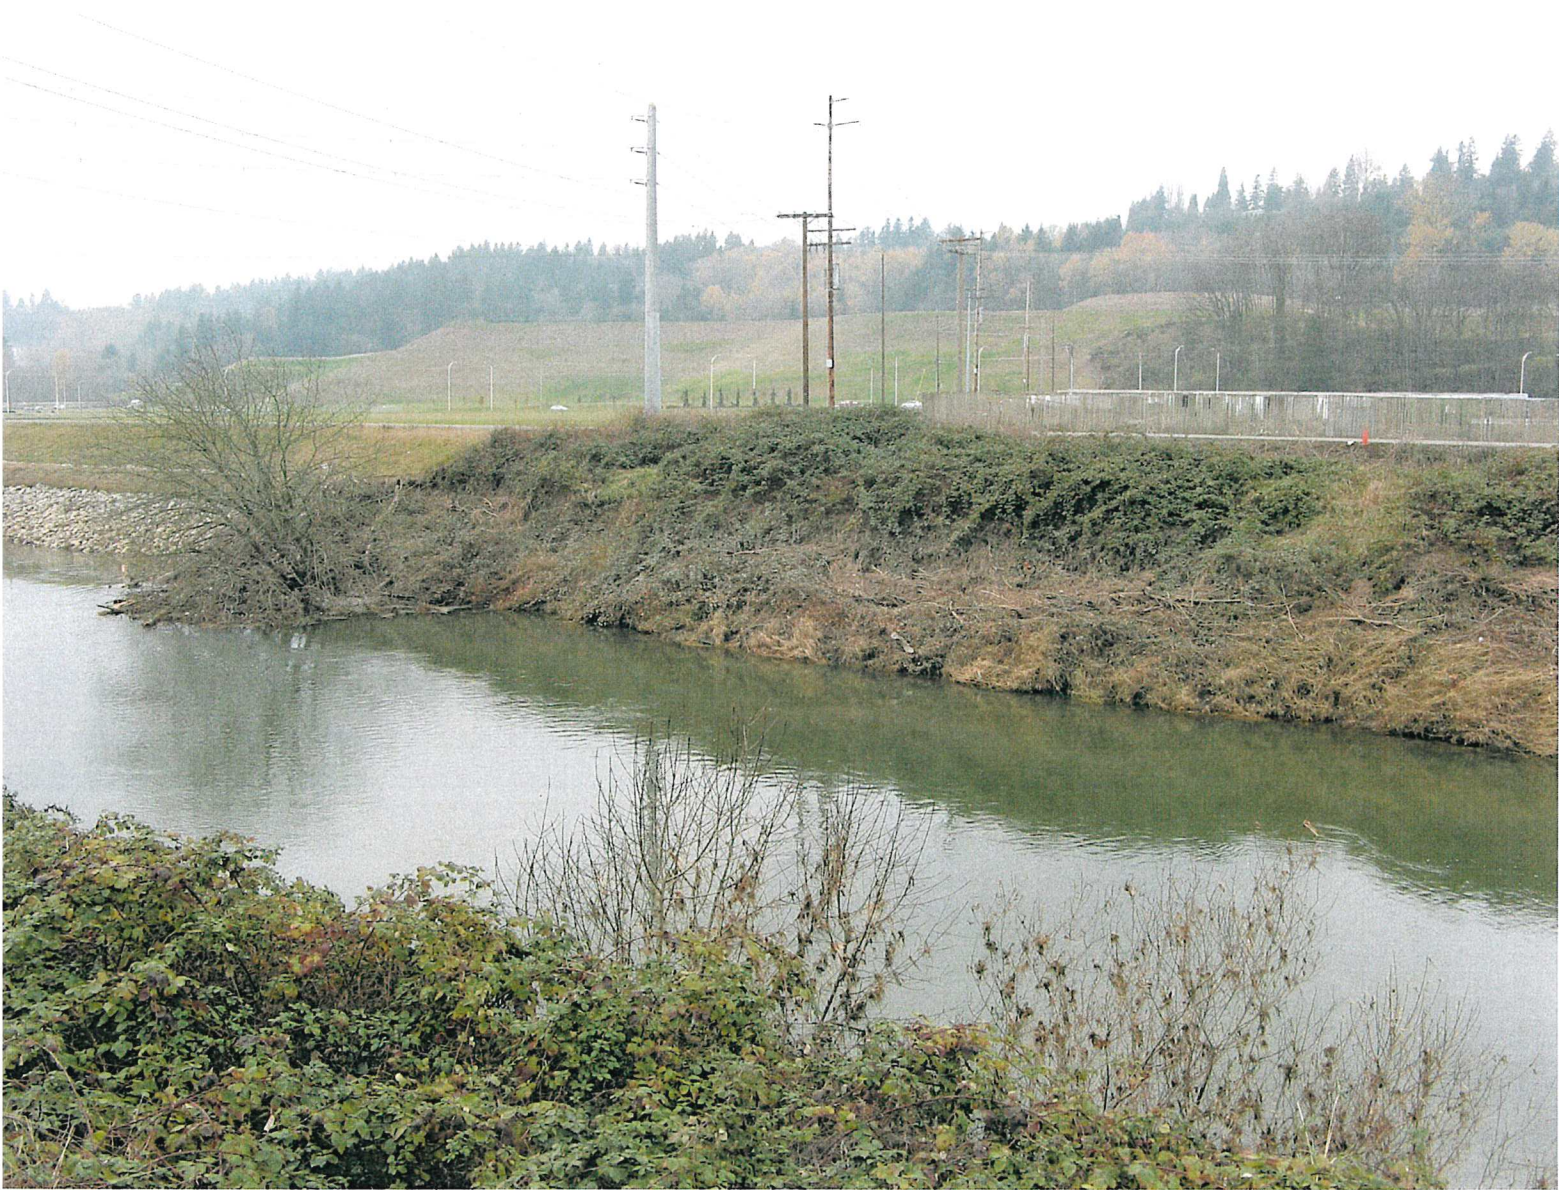
The first area is slump that is approximately 120 feet in length that begins just upstream of the Tukwila 205 cutoff levee and extends approximately 40 feet downstream into the levee. This damage is located at approximately River Mile 16.7 on the left bank.

The Site 1 repair is limited and will be repaired within its original footprint without setting the levee back or using a floodwall. Minor plantings will also be done at this location.

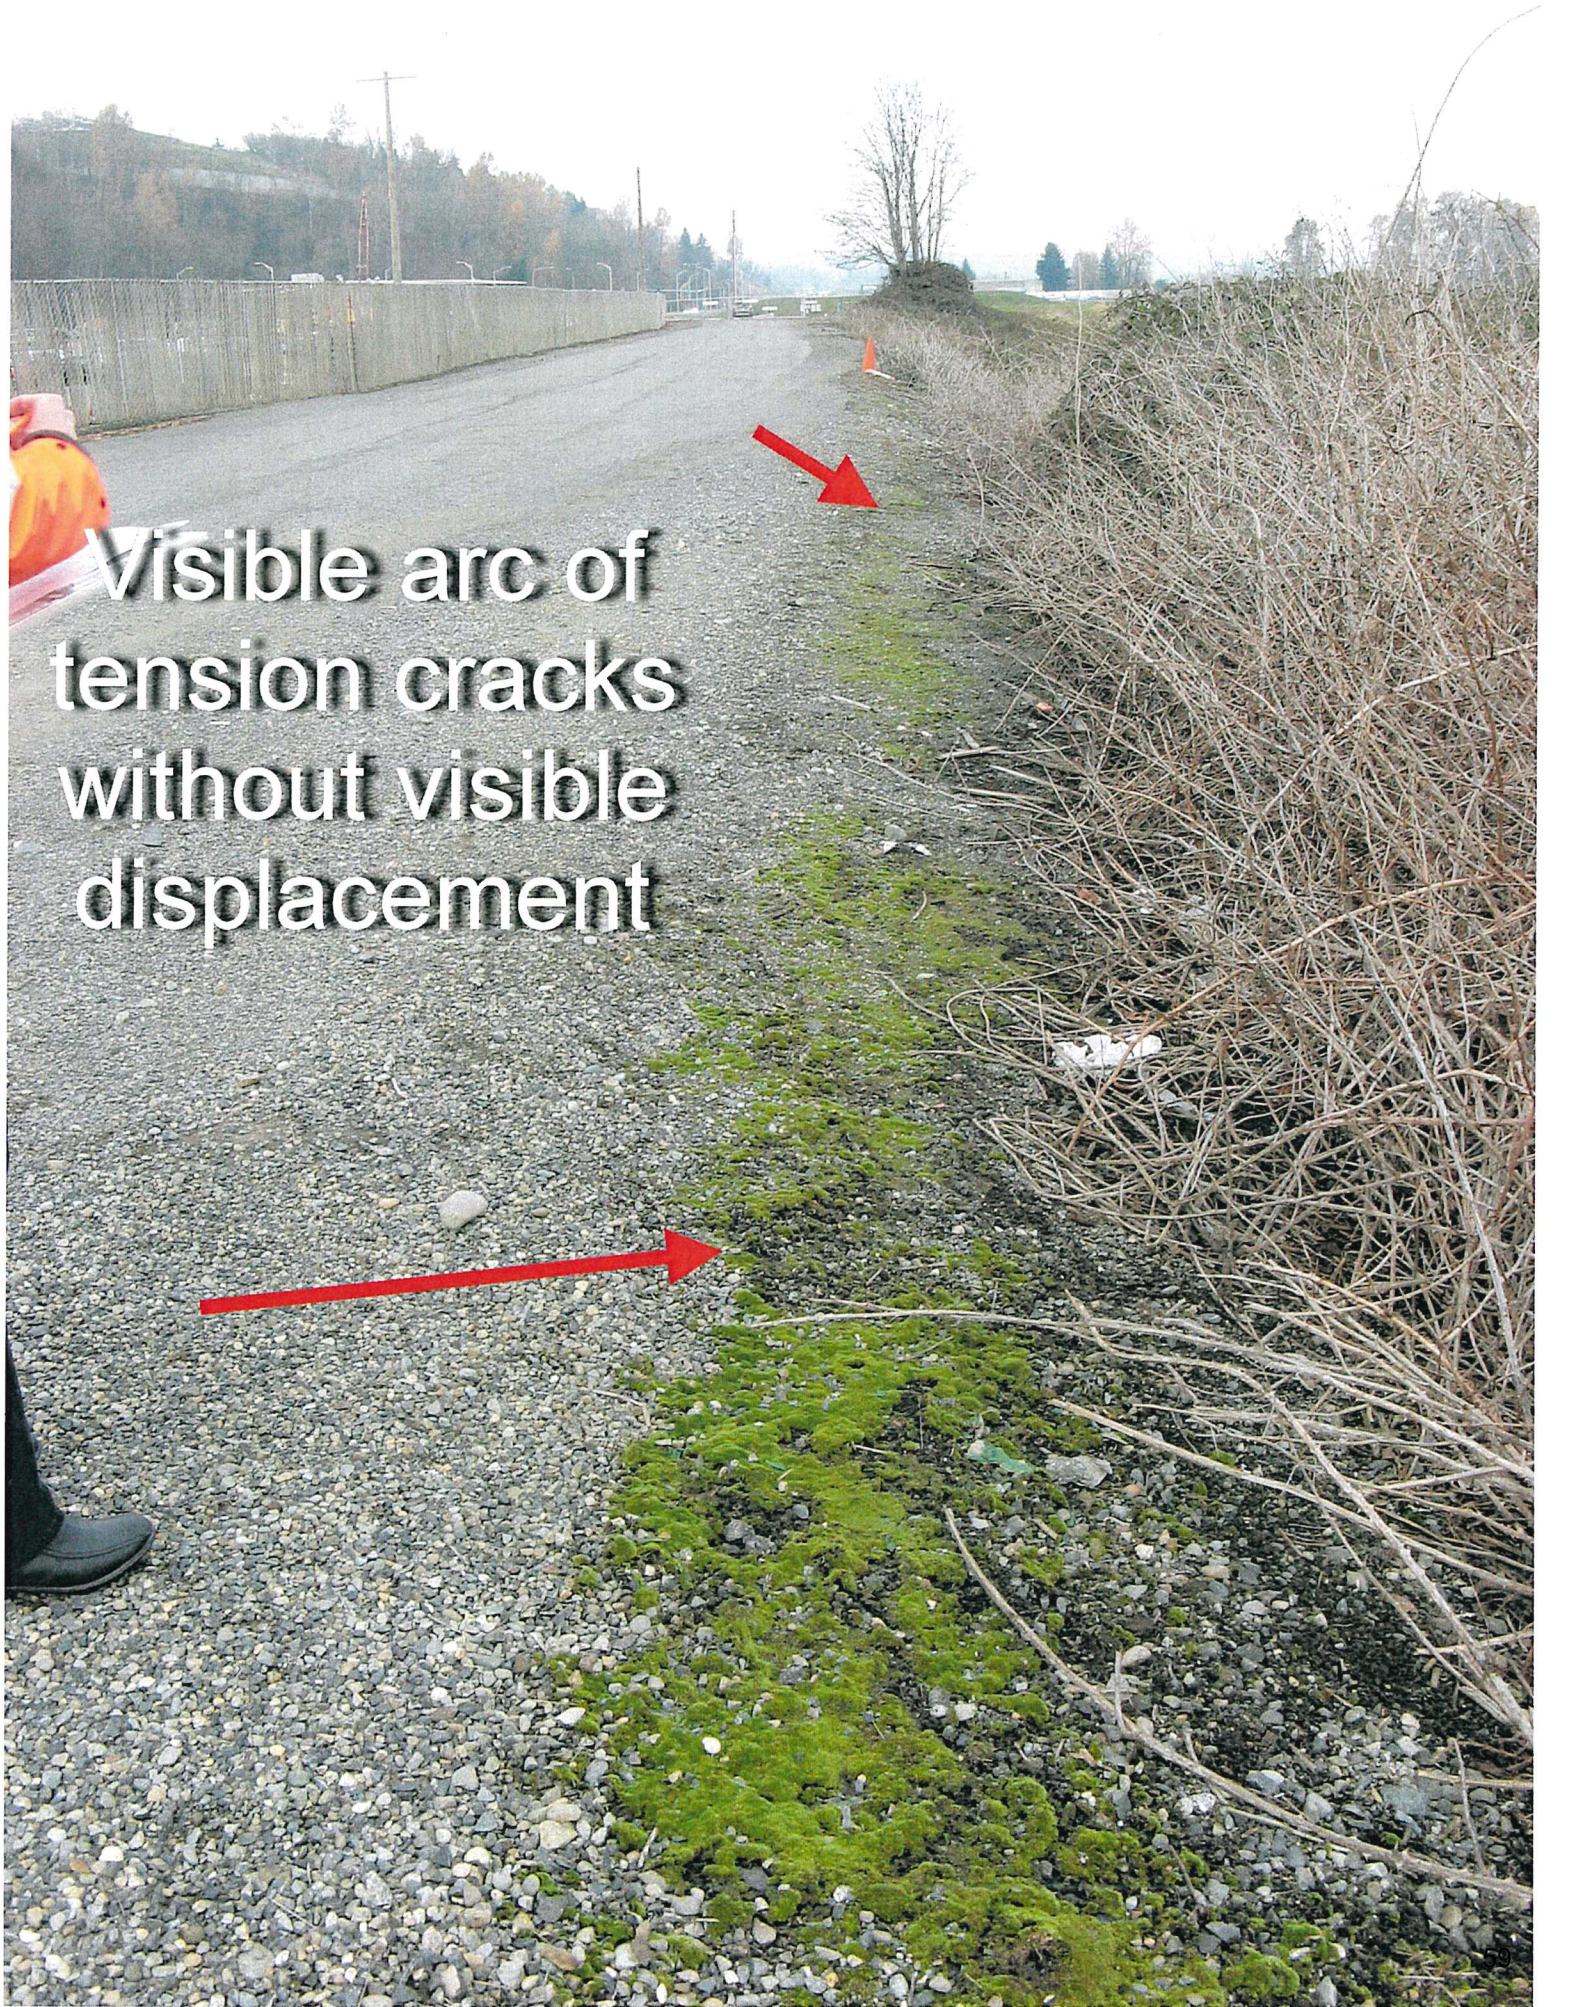
Visible arc of tension cracks without visible displacement

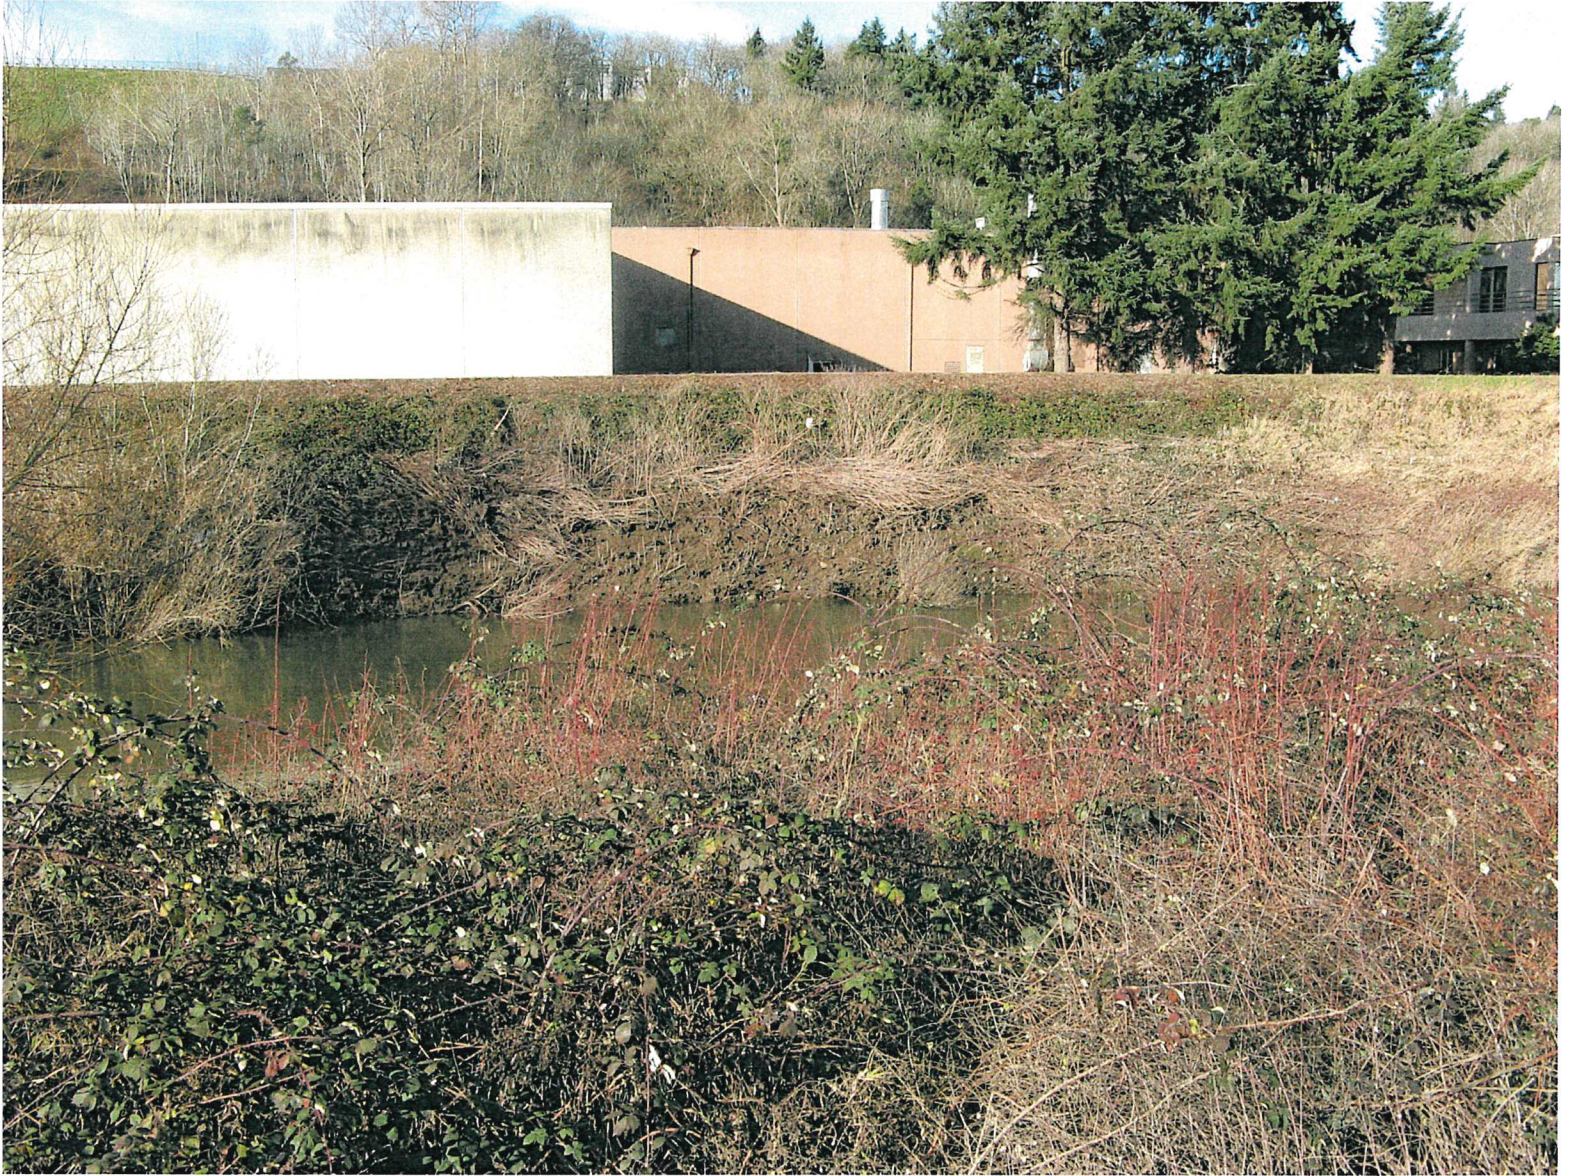
The second area of damage is an area of scour that has exposed rock armor. It is located at river mile 15.8 on the left bank and is adjacent to Mitchel moving and Storage.
