TO: Transportation and Infrastructure Committee
FROM: Henry Hash, Public Works Director
BY: Hari Ponnekanti, City Engineer
CC: Mayor Allan Ekberg
DATE: March 15, 2019
SUBJECT: BNSF Intermodal Facility Access Project
Project No. 99510409
Schedule Update and next steps

The 42nd Avenue South Bridge is a 3-span 280-foot-long bridge built in 1949. The bridge is composed of a 220-foot-long fracture critical steel thru-truss main span with 30-foot-long concrete T-beam approach spans at each end. The existing bridge is both Structurally Deficient and Functionally Obsolete.

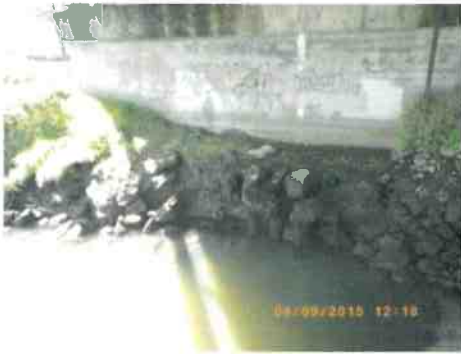
The bridge is located within the City of Tukwila on a sharp bend of the Duwamish River that produces turbulent high velocity flows at the truss abutments. These frequent flows

have caused scour damage at the bridge abutments and at the north approach roadway. Because the bridge foundation depths are unknown and there is active scour, the City has implemented a scour Plan of Action (POA) for high flow events. Additionally, existing riprap at Pier 2 is either washing away or is falling into a scour hole developing on the river side of the pier. The bridge is the only access for the BNSF intermodal yard located at the end of South 124th Street as other

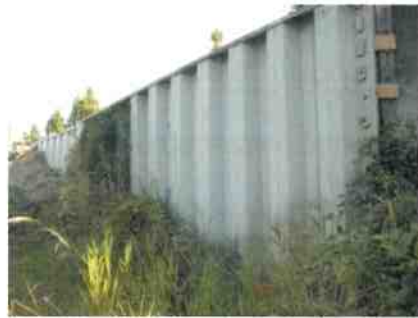
The City of Tukwila has struggled for years to maintain the bridge. Maintenance projects include a major paint project in the mid-1990’s and a significant project to rebuild the north bridge approach after erosion, caused by scour, threatened the existing roadway. This problem is currently resurfacing even after the City installed a sheet pile wall to protect the approach. A dramatic illustration is the sinking of the north approach guardrail posts with a section of the rail

currently at almost ground level. There is also the ongoing problem of keeping the bridge clean enough to perform valid inspections. Cleaning the bridge adds significant cost to the

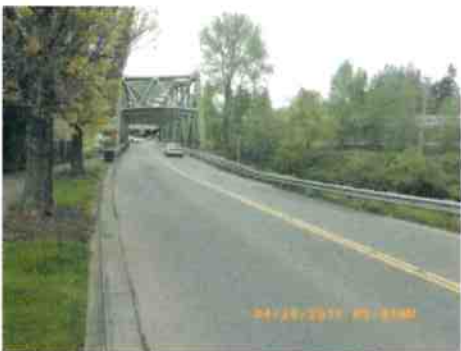
In addition to the substructure problems, the deck and floor system are in distress as evidenced by significant loud floor system creaking and deck panel banging under traffic. These problems have been reported by bridge inspectors and Tukwila

Maintenance for years. These noises cannot be associated with specific damage at this point but are worrisome in a fracture critical bridge subjected to extreme fatigue stresses by the heavy truck traffic.

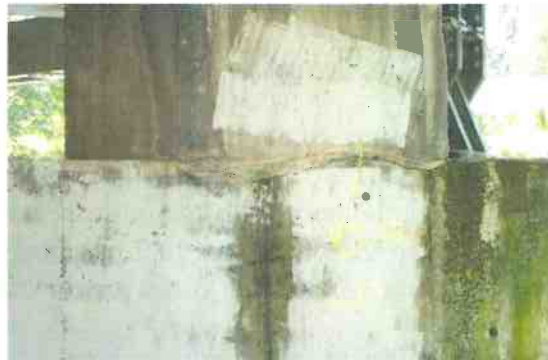
Next, seismic forces were analyzed and were shown to be large enough to yield the interface of the short columns and the piers wall as the forces are transferred through the semi rigid link caused by the frozen bearings. This condition is accentuated at the obtuse corner (i.e. Column Plinth 3A at northwest corner of the Pier 3).

The existing bridge design, which includes an extreme skew of 38°, puts these columns at additional risk from seismic events as well as from normal temperature and traffic forces as torque forces are developed and added to the high shear forces.

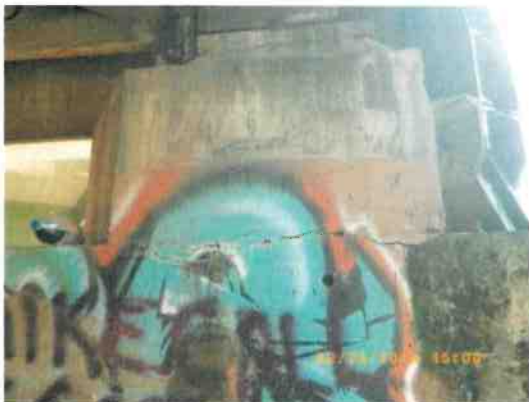
The interface cracking has been documented since 2001 (upper photo) and the cracks are currently opening and starting to spall. In addition, there has been documented evidence for many years of the deterioration of the reinforcing steel as evidenced by rusty leaching. These problems may have been initiated during the April 29, 1965 South Sound Earthquake and were likely compounded by the February 28, 2001 Nisqually earthquake. However, the damage is aggravated daily by the constant truck traffic and seasonally due to normal temperature

forces. This constant cyclical bombardment of Column 3A make it a failure risk for Span 3.

1676 **SUBSTRUCTURE**
 Code reduced to 4 due to condition of concrete plinths under rocker bearings at piers 2 and 3.
 Pier 2 plinth 2A, and 2B have open cracks at interface with pier cap. All plinths have large spalls with exposed rebar along edges, several are spalled under bearing plates.
 Pier 3 plinth 3A and 3B have open cracks at interface with pier cap. Several plinths have spalls with exposed rebar.

Repair No	Pr	R	Repair Descriptions	Noted	Maint	Verified
13475	2	B	STRUCTURAL SUBSTRUCTURE: (RPH Revised 4/8/13) Concrete columns supporting sliding bearings at Piers 2 and 3 have horizontal cracks at cap interface, exposed rusty rebar, spalls and delaminations. Pier 2 - Cap has spall, with rusted rebar and open cracks up to .05mm. Pier 3 - heavily abraded at waterline. Pier 4 - columns 4A-C have horizontal cracks. Abutment backwall is undermining along west half. West wing wall has large open crack and spalls. REPAIRS: P2 and P3 bearing columns - recommend design seismic retrofit steel collar and construct around bearing columns, anchored to cap, then fill tight with epoxy. Pier 2 - cap clean exposed rebar and patch spalls, epoxy inject cracks. Pier 3 - clean and patch abraded areas of pier wall Pier 4 - FRP wrap columns 4 A-C. Reinforce west wingwall. Add quarryspall along abutment 4 and under span 3 to retain fill and discourage transient activity.	4/16/2013

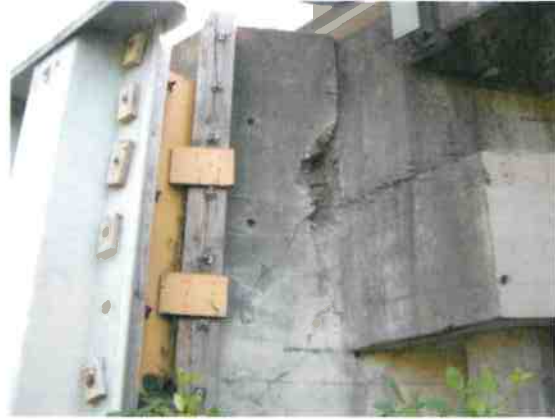
Since the rocker bearings located on the plinths are all completely frozen, there is a semi-rigid link allowing these high magnitude forces to be transmitted through Span 3 to the North Abutment, Pier 4. Again, due to the bridge's large skew, a concentration of force is toward the northwest side of the abutment as illustrated by the damage at this location. This concentration of force may play a role in the continued settlement issues of the north bridge approach roadway at the steel sheet pile wall repair mentioned above.
