INFORMATIONAL MEMORANDUM

TO: **Transportation and Infrastructure Committee**
FROM: **Henry Hash, Public Works Director** *H.H.*
BY: **Hari Ponnekanti, City Engineer**
CC: **Mayor Allan Ekberg**
DATE: **January 31, 2020**
SUBJECT: **42nd Ave South Bridge Replacement**
Project No. 91810404
Project Update and Next Steps

PROJECT: 42nd Ave S Bridge Replacement

The City of Tukwila Public Works

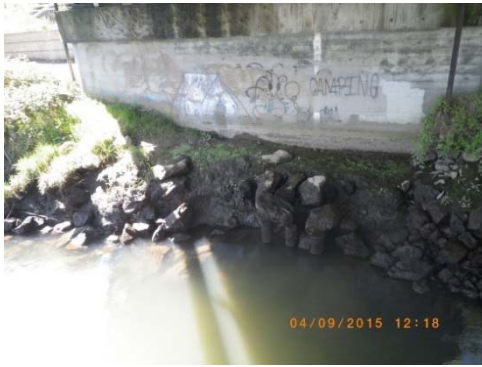
The bridge is located within the City of Tukwila on a sharp bend of the Duwamish River that produces turbulent high velocity flows at the truss abutments. These frequent flows

have caused scour damage at the bridge abutments and at the north approach roadway. Because the bridge foundation depths are unknown and there is active scour, the City has implemented a scour Plan of Action (POA) for high flow events. Additionally, existing riprap at Pier 2 is either washing away or is falling into a scour hole developing on the river side of the pier. The bridge is the only access for the BNSF intermodal yard located at the end of South 124th Street as other

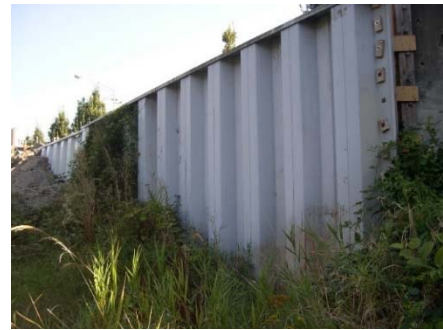
The City of Tukwila has struggled for years to maintain the bridge. Maintenance projects include a major paint project in the mid-1990’s and a significant project to rebuild the north bridge approach after erosion, caused by scour, threatened the existing roadway. This problem is currently resurfacing even after the City installed a sheet pile wall to protect the approach. A dramatic illustration is the sinking of the north approach guardrail posts with a section of the rail currently at almost ground level. There is also the ongoing problem of keeping the bridge clean enough to perform valid inspections. Cleaning the bridge adds significant cost to the

already expensive fracture critical inspections as well as adding equipment scheduling complications.

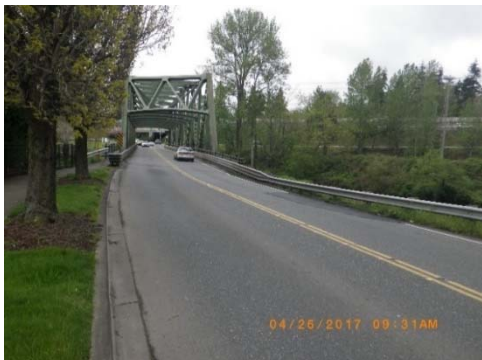
In addition to the substructure problems, the deck and floor system are in distress as evidenced by significant loud floor system creaking and deck panel banging under traffic. These problems have been reported by bridge inspectors and Tukwila

Maintenance for years. These noises cannot be associated with specific damage at this point but are worrisome in a fracture critical bridge subjected to extreme fatigue stresses by the heavy truck traffic.

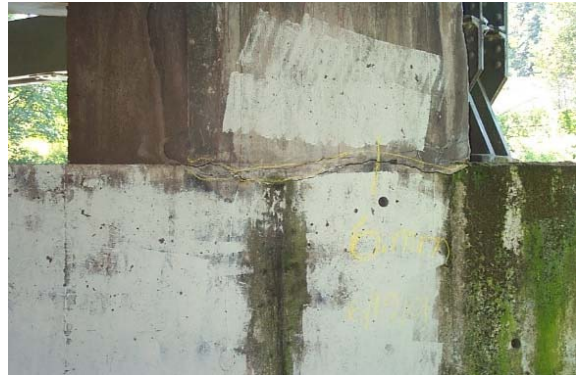
Next, seismic forces were analyzed and were shown to be large enough to yield the interface of the short columns and the piers wall as the forces are transferred through the semi rigid link caused by the frozen bearings. This condition is accentuated at the obtuse corner (i.e. Column Plinth 3A at northwest corner of the Pier 3).

The existing bridge design, which includes an extreme skew of 38°, puts these columns at additional risk from seismic events as well as from normal temperature and traffic forces as torque forces are developed and added to the high shear forces.

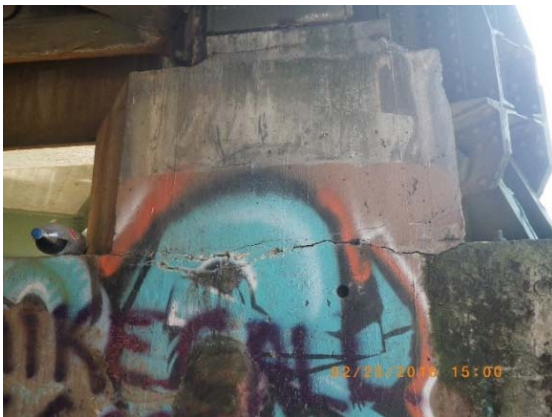
The interface cracking has been documented since 2001 (upper photo) and the cracks are currently opening and starting to spall. In addition, there has been documented evidence for many years of the deterioration of the reinforcing steel as evidenced by rusty leaching. These problems may have been initiated during the April 29, 1965 South Sound Earthquake and were likely compounded by the February 28, 2001 Nisqually earthquake. However, the damage

is aggravated daily by the constant truck traffic and seasonally due to normal temperature

forces. This constant cyclical bombardment of Column 3A make it a failure risk for Span 3.

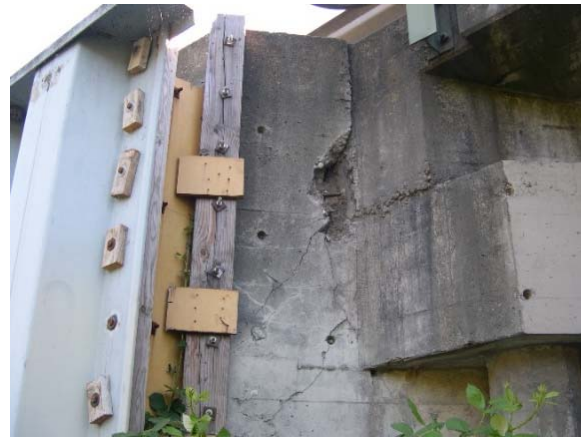
Since the rocker bearings located on the plinths are all completely frozen, there is a semi-rigid link allowing these high magnitude forces to be transmitted through Span 3 to the North Abutment, Pier 4. Again, due to the bridge's large skew, a concentration of force is toward the northwest side of the abutment as illustrated by the damage at this location. This concentration of force may play a role in the continued settlement issues of the north bridge approach roadway at the steel sheet pile wall repair mentioned above.
