INFORMATIONAL MEMORANDUM

BACKGROUND

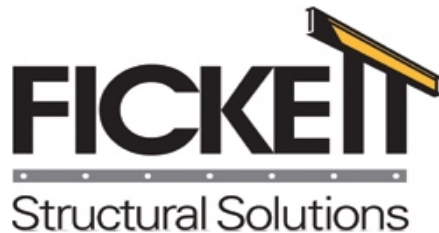
Co-Inspector Signature:

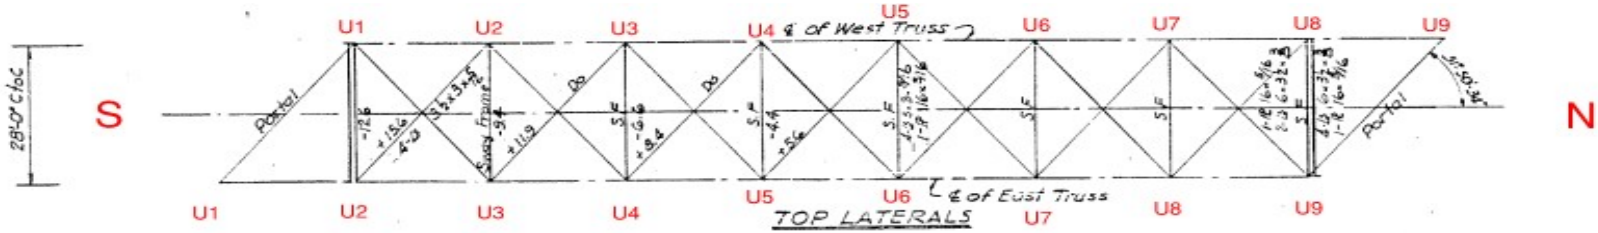
NOTE
Tension thus +
Compression thus -

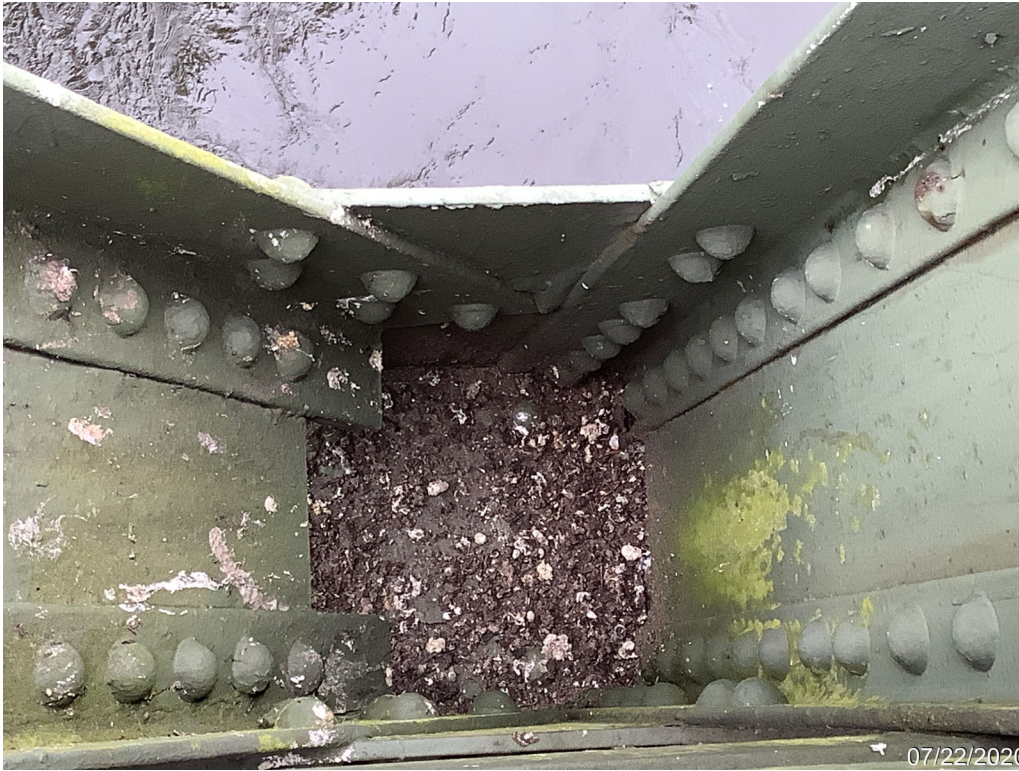
Inspection Photo 3 – Lower Connections with Horizontal Gussets Retain Moisture and Guano

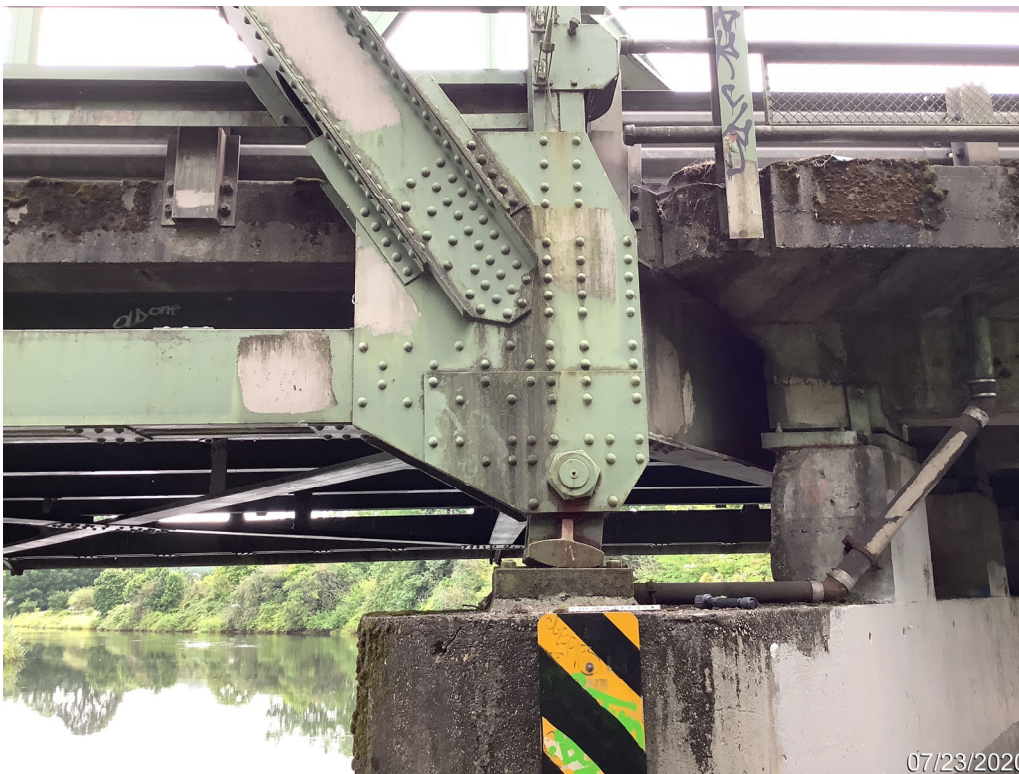
Inspection Photo 4 – Frozen Truss Bearings Induce Additional Stresses on the Trusses

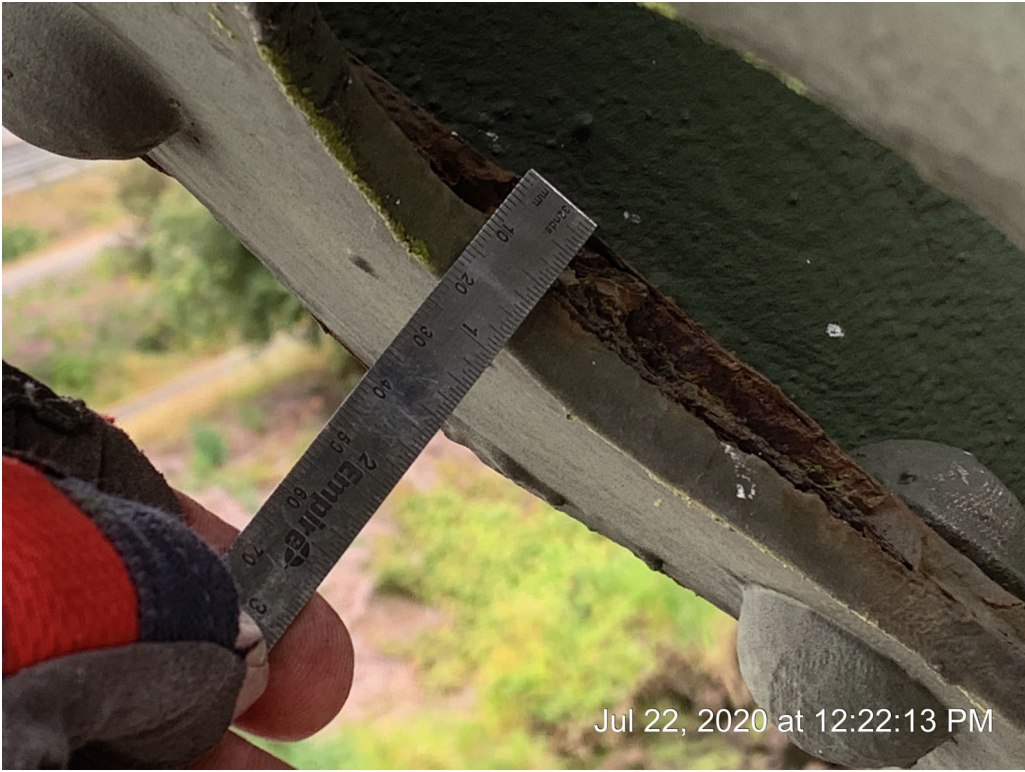
Inspection Photo 5 – Pack Rust is Distorting some Connections

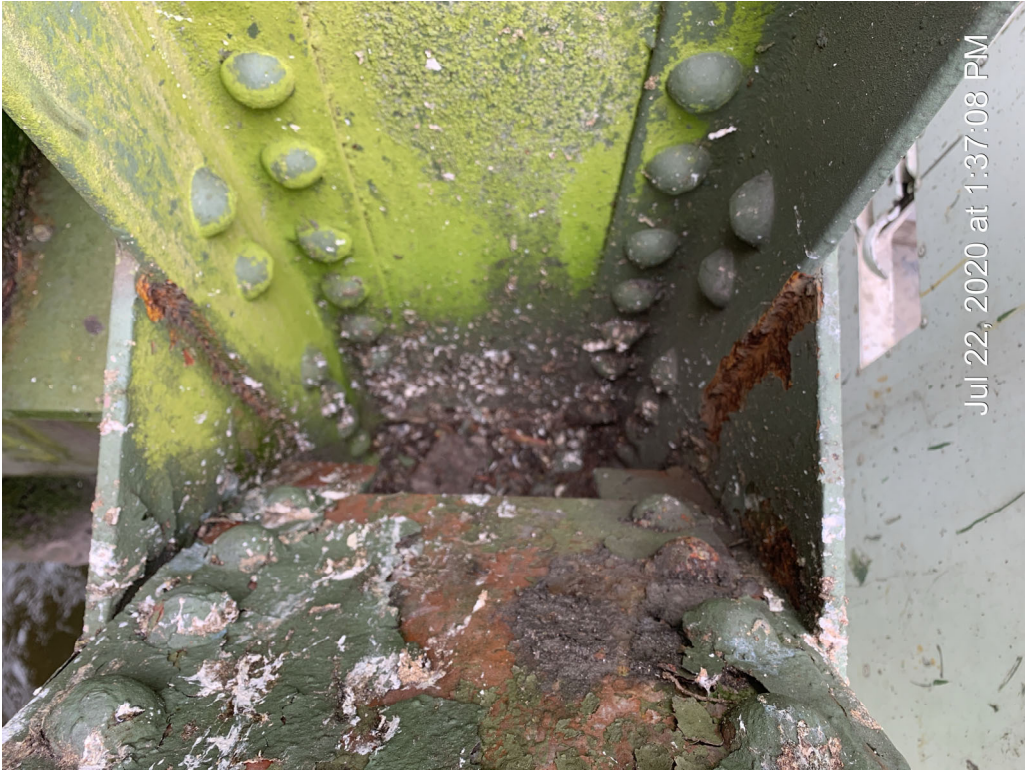
Inspection Photo 6 – Rust and Guano at Truss Bottom Chord

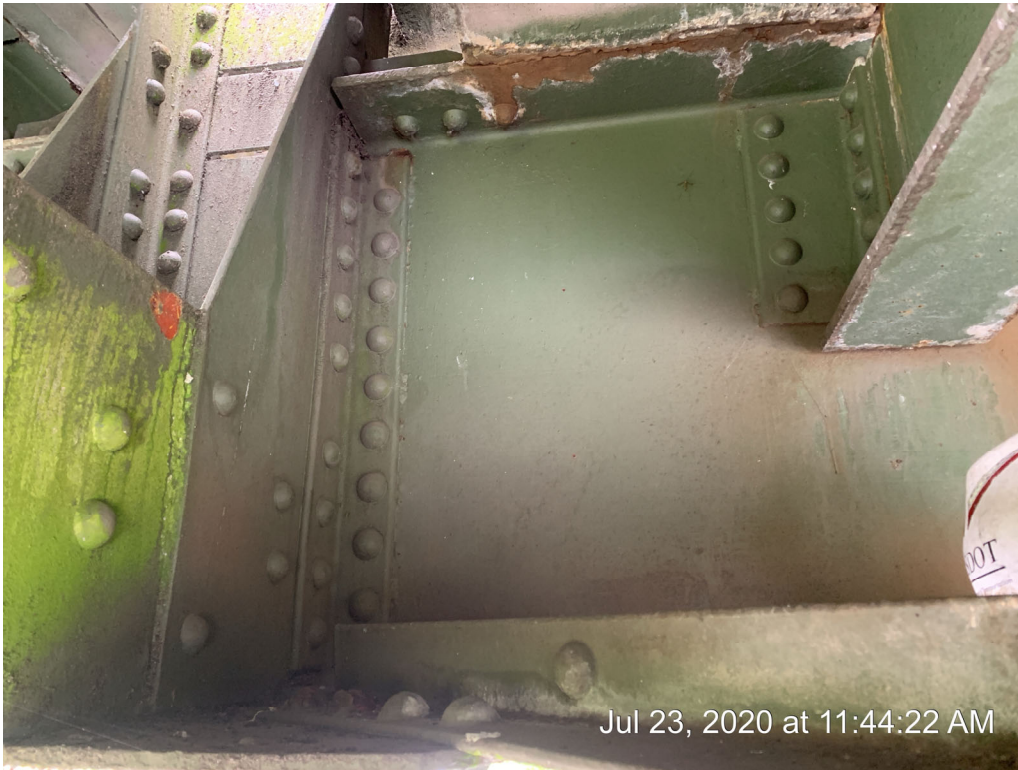
Inspection Photo 7 – Rust at Top Flange of Fracture Critical Floor Beams

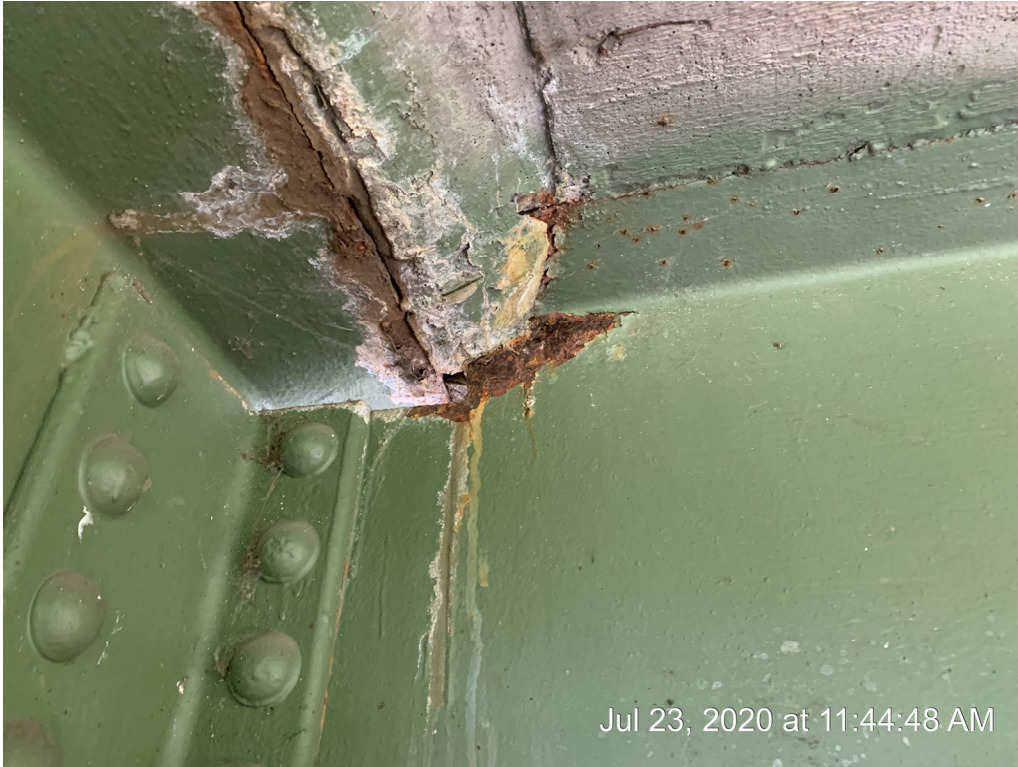
Inspection Photo 8 – Moisture from Deck Penetrating and Corroding Top Flange of Stringers
