# PROPERTY CONDITION ASSESSMENT

## Fire Station 52

5900 South 147<sup>th</sup> Street, Tukwila, WA 98168

**April 26, 2021**

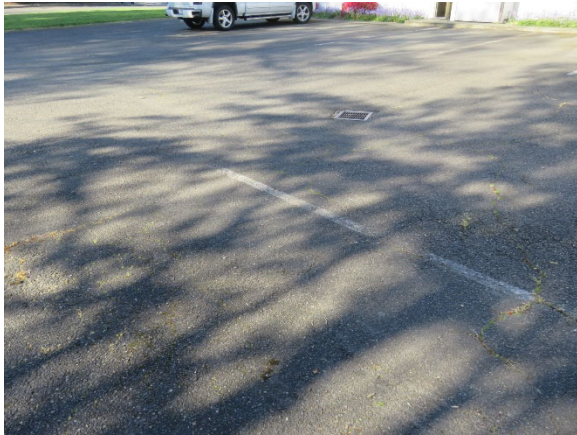
East Asphalt Parking Lot

Generally, the asphalt appears to be in fair condition. However, we recommend that the asphalt be sealed and restriped in 2021. The cost to seal and stripe a lot of this size will be approximately 36 cents per square foot including tax. This level of maintenance will likely be necessary every 5 years.

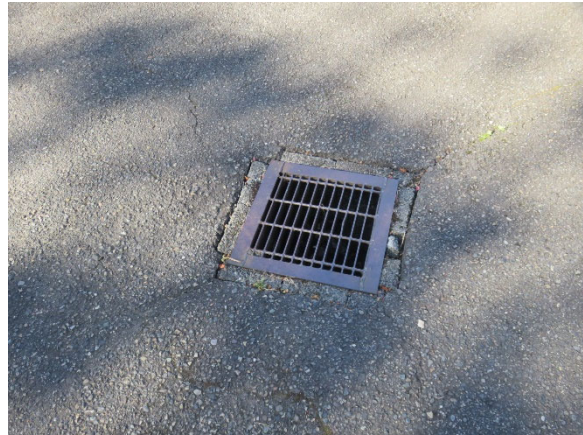
There are storm drains located in the parking lots. We do not know the specific configuration of this storm system as no drawings were available. However, the storm system appears to be effective as there was no evidence of significant standing water in the parking lot around this property.

Storm Drain

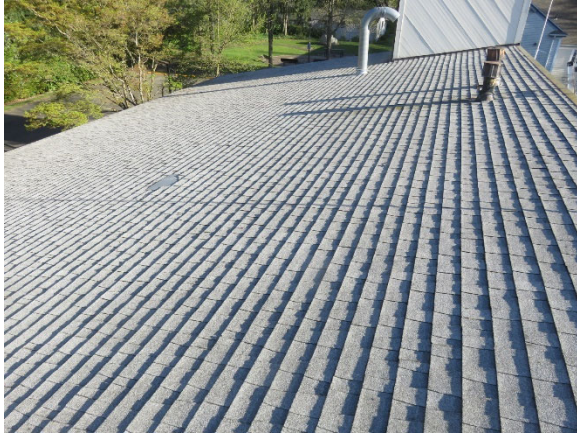
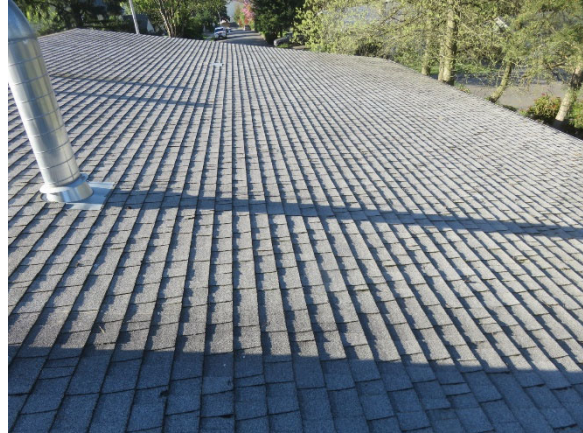
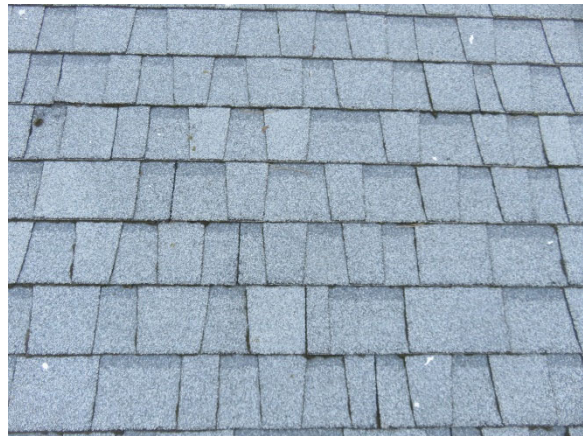
The roof surface is nominally a 30-year surface; however, we do not know when this roof surface was installed. The actual shingles of this roof appear to have approximately 5 years remaining life; however, there have been numerous leaks in this roof over the recent past that we suspect that this was not an adequate roof installation, perhaps the underlayment was not installed properly. Therefore, we recommend that the roof surface be replaced within the next year.

Upper Roof of the Building

Close-up of Upper Roof of the Building

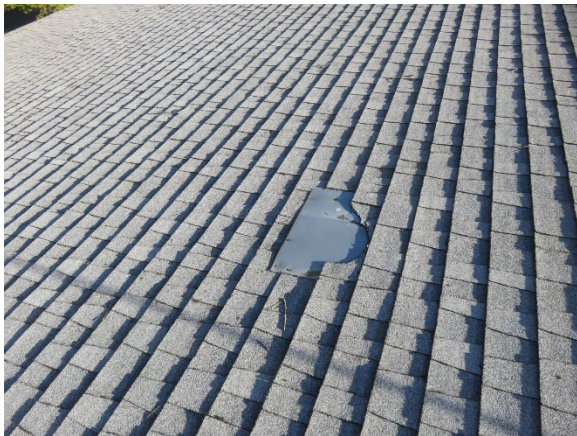
Repairs of Former Damage to the Upper Roof

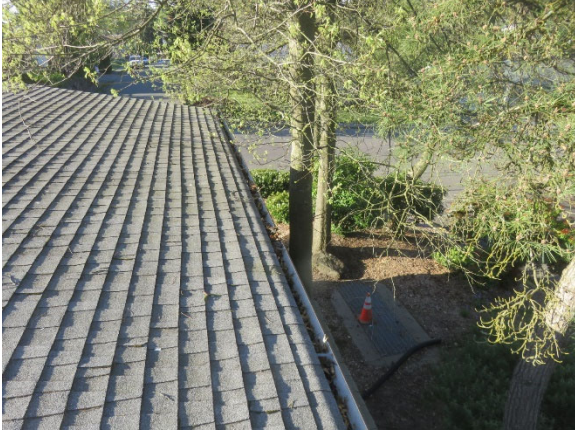
The gutters and downspouts appear to be functioning properly; however, they are old, and it would make sense to replace the gutters and the downspouts when this building is re-clad.

Western Gutter

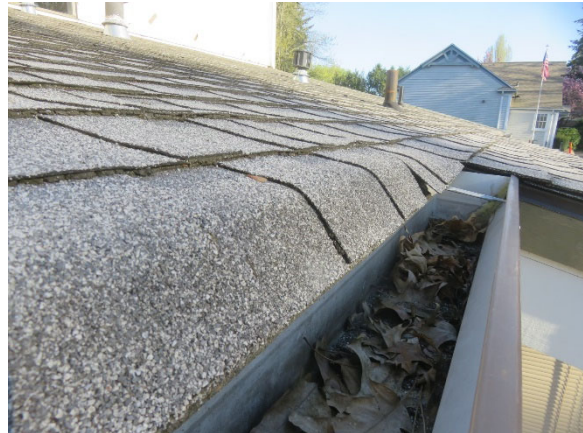
Shingles Bent into Gutter on Lower Roof of the Building

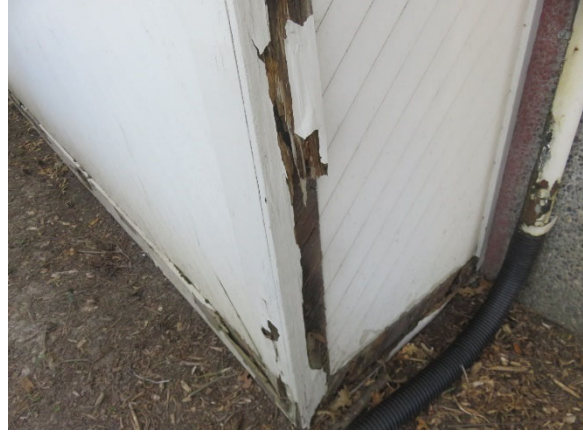
Many areas of the wood trim on this building are rotting, plus areas of the siding on the west side of the building and the west side of the tower are rotting. While other areas of the siding do have some life remaining, the siding was never primed before it was painted. Therefore, we believe that complete removal of the current paint, spot repairs, priming, and painting would not be nearly as good of a value as simply replacing the siding and trim; as complete replacement would still be necessary within the next 5-7 years. Therefore, we recommend complete replacement of the wood siding and trim within the next year.

Rot Present on the West Side of the Building

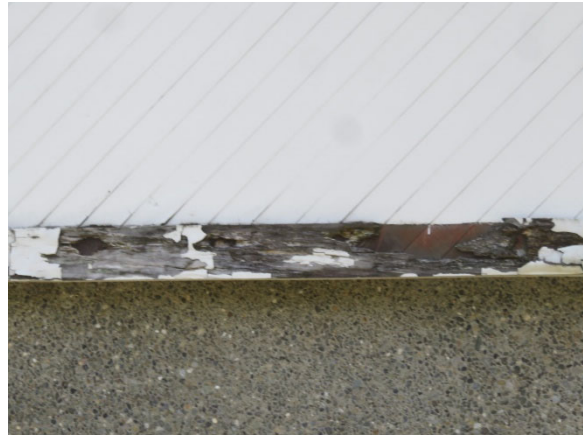
Rot in the Trim of the North Side of the Building

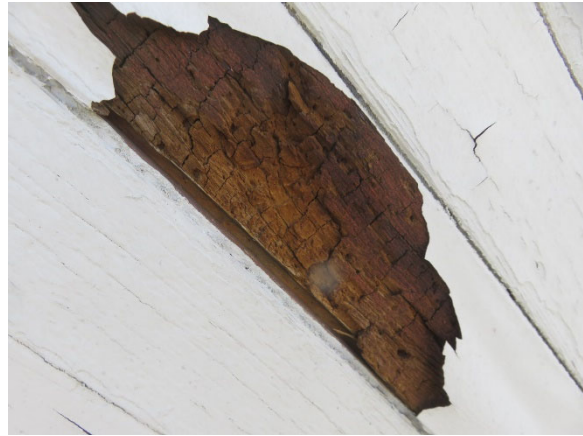
Rot in the Siding of the West Side of the Tower

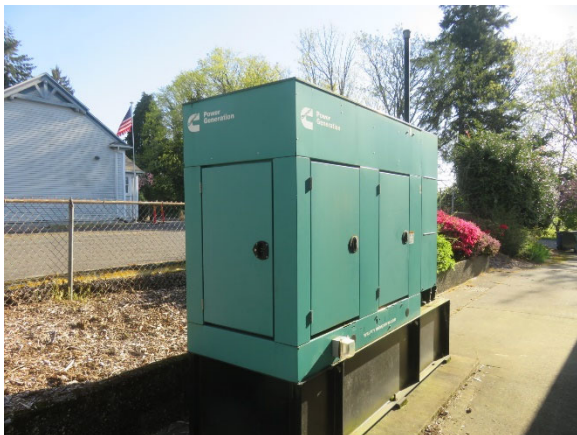
There is a Cummins Generator at the north side of the building that appears to be relatively modern. This generator and the generator transfer switch should have a lifespan well beyond the 12-year duration of this study.

Generator

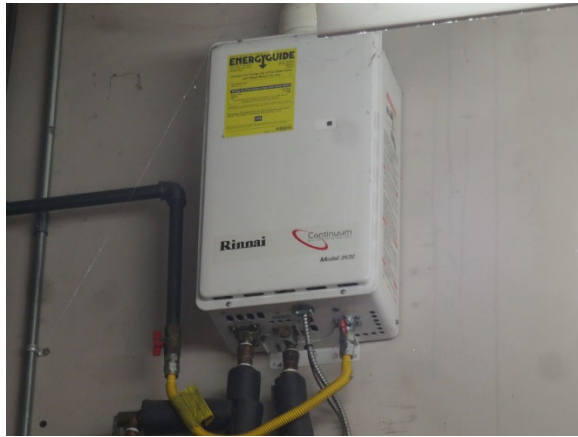
The domestic water in this building is provided by one Rinnai tankless water heater. These types of tankless water heaters have a typical lifespan of 15 years.

Rinnai Tankless Water Heater

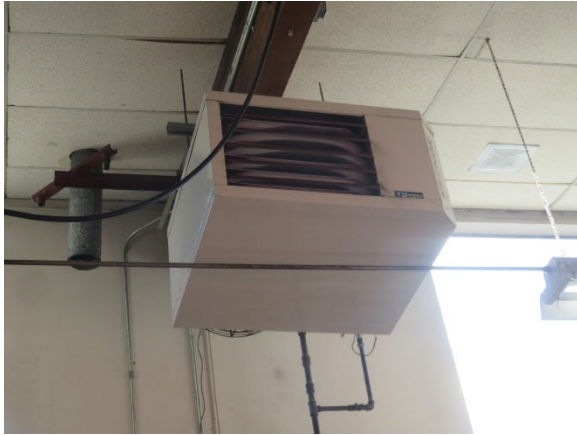
The hanging Reznor heater appears to be a fairly old unit; however, we could not pull the date off of this unit. It is difficult to determine how long the Reznor furnace will last; however, at some point in the future when is no longer functional, it will cost approximately \$2,800 to replace.

Hanging Reznor Furnace

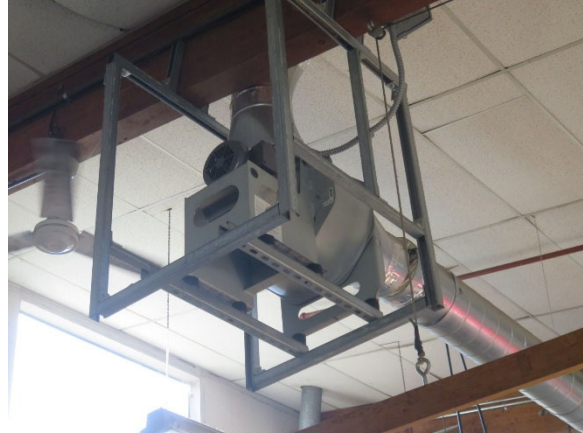
The exhaust capture unit also appears to be relatively old. As we understand, this building will most likely not be used as a garage anymore; therefore, this unit no longer serves a function.

Exhaust Fan Capture Unit

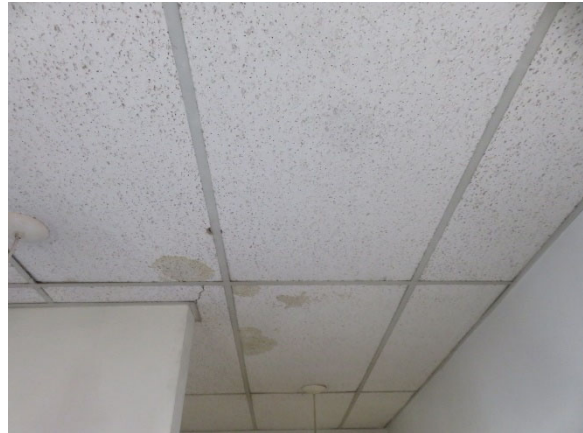
There are some stained and damaged acoustic ceiling tiles that will need to be replaced. Beyond this, there is nothing that must be done on the interior of this building, as we did not identify any areas of the interior that needs work at this time. We assume that future upgrades and renovations will occur after a future use is determined for this building.

Acoustic Ceiling Tiles

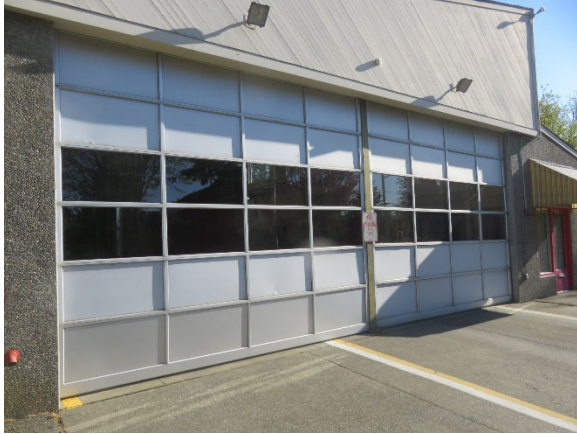
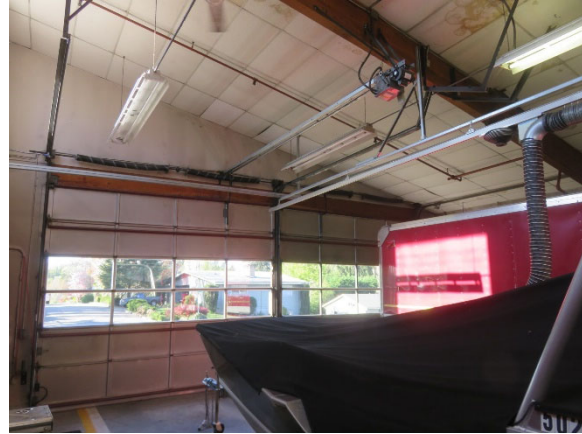
There are 2 garage doors at the south side of this building. Both of these garage doors were operating effectively at the time of our inspection. Due to the frequent use of the garage doors, we recommend budgeting for replacing these garage doors every 16 years and the garage door openers every 8 years.

Garage Doors

We also recommend a full maintenance contract be in place for these garage doors with a door technician such as Cressy Door or Davis Door.

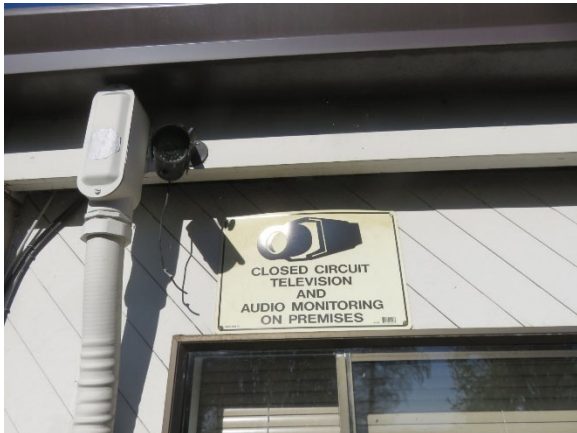
There is an old surveillance camera at the front of this building that was no longer functional.

Old Surveillance Camera
