SUBJECT: **Disposition of former Fire Station 52 building and property**

PROPERTY CONDITION ASSESSMENT

Fire Station 52

5900 South 147th Street, Tukwila, WA 98168

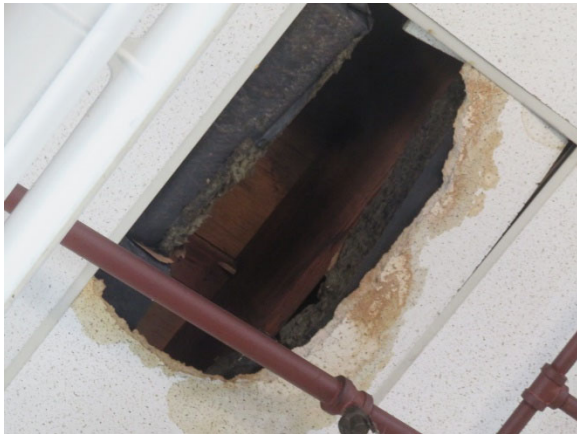
Wood Rafters Visible in the Damaged Ceiling

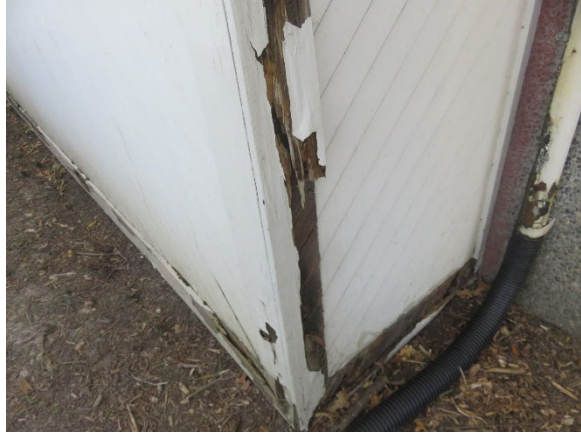
Many areas of the wood trim on this building are rotting, plus areas of the siding on the west side of the building and the west side of the tower are rotting. While other areas of the siding do have some life remaining, the siding was never primed before it was painted. Therefore, we believe that complete removal of the current paint, spot repairs, priming, and painting would not be nearly as good of a value as simply replacing the siding and trim; as complete replacement would still be necessary within the next 5-7 years. Therefore, we recommend complete replacement of the wood siding and trim within the next year.

Rot Present on the West Side of the Building

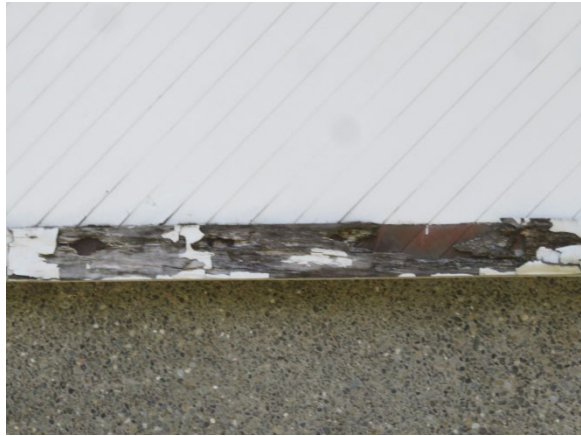
Rot in the Trim of the North Side of the Building

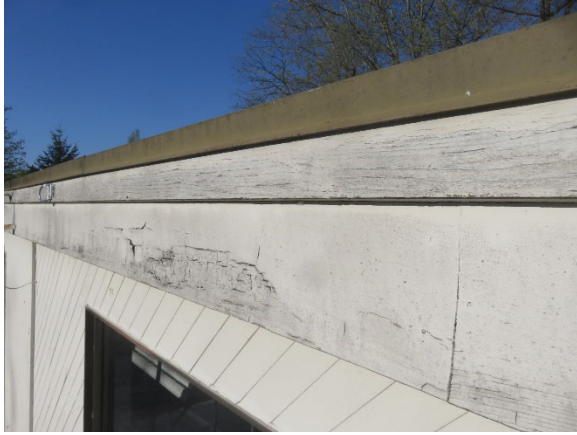
Rotten Trim of the Clerestory

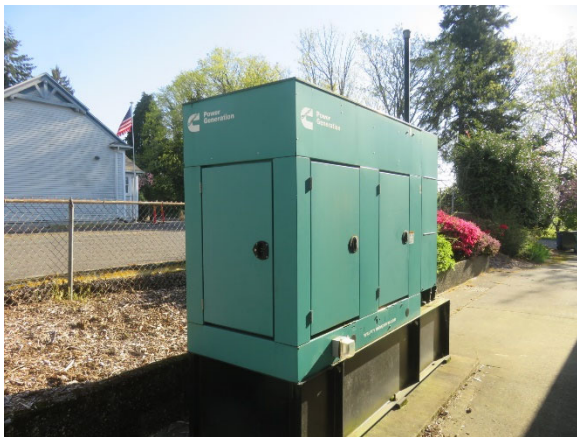
There is a Cummins Generator at the north side of the building that appears to be relatively modern. This generator and the generator transfer switch should have a lifespan well beyond the 12-year duration of this study.

Generator

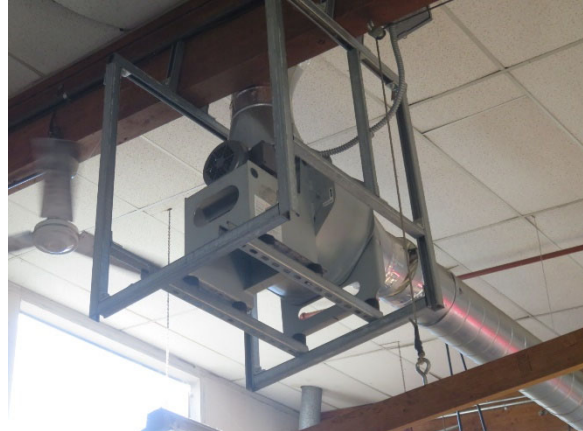
The exhaust capture unit also appears to be relatively old. As we understand, this building will most likely not be used as a garage anymore; therefore, this unit no longer serves a function.

Exhaust Fan Capture Unit

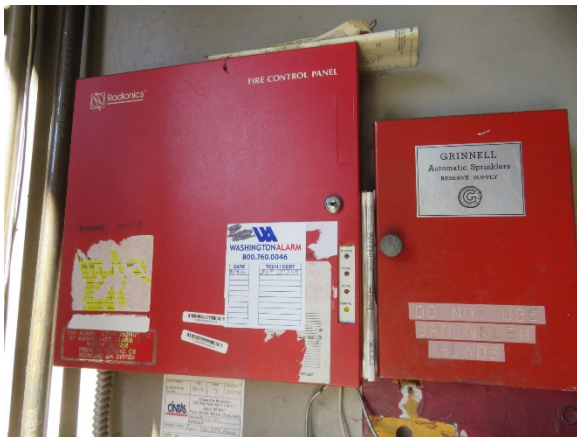
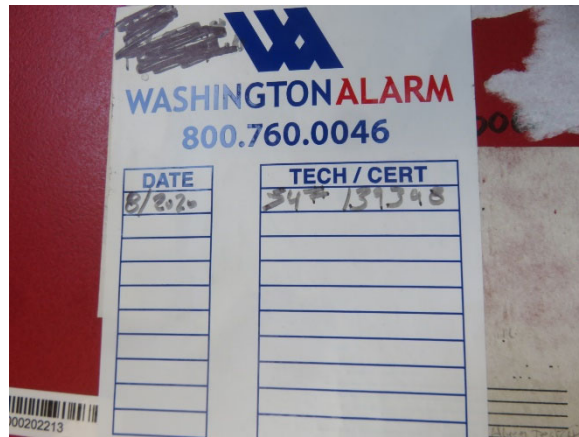
This building has a central fire alarm system. The fire alarm system includes smoke and heat detectors, pull stations, audio-video annunciators (combination strobe and speaker), and links to the fire sprinkler flow meters. Manual pull stations are located at the exits and critical points within the building. Annunciator units are located in all occupied spaces, rooms, and corridors. We have assumed that this system will be updated every 25 years. This system is currently monitored and tested via Washington Alarm, but is now 8 months out of service, based on the tag.

Fire Alarm Control Panel

Fire Alarm Control Panel Maintained by Washington Alarm

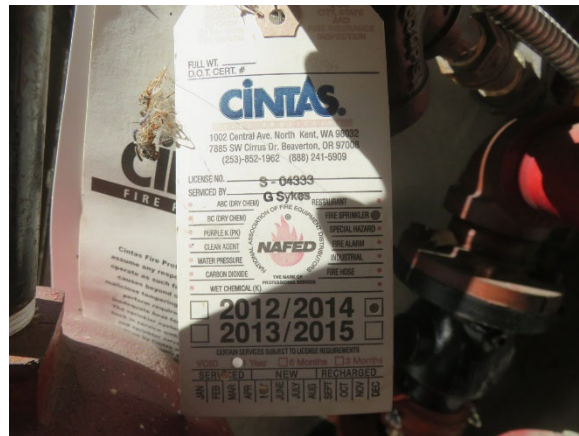
This building is served by a wet fire suppression system, meaning that it utilizes only water for fire suppression. This system is currently monitored and tested via Cintas but is now 7 years out of service based on the tag. We do not anticipate any capital needs expenditures associated with the fire suppression system within the 12-year duration of this study.

Fire Suppression System Formerly Maintained by Cintas

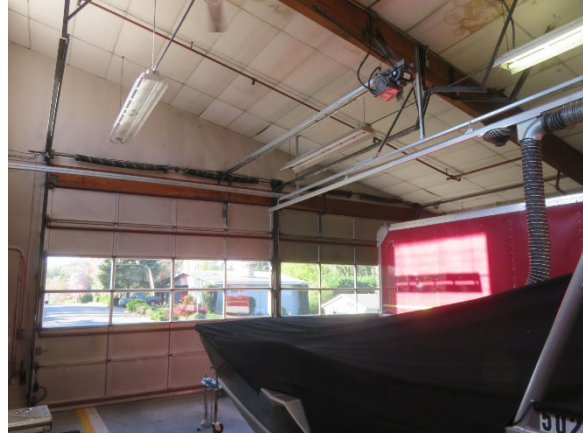
There are 2 garage doors at the south side of this building. Both of these garage doors were operating effectively at the time of our inspection. Due to the frequent use of the garage doors, we recommend budgeting for replacing these garage doors every 16 years and the garage door openers every 8 years.

Garage Doors

We also recommend a full maintenance contract be in place for these garage doors with a door technician such as Cressy Door or Davis Door.
