**TUKWILA LEVEE ACCREDITATION
PHASE 2 – LEVEE SEGMENT ASSESSMENT AND PROPOSED
SEQUENCING FOR LARGE SCALE IMPROVEMENTS**

INTERIM REPORT

Northwest Hydraulic Consultants Inc.
Tukwila, WA

October 17, 2018

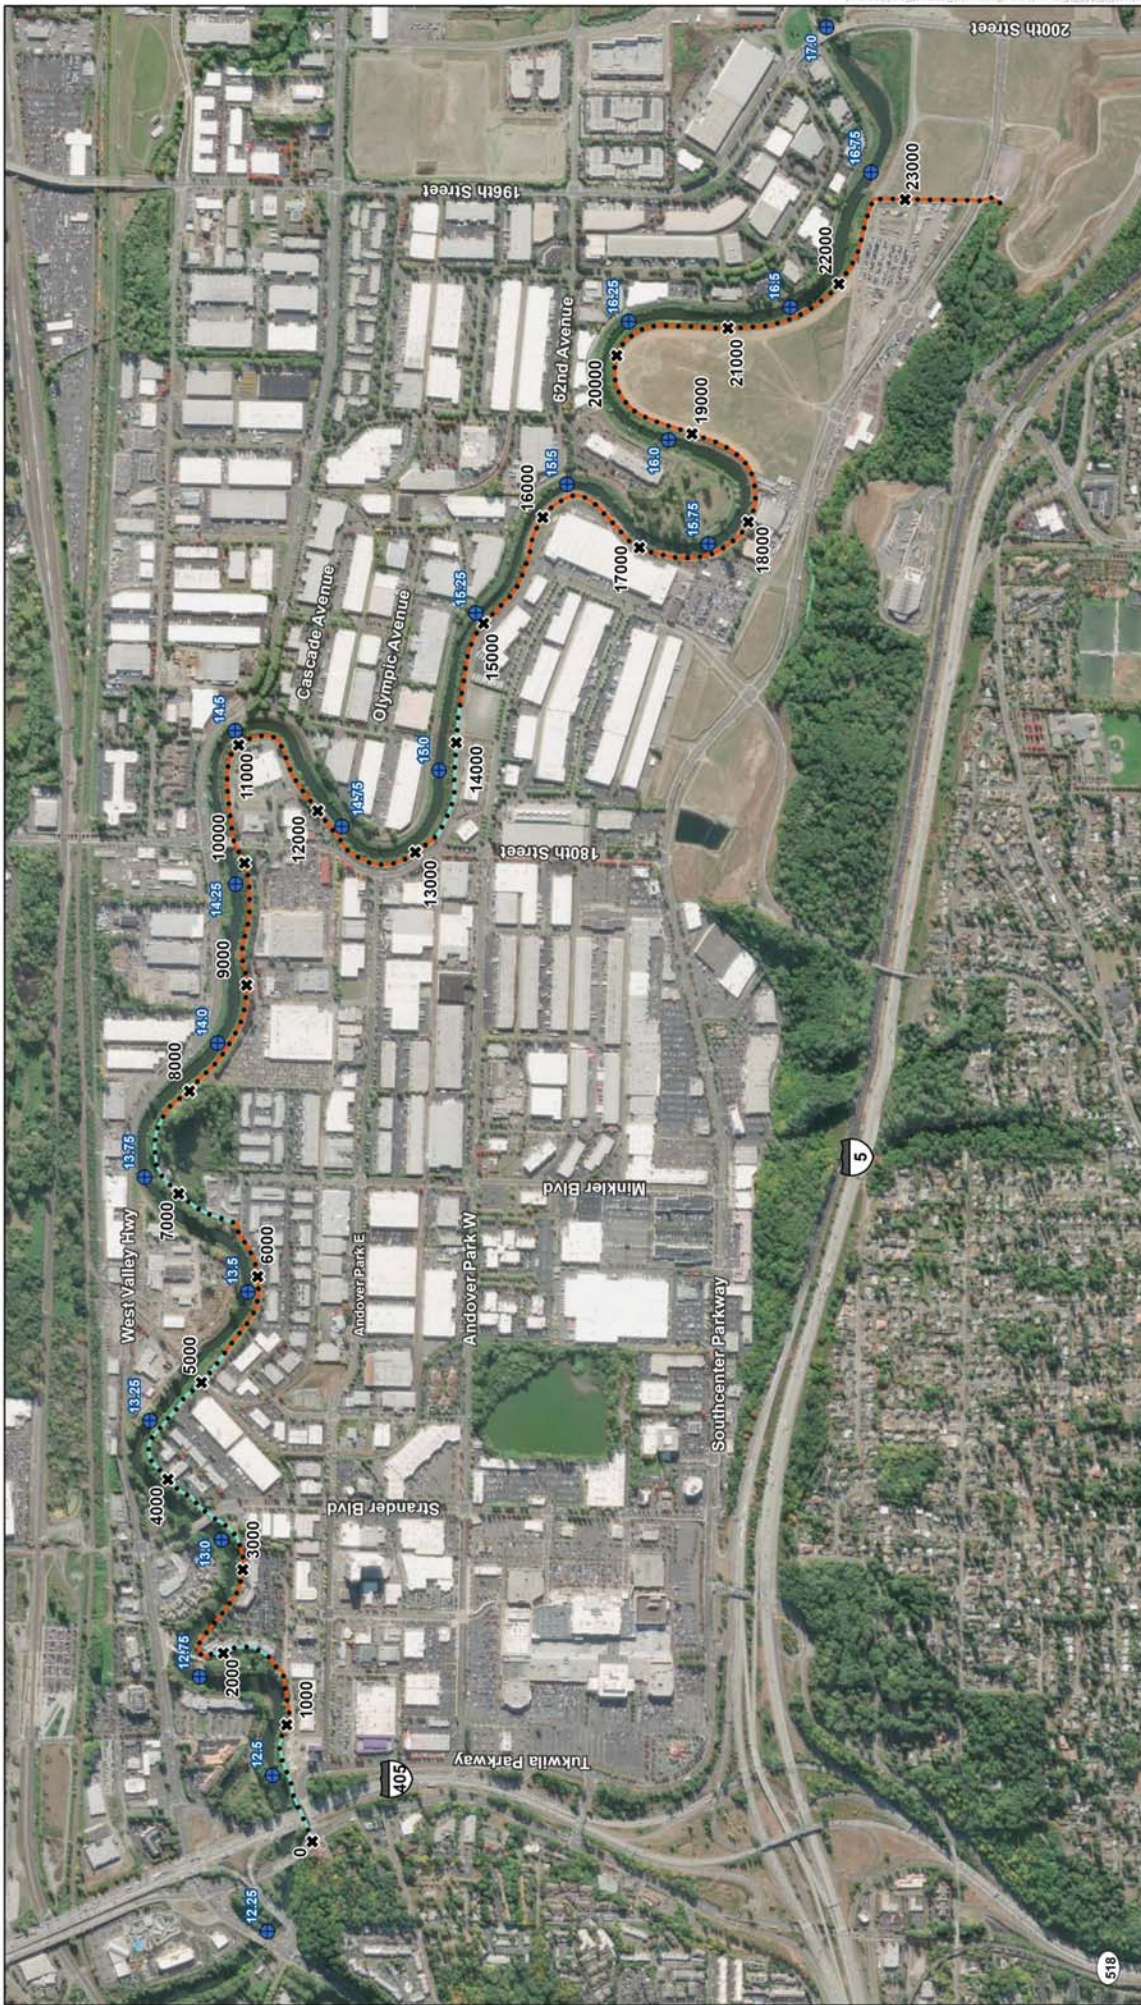
Figure 2. Levee Condition

The project reach was discretized based on common physical characteristics and relative complexity of levee reconstruction alternatives needed to achieve certification (Figure 2) and then detailed analysis conducted to determine if existing levee conditions for each segment could be certified to provide flood protection. Table 1 provides a brief description of the individual segments. To try and provide more detailed site information and maximize the levee lengths that could be certified, Wood collected additional soil characteristics through cone penetration test (CPT) probes (Wood, 2018) and additional bathymetric data were surveyed for the entire study reach.

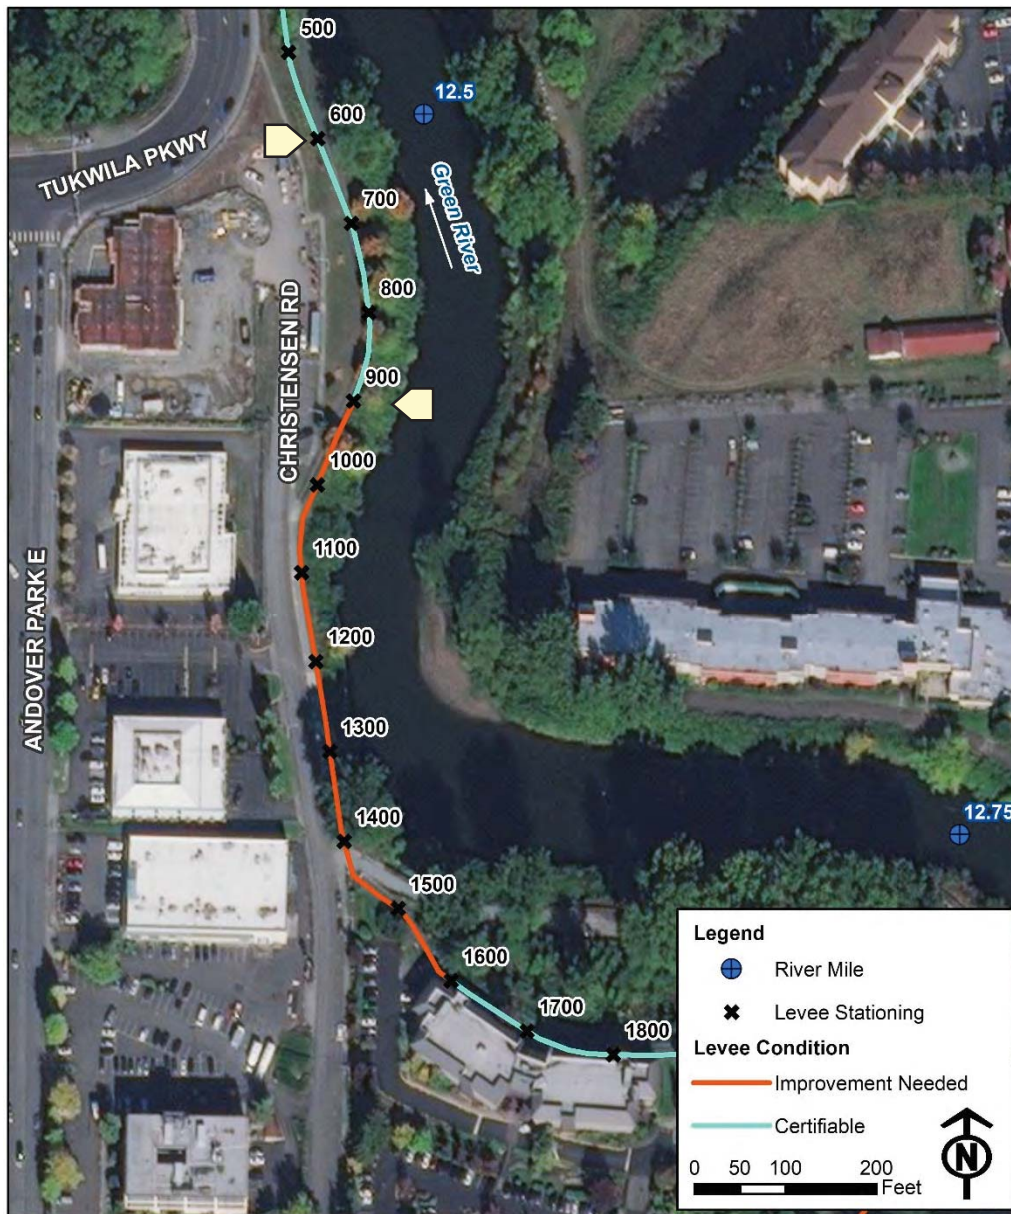
- Levee stationing 0 to 600. This segment includes the 66th Avenue S approach road to the bridge crossing I-405, I-405, and ground to the north of I-405 (Figure 3). For this segment, should the levee fail, there is sufficient width of ground landward, that is at or above the BFE (27'), to provide flood protection.
- Levee stationing 600 to 900. 68th Avenue S./Christensen Road (Figure 4). Approximately 300 feet of this segment could be certified. Simulated geotechnical failures would leave 11' or more of existing ground (at 30') at or above the BFE (27').
- Levee stationing 1600 to 2100. The levee is approximately 100 feet or more away from the channel edge behind a forested floodplain bench (Figure 4), and further than any potential point of slope failure.

Figure 4. Tukwila Levee segment 600 through 1600 where existing portion 600 through 900 can be certified.

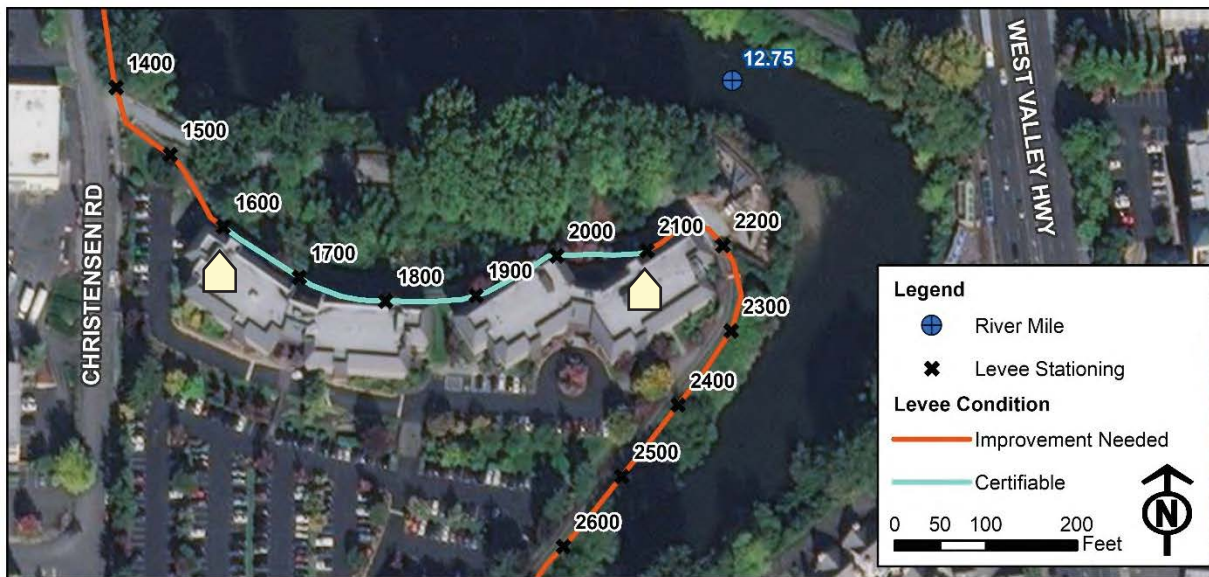
Figure 5. Tukwila Levee segment where stationing 1600 through 2100 can be certified.

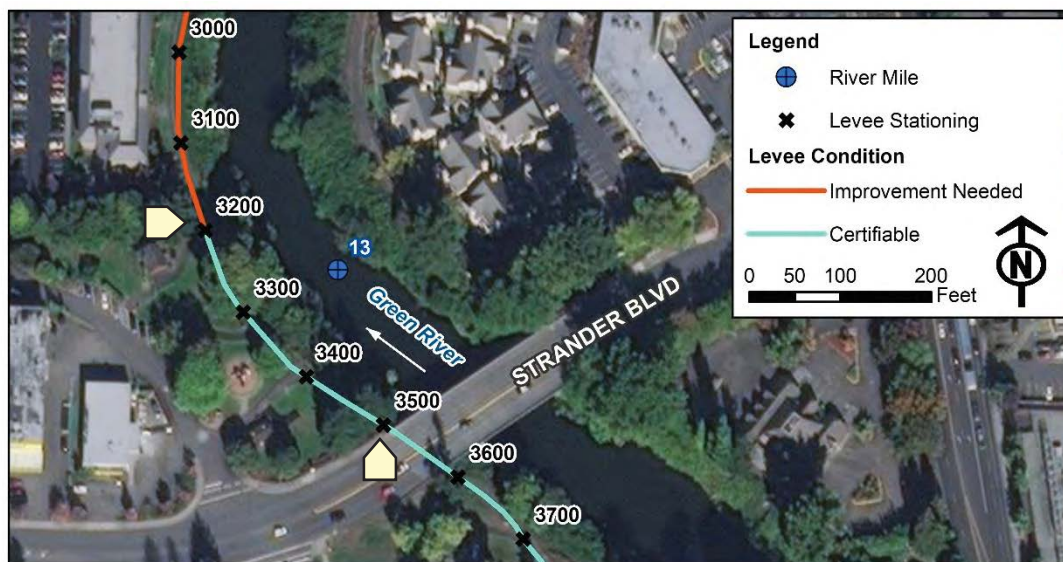
- Levee stationing 3200 to 3500. Bicentennial Park (Figure 6). Slope failure may reach landward of the levee; however, the ground elevation (28') is still greater than the BFE (27.7').
- Levee stationing 3500 to 5300. Strander Boulevard and upstream section through the business parks and related parking have stable slopes (Figure 7).
- Levee stationing 6500 to 7700. Portions of the levee along the Tukwila Pump Station and a portion of the business park downstream of the pump station (Figure 8) have stable slopes.
- Levee stationing 10150 to 10250. It's assumed sufficient documentation exists to certify this approximate 100' long existing S 180th Street bridge crossing section.
- Levee stationing 13200 to 14300. Business parks and associated parking (Figure 9) along the Corps 2008 levee repair have stable bank slopes.

Figure 6. Tukwila Levee segment where stationing 3200 through 3500 can be certified.

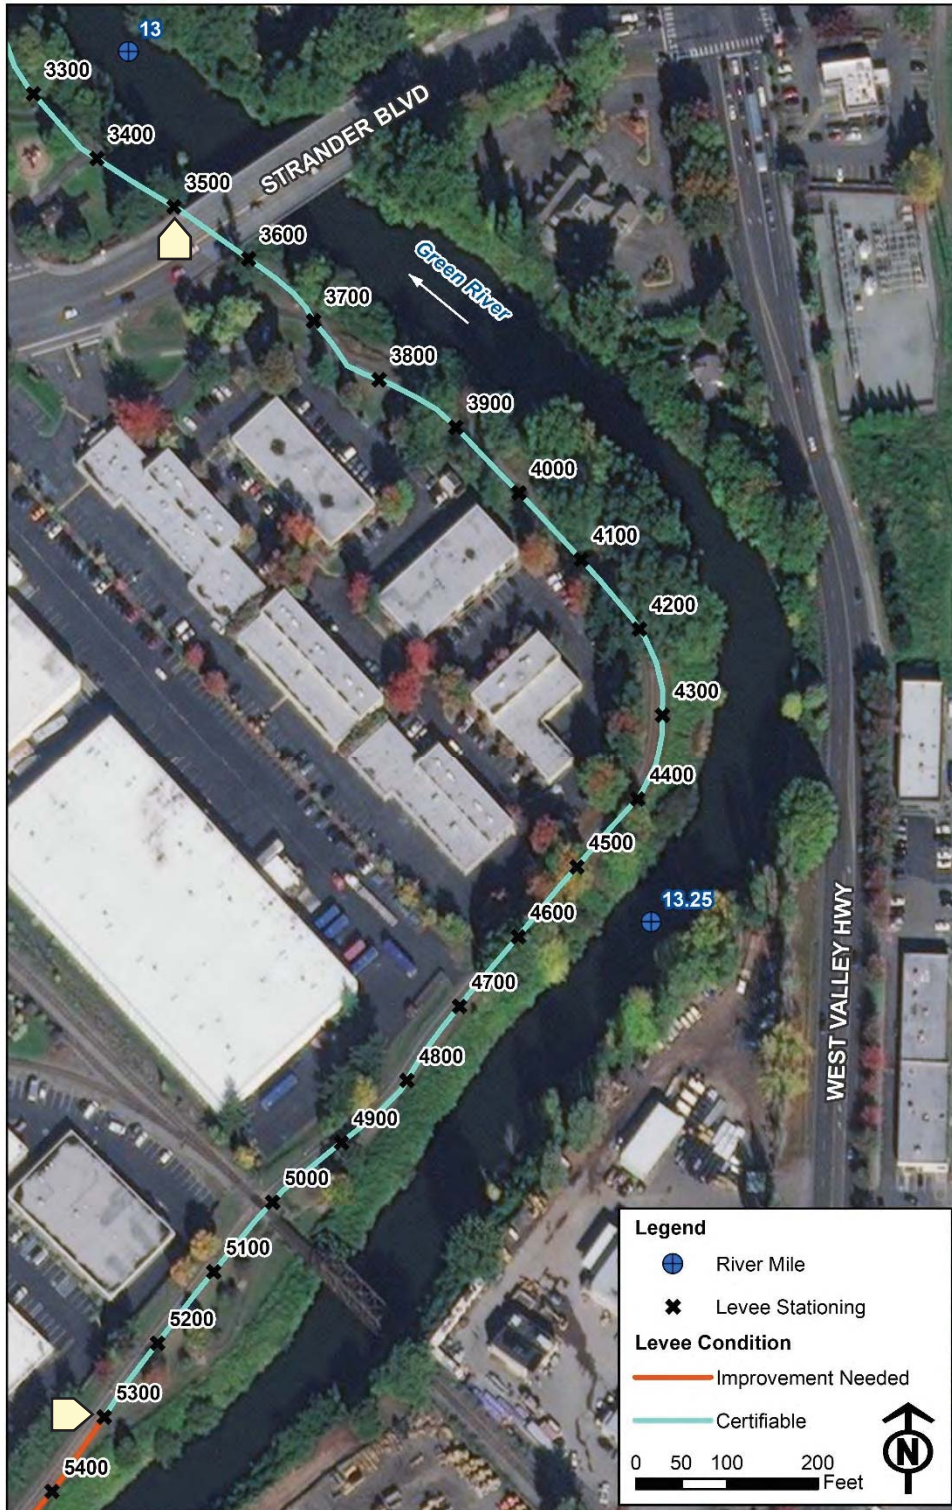
Figure 7. Tukwila Levee segment where existing section 3500 to 5300 can be certified.

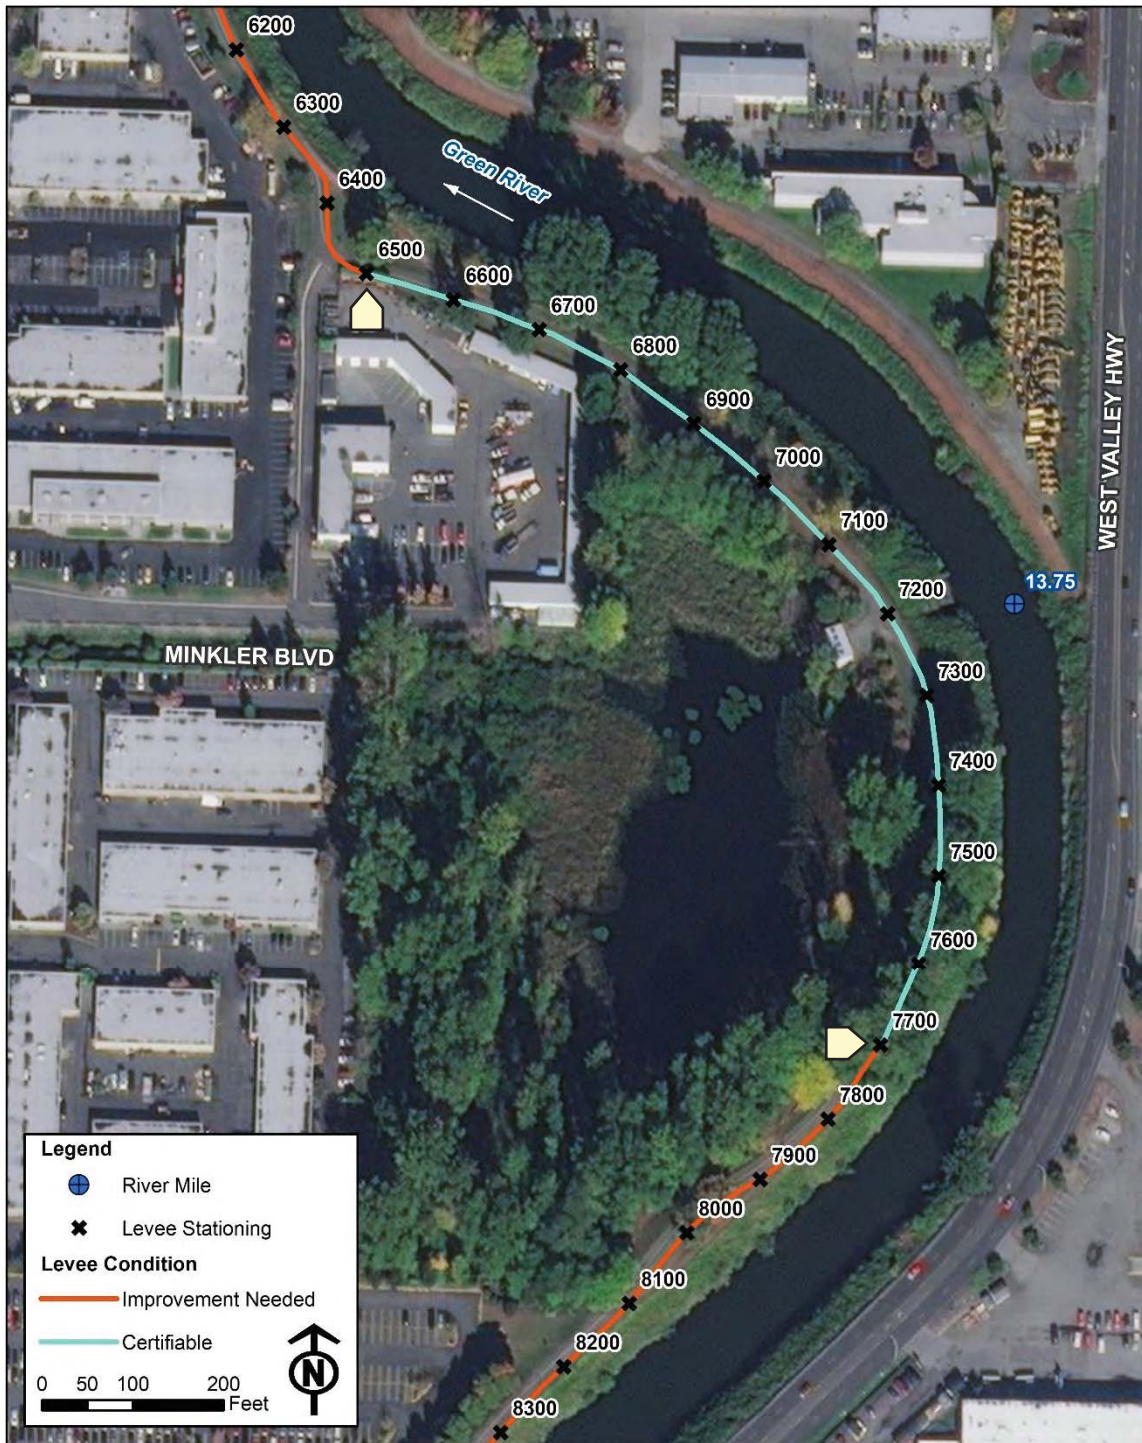
Figure 8. Tukwila Levee segment where existing section 6500 to 7700 can be certified.

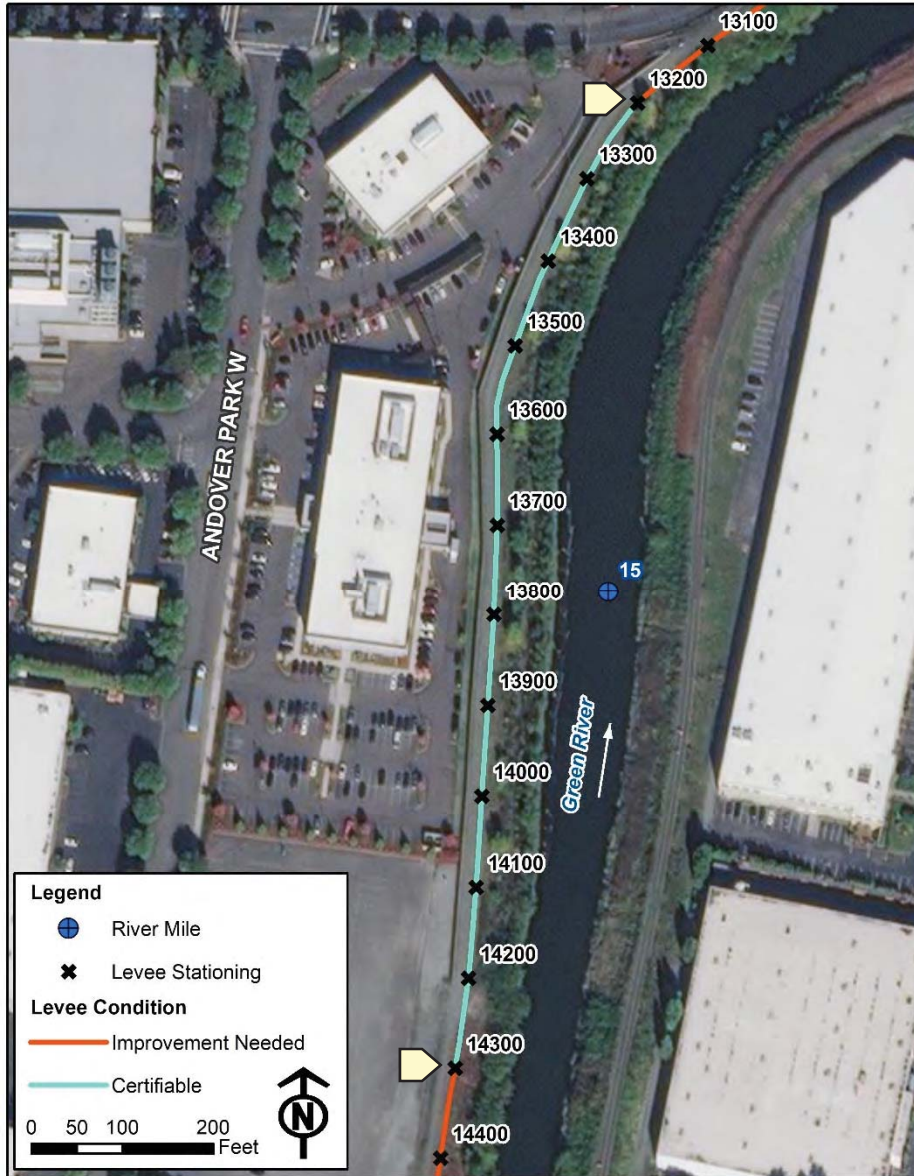
Figure 9. Tukwila Levee segment where existing section 13200 to 14300 can be certified.

Results of the geotechnical slope stability analysis for additional cross-sections evaluated in Phase 2 are presented in Table 3. In order to be certified on the embankment and foundation criteria, the representative cross-section for the levee segment must have a computed factor of safety greater than a USACE minimum value for all cases (e.g. evaluations at river miles 13.055, 13.11 and 13.219 define stable slopes for levee segment 3600 to 5300, evaluations at river miles 13.624 and 13.892 define stable slopes for levee segment 6500 to 7700, and the evaluation at river mile 14.934 defines stable slopes for levee segment 13200 to 14300).

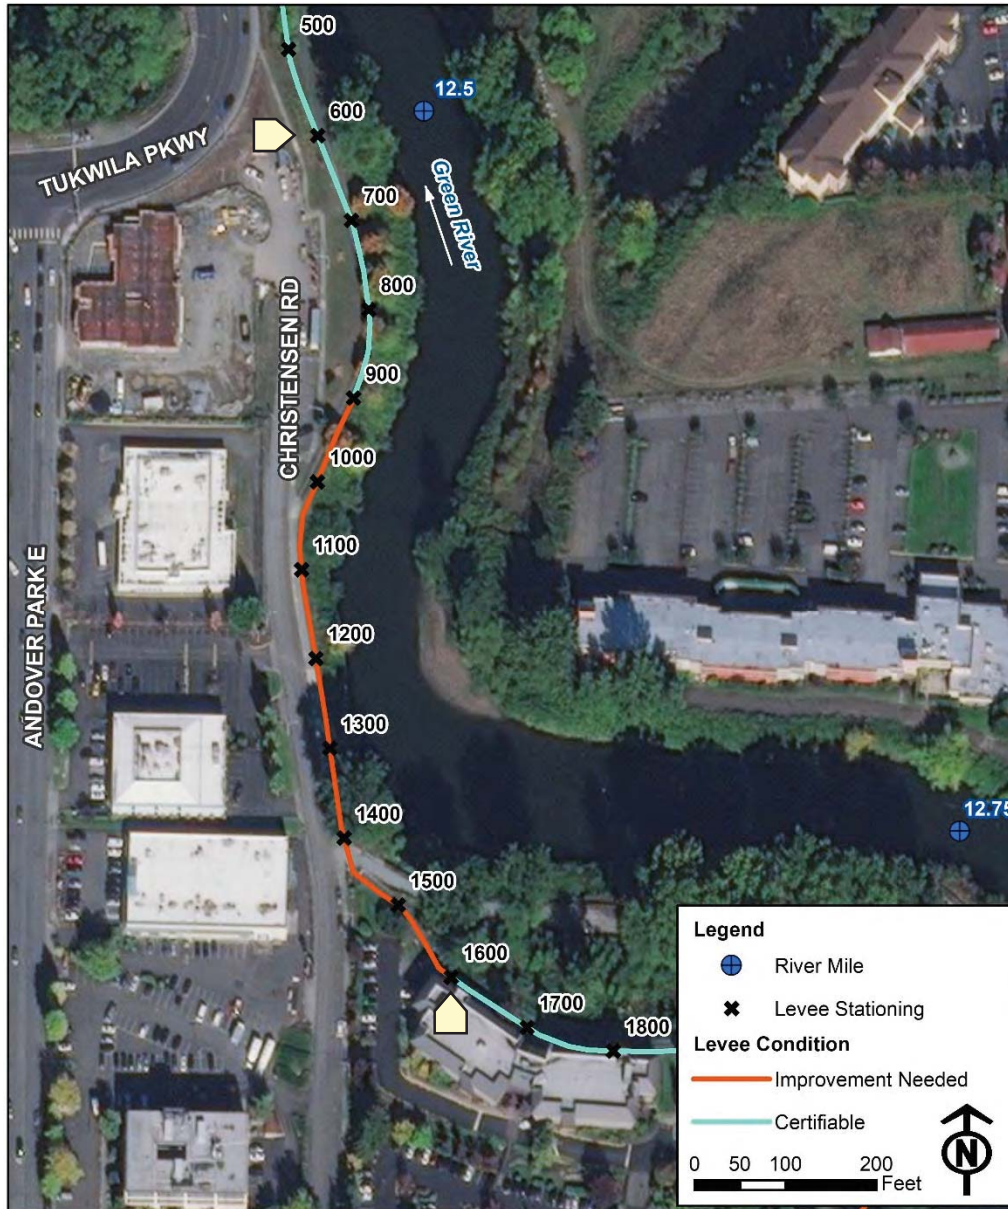
Segment stationing 600 through 1600 parallels 68th Avenue South/Christensen Road (Figure 10). Here steep slopes exacerbated by anticipated river channel scour could lead to a levee bank failure (as evaluated at cross-section 12.61 in Table 5) that includes portions of the roadway and the Green River trail. As discussed in prior Section 4.1, the segment of this levee from stationing 600 to 900 can be certified as is, as there is sufficient existing ground remaining after the predicted failure, that is at or above the BFE, to prohibit floodwaters from reaching landward infrastructure. Similarly, from station 900 to 1600, a slope failure would not flood landward of the levee (the ground elevation at the point of extent of failure is very close to, but above, the 27' BFE); however, a portion of Christensen Road, as well as nearby parking and potentially the closest buildings, would be lost. Slope stability in this reach is relatively less of a concern at this segment compared to other portions of the levee, based on the computed factor of safety from the geotechnical analysis of this segment (Table 5).

Figure 10. Tukwila Levee segment 600 through 1600 where existing portion 900 through 1600 can't be certified.

A construction fix here to protect the roadway, trail, and buildings up to the 500-year level of protection includes either a levee setback, raising the levee, or a floodwall. Table 4 provides a planning level cost estimate for these alternatives. For all concepts, the construction fix was assumed to occur for the entire length of the segment, so that the same level of protection would be continuously provided from stationing 600 through 1600. For the levee setback and raising options, a retaining wall would likely be placed on the landward side of the levee, where existing buildings would limit ability to construct a 2:1 backslope. This alternative would require relocation of any utilities and raising of Christensen Road to provide access to the Holiday Inn constructed in 2018.

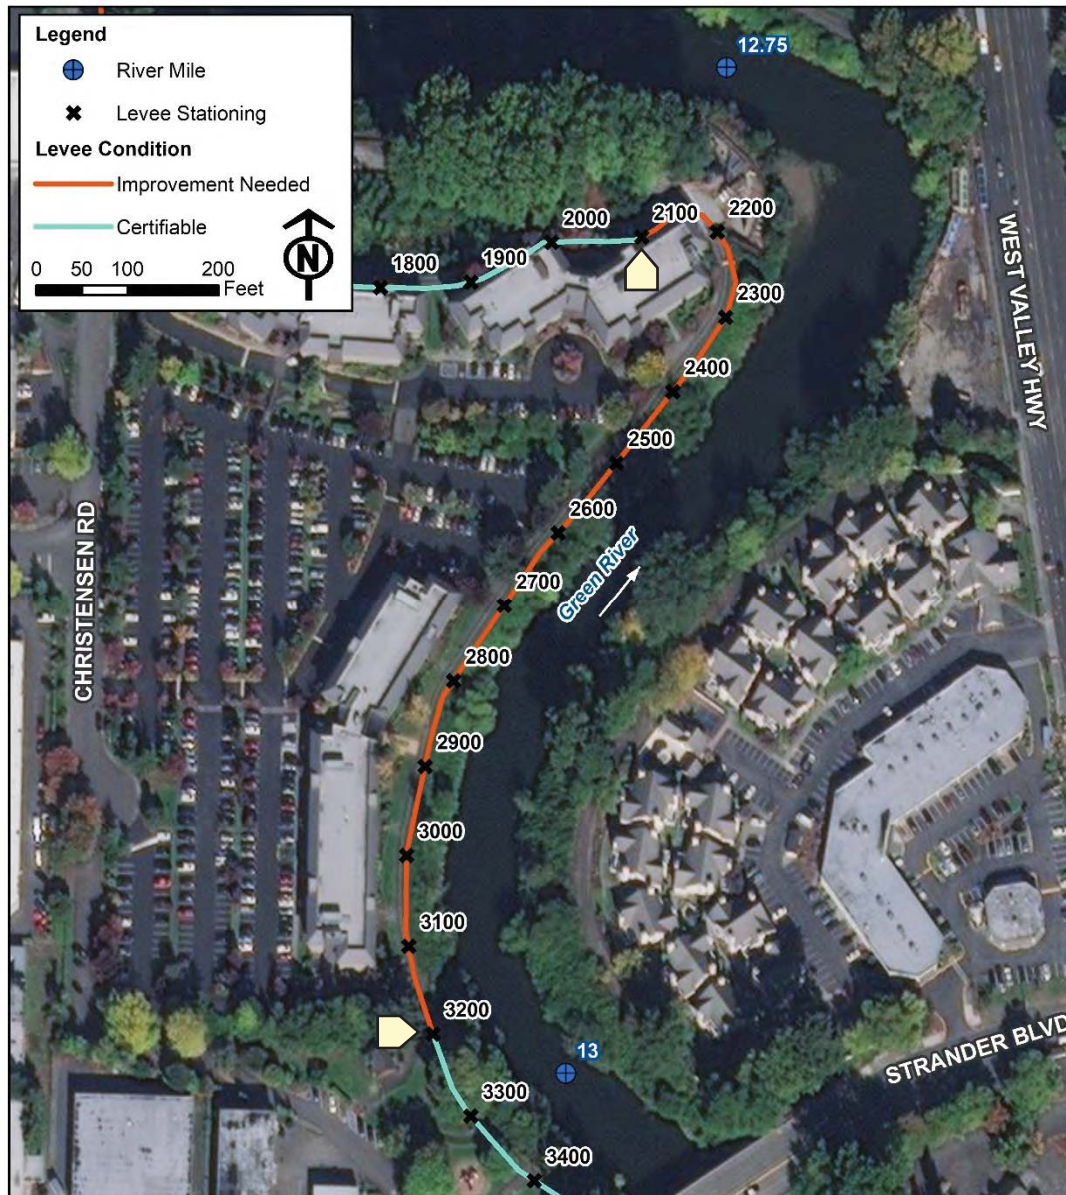
Segment 2100 through 3200 parallels the Riverview Plaza business park, which is built up to the levee edge (Figure 11). Estimated scour depths here and the short distance between river edge and the business park, preclude any realistic fix other than sheet pile walls. Table 4 provides a cost estimate for a construction fix at this segment. There is a short reach from approximately 2400 to 2700 that has an open parking lot, where the levee potentially could be set back or a design other than a sheet wall could be considered as part of the final design. Slope stability in this reach is relatively moderate compared to other segments, based on the computed factor of safety from the geotechnical analysis of this segment (as evaluated at river mile 12.98 in Table 5).

Figure 11. Tukwila Levee segment 2100 through 3200 that can't be certified in its existing condition.

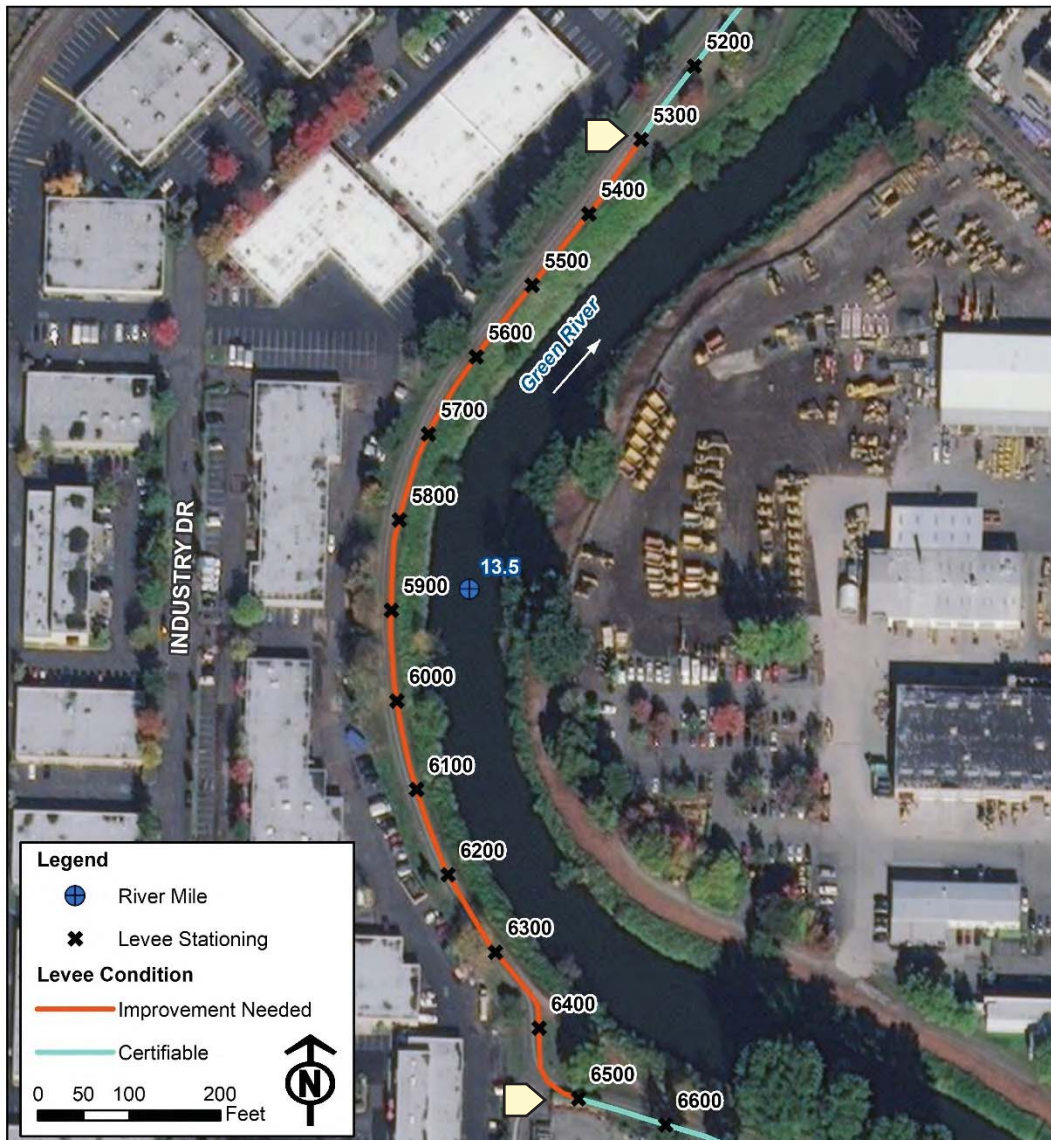
Segment 5300 through 6500 (Figure 12) is in the outside of a river bend and includes the Green River SWIF Christensen Road capital project. Similar to other levee segments, unstable channel slopes under anticipated potential channel scour create conditions that can't be certified (as evaluated at river mile 13.53 in Table 5). Failure risk here, where scour is greater in the outside of a channel bend, is some of the greatest in the system. Levee setback, levee raising, and floodwall alternatives were considered for this site (cost estimates provided in Table 4). The levee setback and raising would take land currently used for business parking.

Figure 12. Tukwila Levee segment 5300 through 6500 that can't be certified in its existing condition.

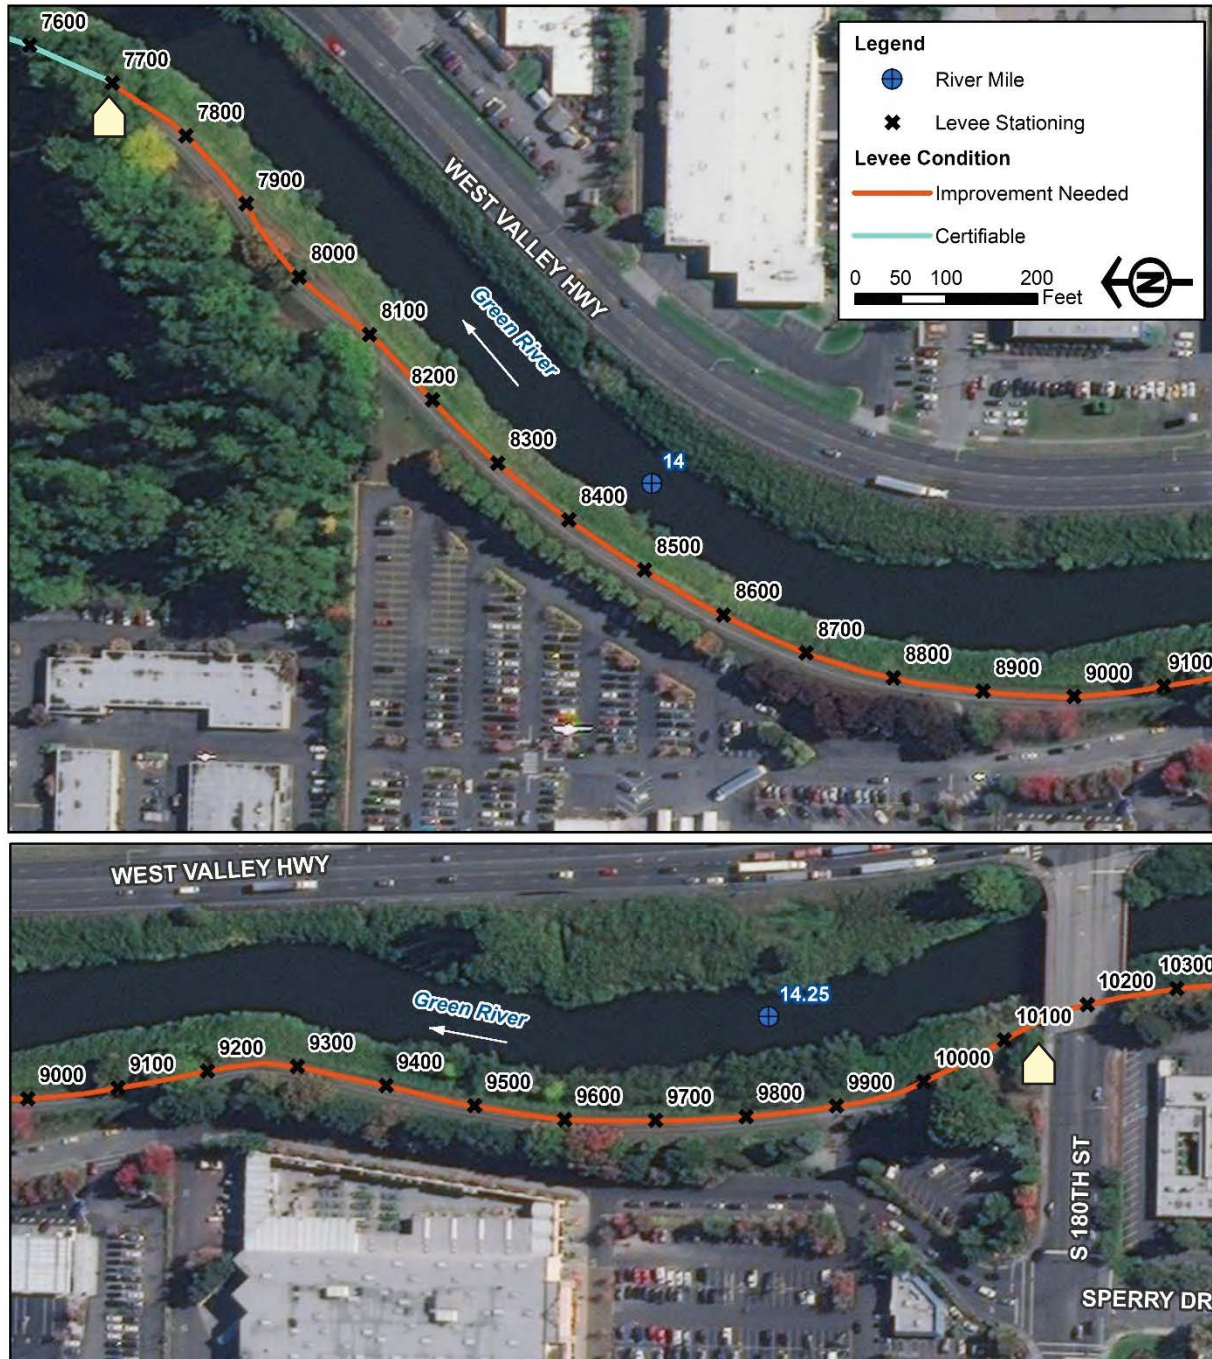
Segment 7700 through 10150 parallels Sperry Drive and parking for large box stores (Figure 13). Slope stability in this reach is relatively moderate compared to other segments, based on the computed factor of safety from the geotechnical analysis of this segment (as evaluated at river mile 14.02 in Table 5). Cost estimates to design and construct both a levee setback and a floodwall for the entire segment are

Figure 13. Tukwila Levee segment 7700 through 10150 that can't be certified in its existing condition.

provided in Table 4. Note that the levee setback and levee raising concepts would modify land currently used for business parking, though parking lots through this segment are relatively wide. A simple site specific concept through just the non-certifiable section of the Tukwila Pump Station Pond, stationing 7700 through 8200, was also considered. The cost of bringing in additional levee material to provide protection to the 500-year water surface plus three feet, for this short 500-foot section, is estimated to be approximately \$2.3 million.

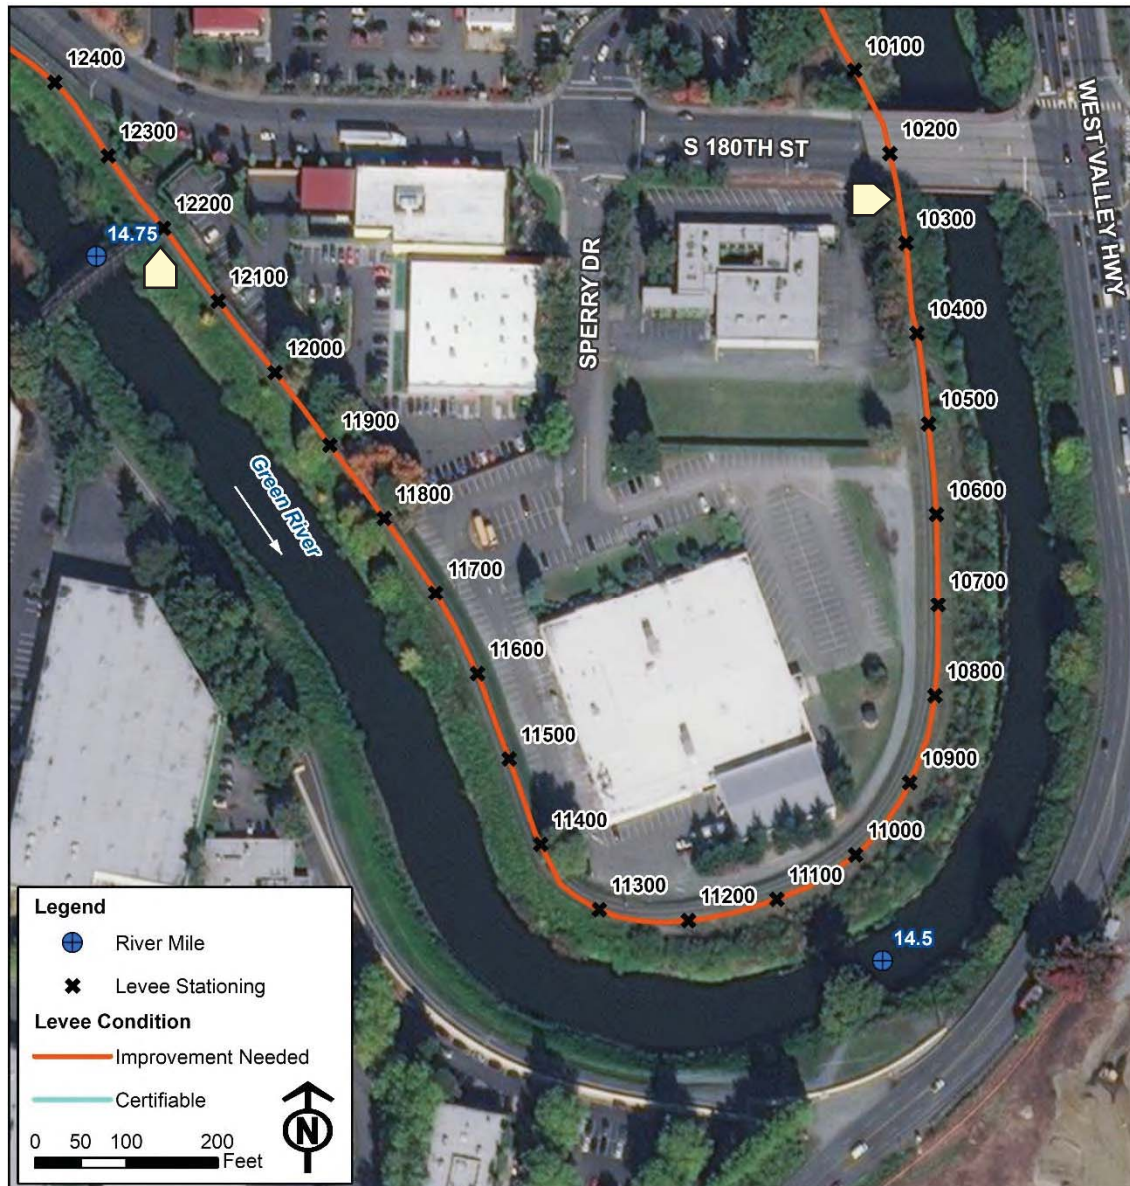
Segment 10250 through 12200 (Figure 14) has a history of slope instability and was repaired most recently in 2008 (Amec, 2015). Slope stability in this reach is relatively moderate to high, depending on location within the segment, compared to other segments (as evaluated at river mile 14.534 in Table 3 and at river mile 14.72 in Table 5). Both a levee setback, levee raising, and floodwall were evaluated as potential construction fixes at this segment (Table 4 provides the estimated costs).

Figure 14. Tukwila Levee segment 10250 through 12200 that can't be certified in its existing condition.

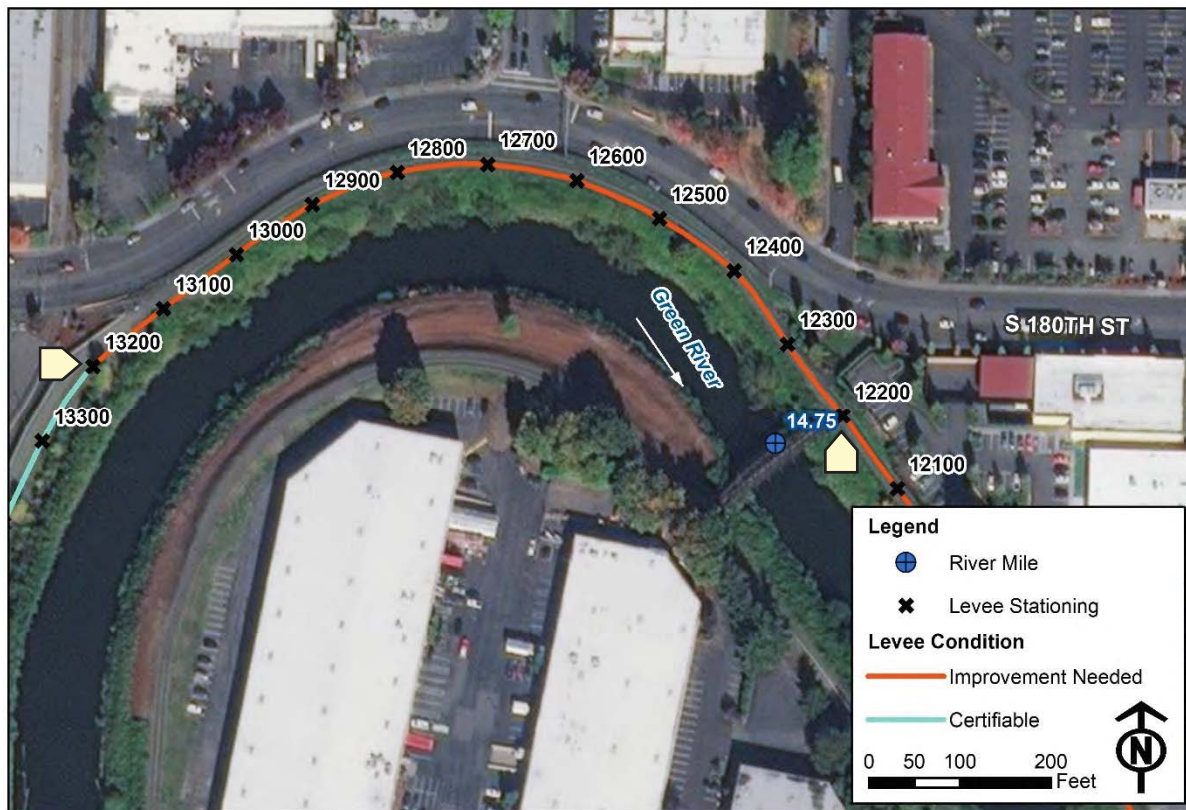
For segment 12200 through 13200, the proximity of S 180th Street severely limits construction options given how close the roadway is to the existing levee (Figure 15). In addition, the levee being in the outside of the river bend has relatively more scour compared to straight river sections, leading to less stable slopes (as evaluated at river mile 14.82 in Table 5). Only sheet pile floodwalls were considered for this site. Table 4 provides a cost estimate to design and construct this project.

Figure 15. Tukwila Levee segment 12200 through 13200 that can't be certified in its existing condition.

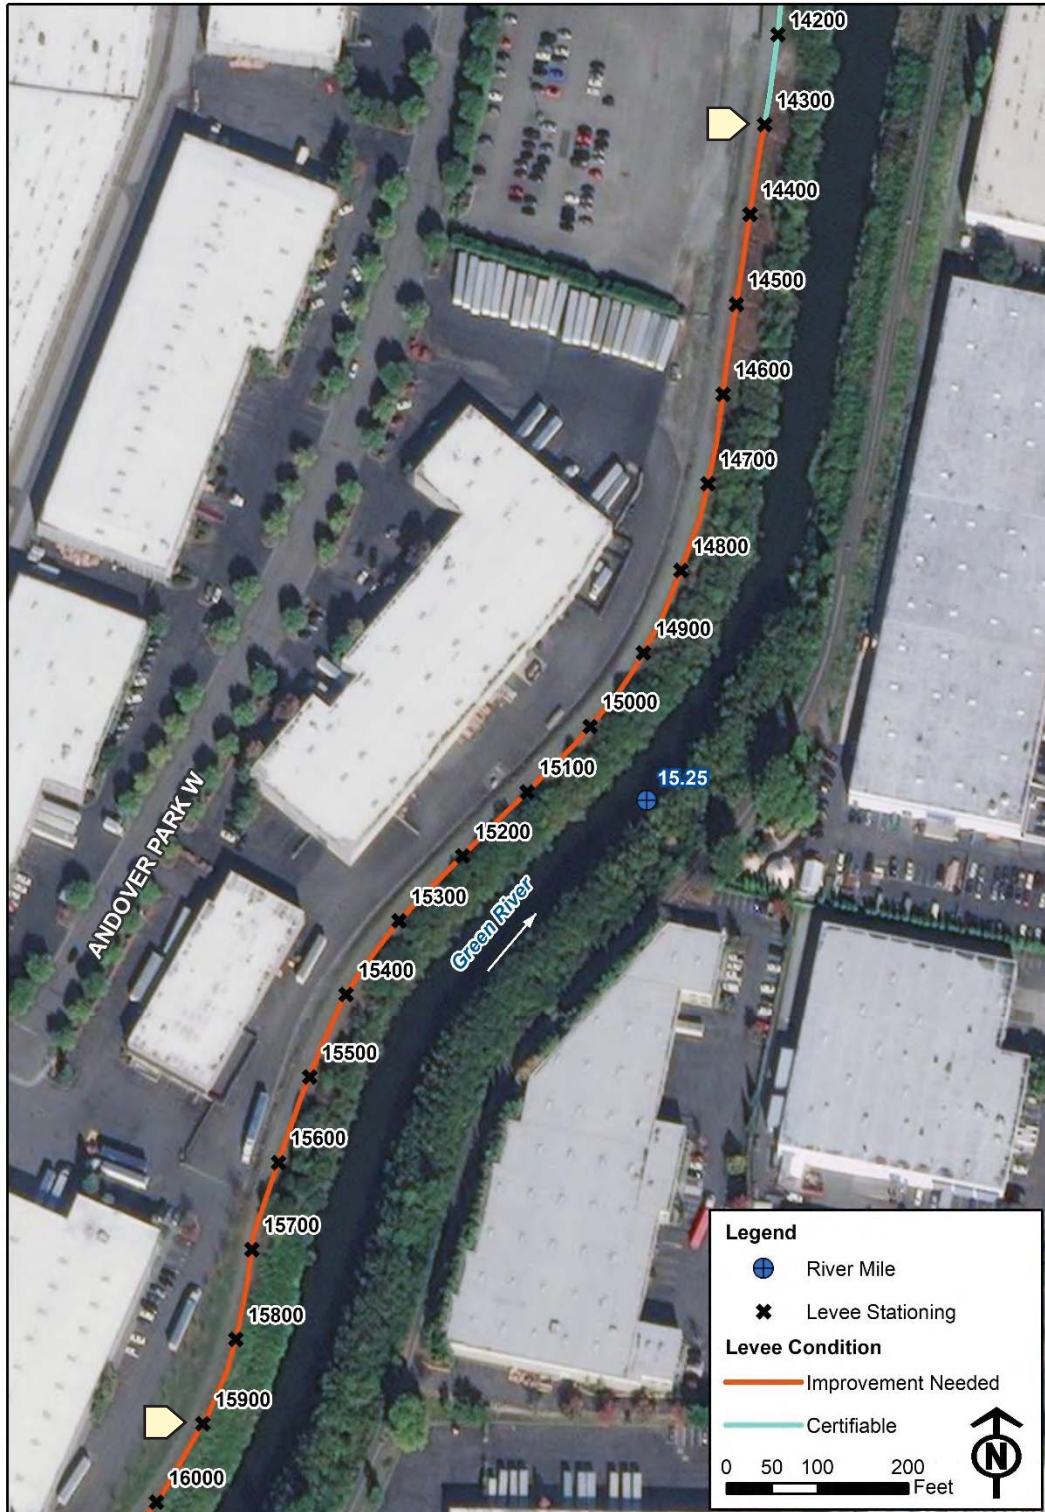
Segment 14300 through 15900 (Figure 16) is the site of an existing repair, like the downstream levee segment; however, unlike the downstream section, steep slopes and soil conditions for this segment indicate that this section can't be certified in its existing condition (e.g. as evaluated at river mile 15.1 in Table 3). This is one section that may warrant additional soil testing (e.g. CPT) to further classify soils and thus potentially be able to certify the levee segment. A levee setback, levee raising, and a floodwall were considered for this site (cost estimate provided in Table 4).

Figure 16. Tukwila Levee segment 14300 through 15900 that can't be certified in its existing condition.
