**TUKWILA LEVEE ACCREDITATION
PHASE 2 – LEVEE SEGMENT ASSESSMENT AND PROPOSED
SEQUENCING FOR LARGE SCALE IMPROVEMENTS**

INTERIM REPORT

Northwest Hydraulic Consultants Inc.
Tukwila, WA

October 17, 2018

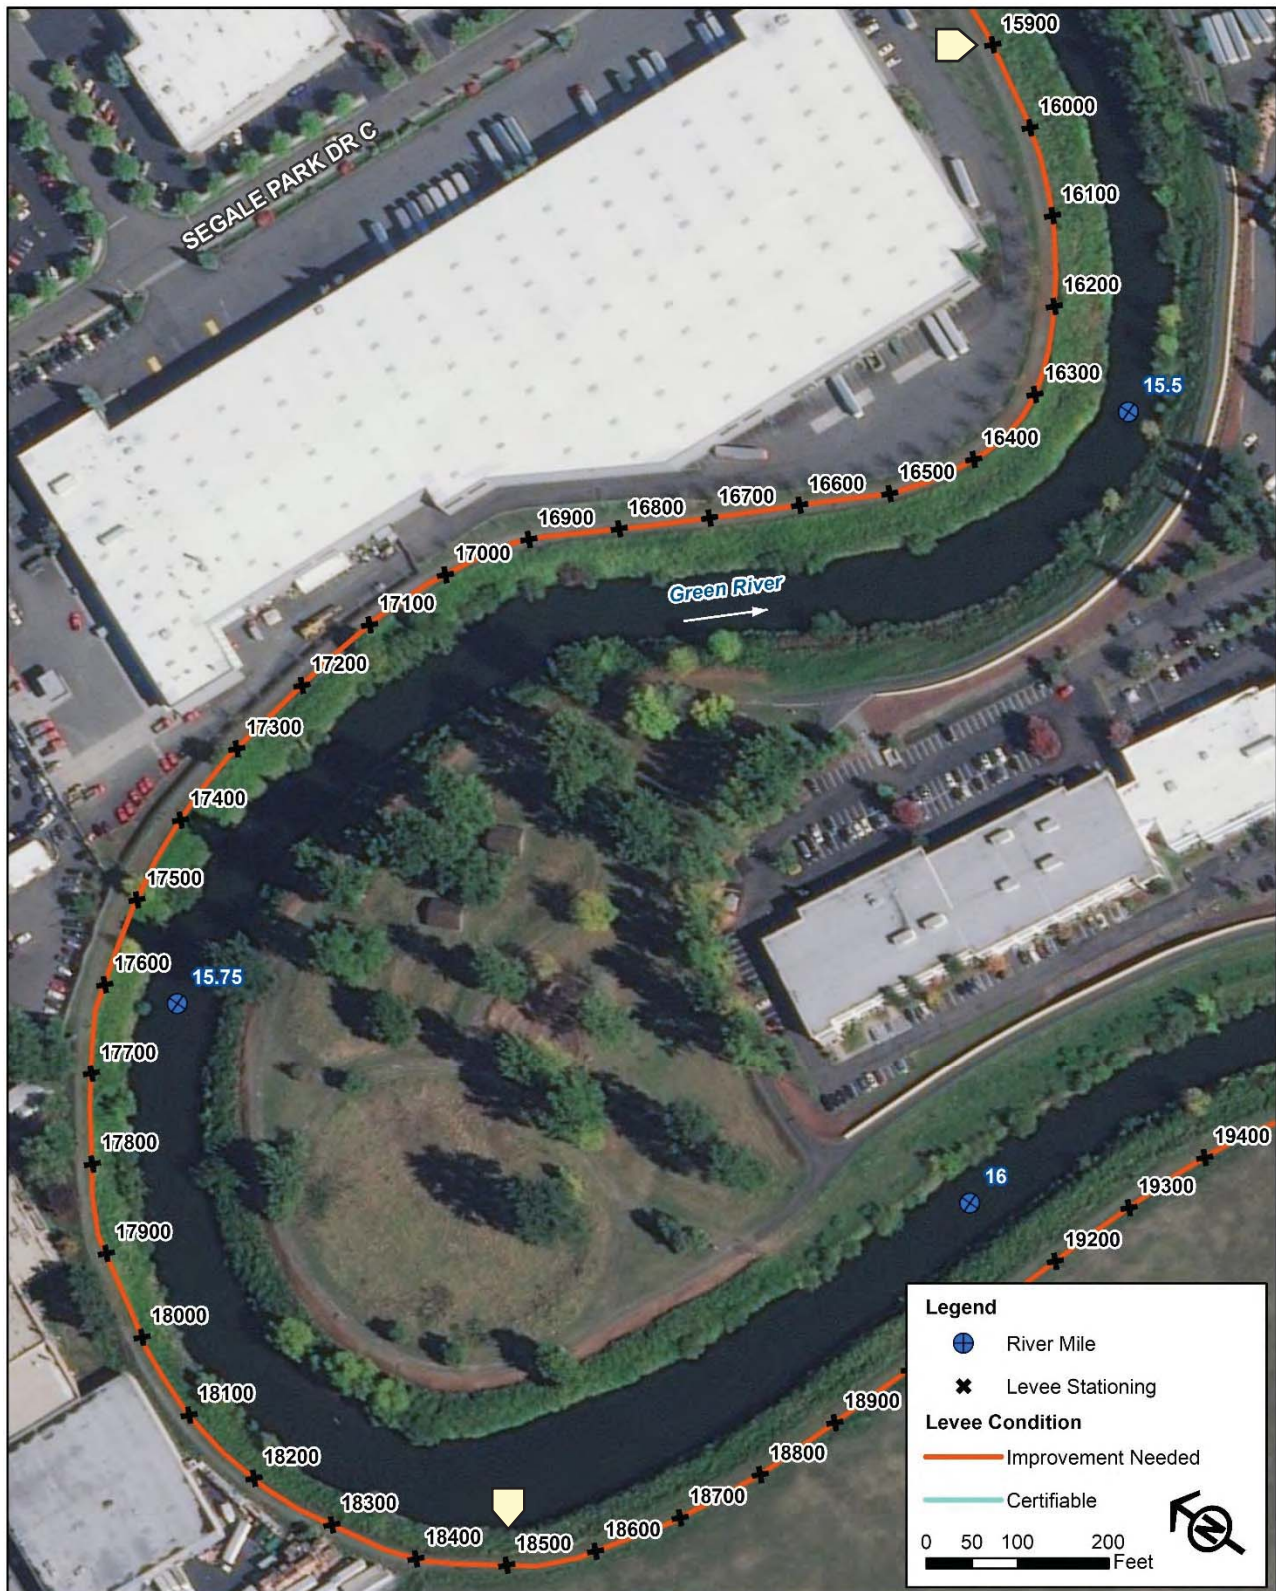
USACE is managing the design and construction of the Gaco-Mitchell Levee repair from station 15900 to 18500 (approximate river mile 15.4 to 15.9) (Figure 17). This has some of the greatest failure risk within the entire levee reach (as evaluated at river mile 15.86 in Table 5). The new levee along the Green River left bank will provide 500-year level of protection plus 3 feet of freeboard per the SWIF. There is a detailed analysis and design being completed for that project, so therefore no additional conceptual level designs and planning level cost estimates were conducted for this Phase 2 work.

Figure 17. Tukwila Levee segment 15900 through 18500 that can't be certified in its existing condition.

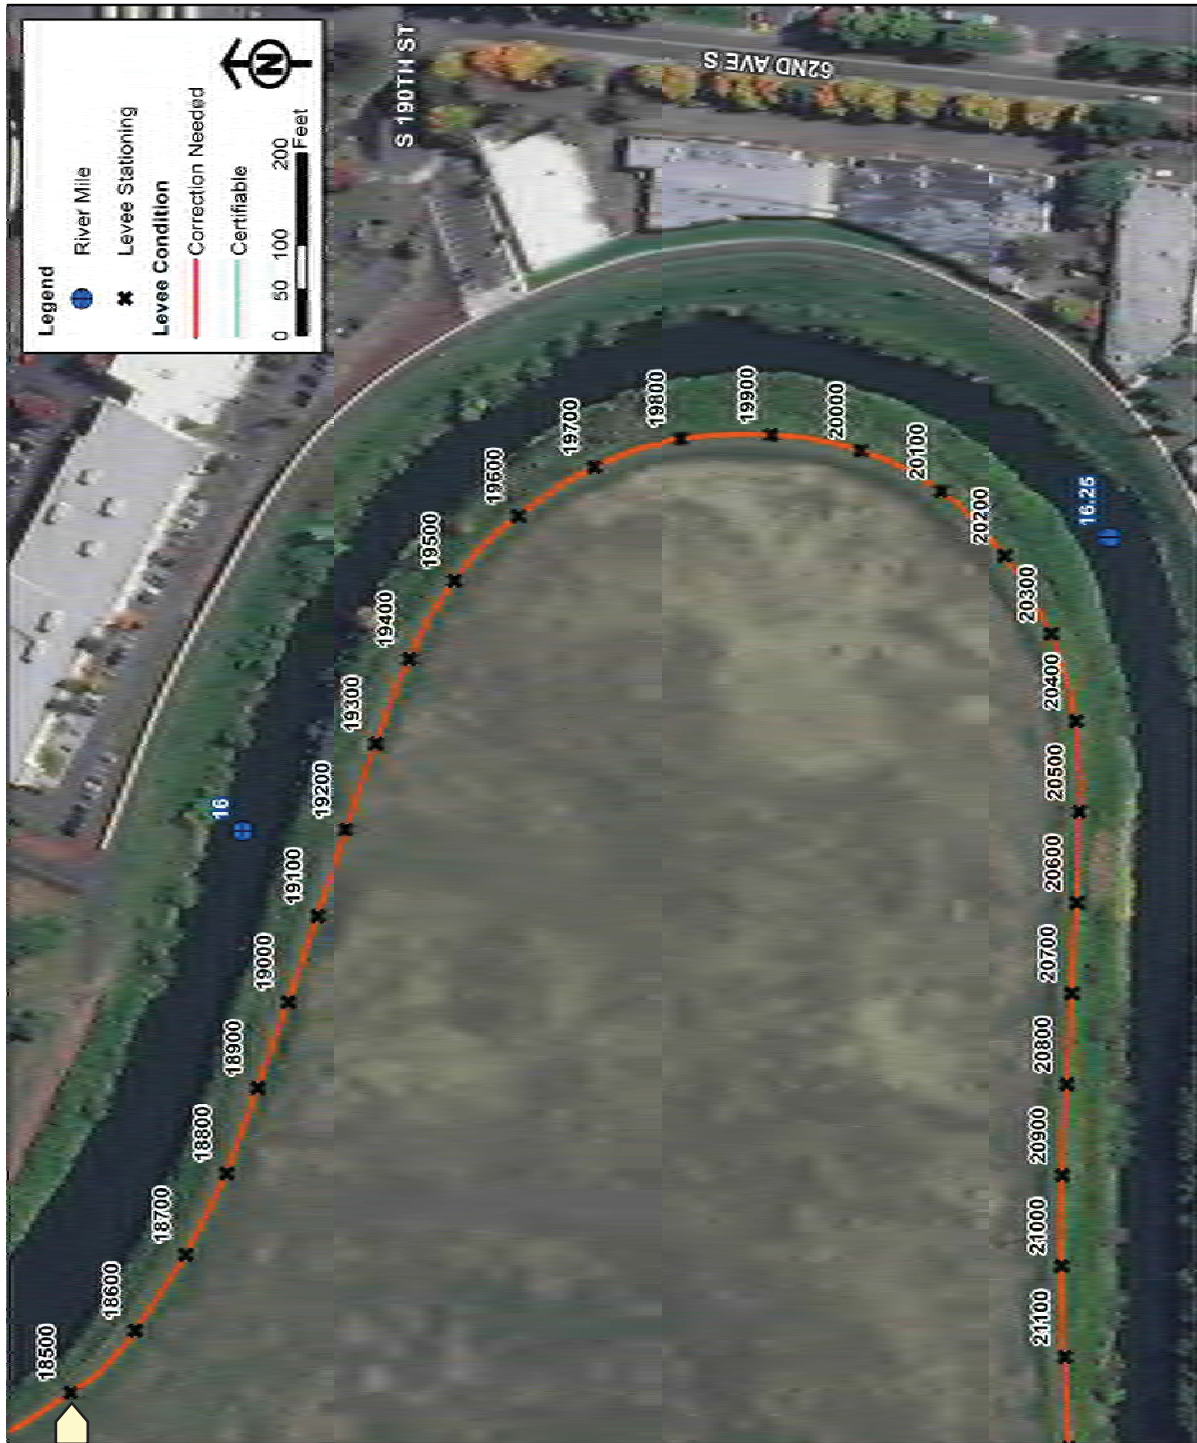
The geotechnical analyses (evaluated at river mile 16.07 and 16.47 in Table 5) indicate that a potential slope failure could occur along the Segale property from station 18500 to 22750 (Figure 18 and Figure 19). However, with the grade landward of any slope stability failure at or above BFE, the section could be certified as is no infrastructure is threatened by a slope failure. This is the only segment of the Tukwila 205 Levee reach, and one of the few remaining in the Lower Green River, where there is currently no development, though site grading has occurred in preparation for construction. As future development plans are uncertain, alternatives were developed for this segment including developing setback levees, raising the levees and constructing sheet pile walls for 500-year protection. Cost estimates for these fixes are provided in Table 4. For the fill option, a site specific cost estimate was made based on actual ground elevations (from 2014) versus computing by linear foot. In addition, a cost was estimated for filling the entire undeveloped area paralleling levee segment 18500 to 22000 (a majority of which is shown in Figure 18) to a uniform elevation at the 500-year level of protection. This is estimated to be approximately \$23 million assuming a fill quality suitable for construction (e.g. free from contamination, compacted and prepared for foundation, etc.) and does not include the cost for purchasing land. Assuming a purchase price of \$10 per square foot for undeveloped property, and approximately 1.7 million square feet of area, land costs are estimated to be another \$17 million. In this segment, work could be completed in phases, with the first phase acquiring land (before development occurs) and then constructing levee improvements (e.g. levee setback) later.

Figure 18. Tukwila Levee segment 18500 through 22750 (downstream portion) that can't be certified in its existing condition.

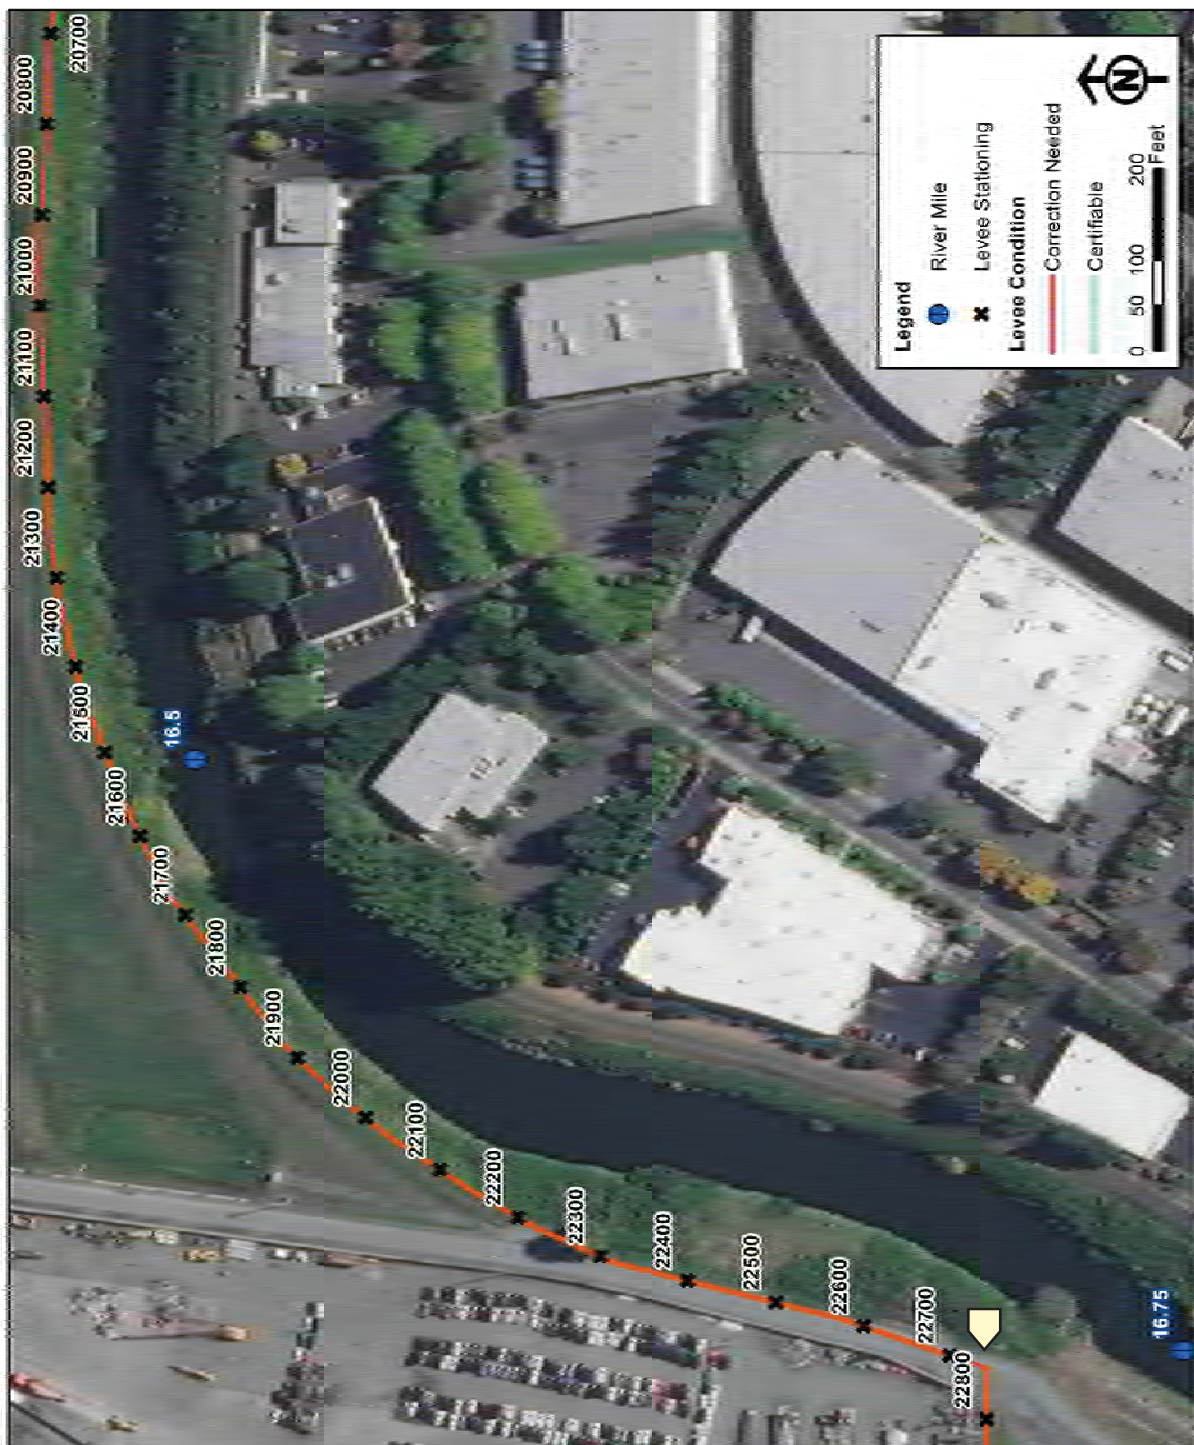
Figure 19. Tukwila Levee segment 18500 through 22750 (upstream portion) that can't be certified in its existing condition.

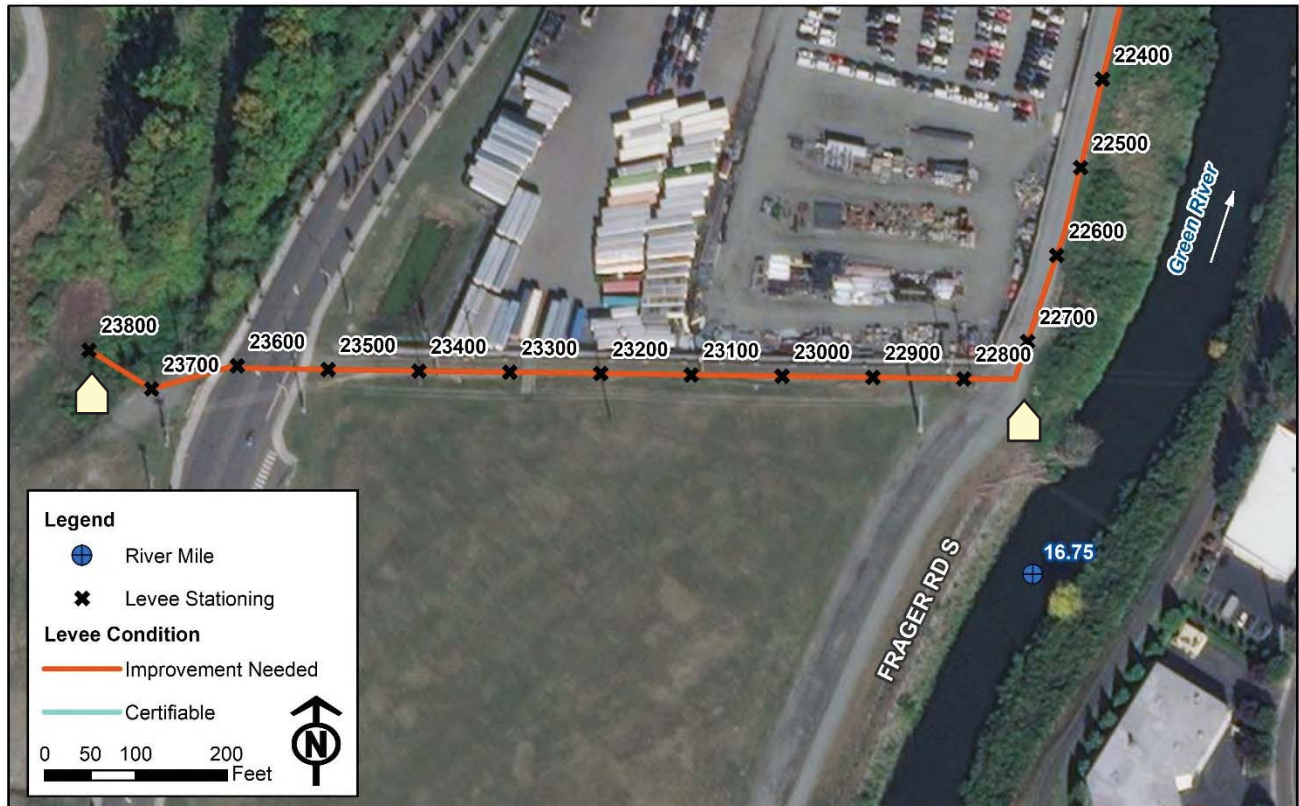
Levee segment 22750 through 23800 is a cross-levee section that spans from the Green River to high ground on the east side of the valley (Figure 20). The BFE here is approximately 35.6 feet and the levee low point is approximately 38.1; therefore, the levee elevation needs to be raised a few inches to be certified. The 500-year elevation plus 3 feet of freeboard is 38.7 feet; therefore, the recommended fix would be to bring this levee up to the 500-year level of protection. Table 4 provides a cost estimate for a construction fix at this segment.

Figure 20. Tukwila Levee segment 22750 through 23800 that can't be certified in its existing condition.
