**Type 4 Watercourse Buffer Enhancement Plan
and Justification for Buffer Reduction**

**15404 40th Avenue South Property
King County Tax ID No.: 004300-0266**

**Dated:
May 14, 2010**

**Prepared by:
Lance Erickson, Environmental Designer**

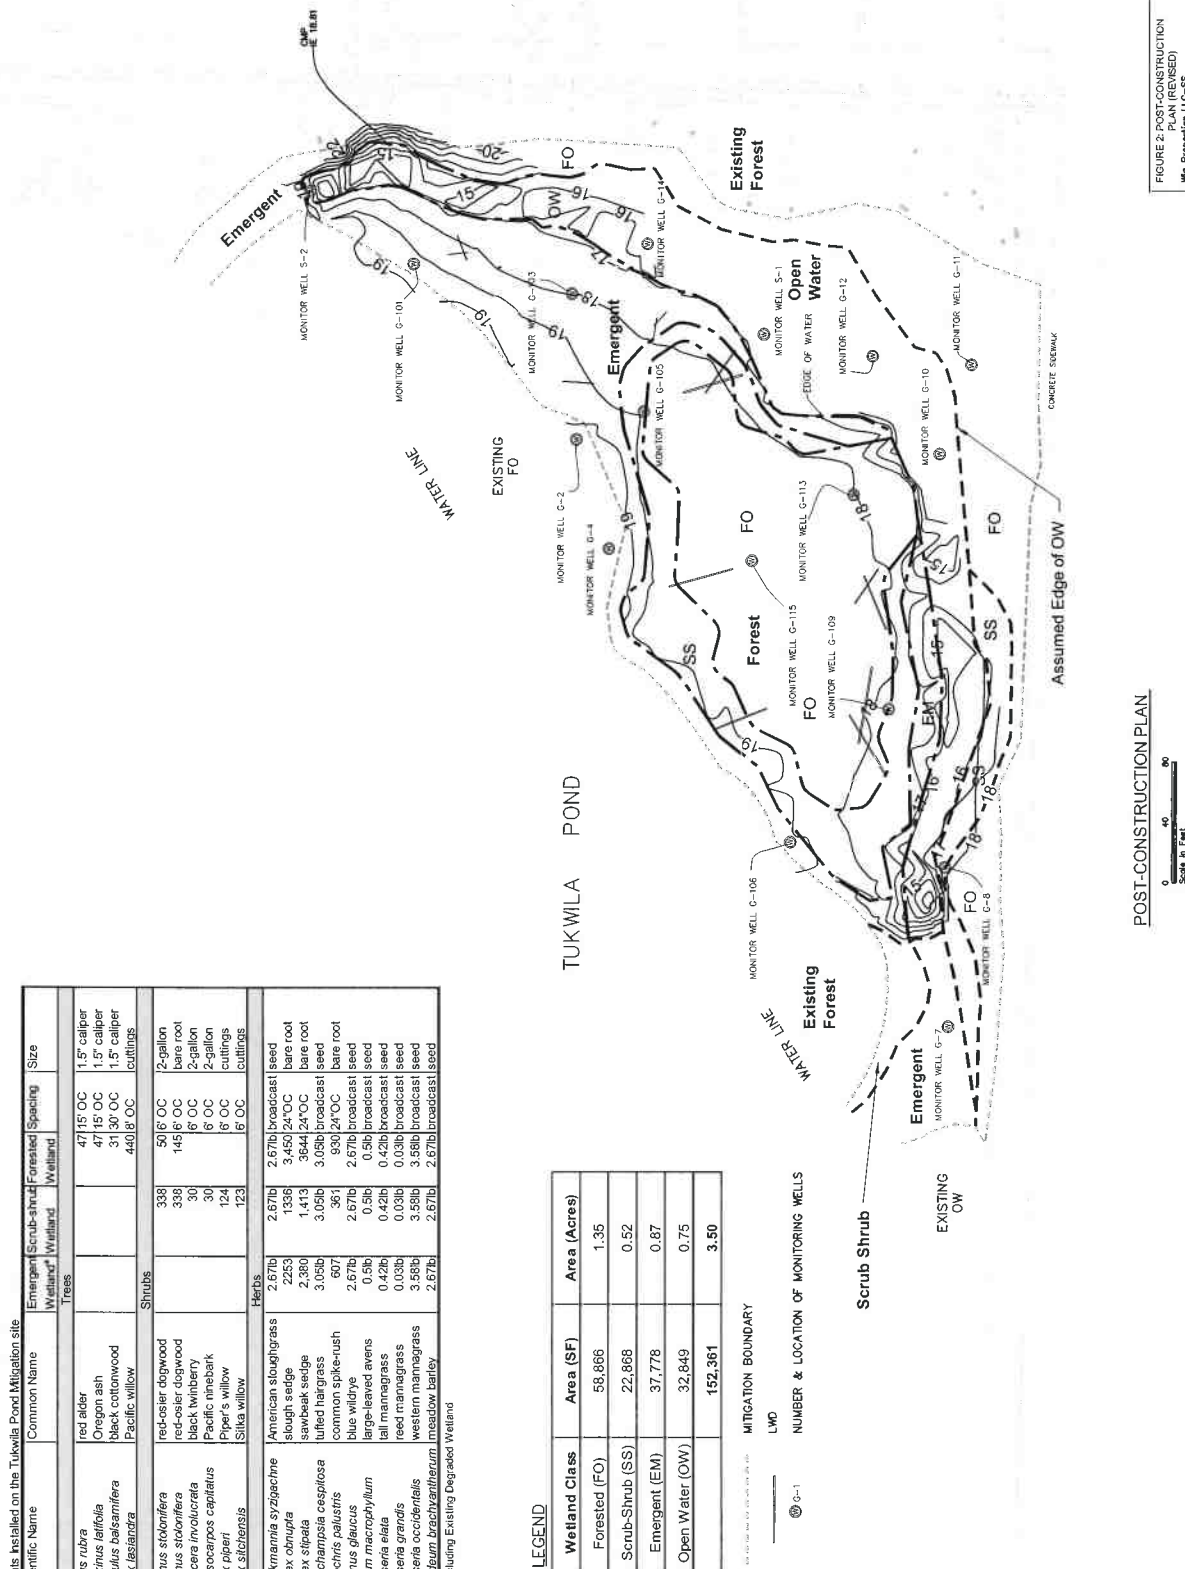
POST-CONSTRUCTION PLAN

NUMBER & LOCATION OF MONITORING WELLS

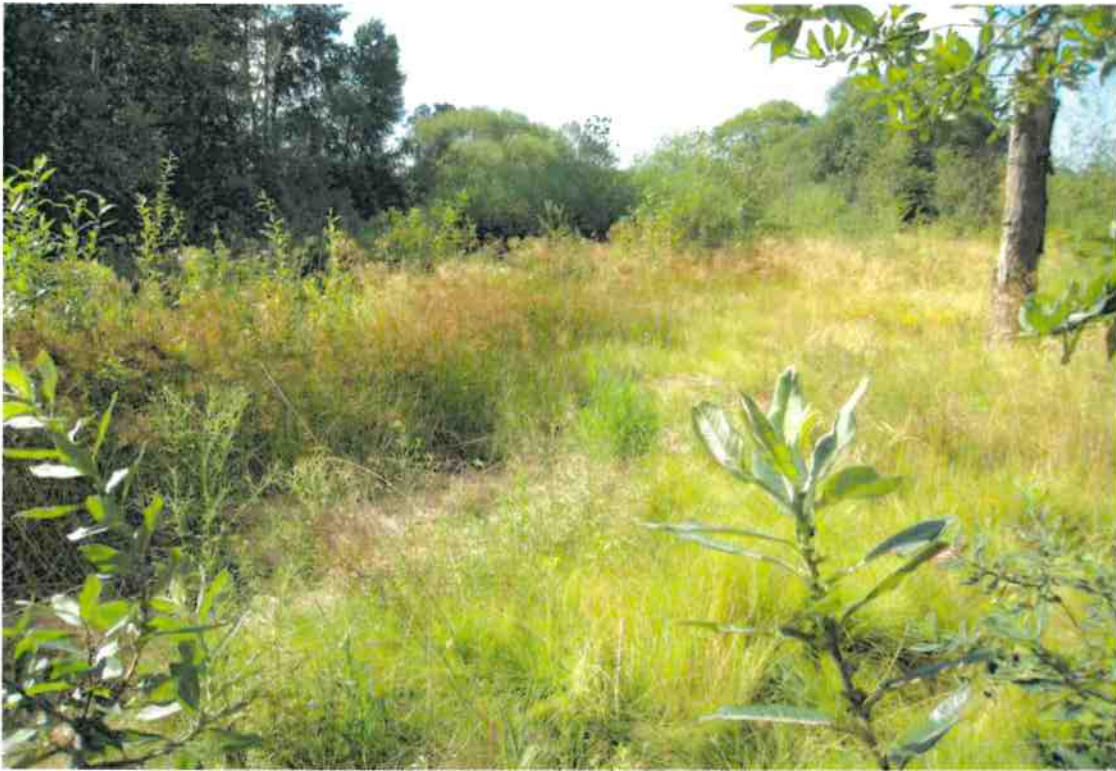
Photograph 1. View of the Emergent Wetland from Plot G-101 looking southeast.

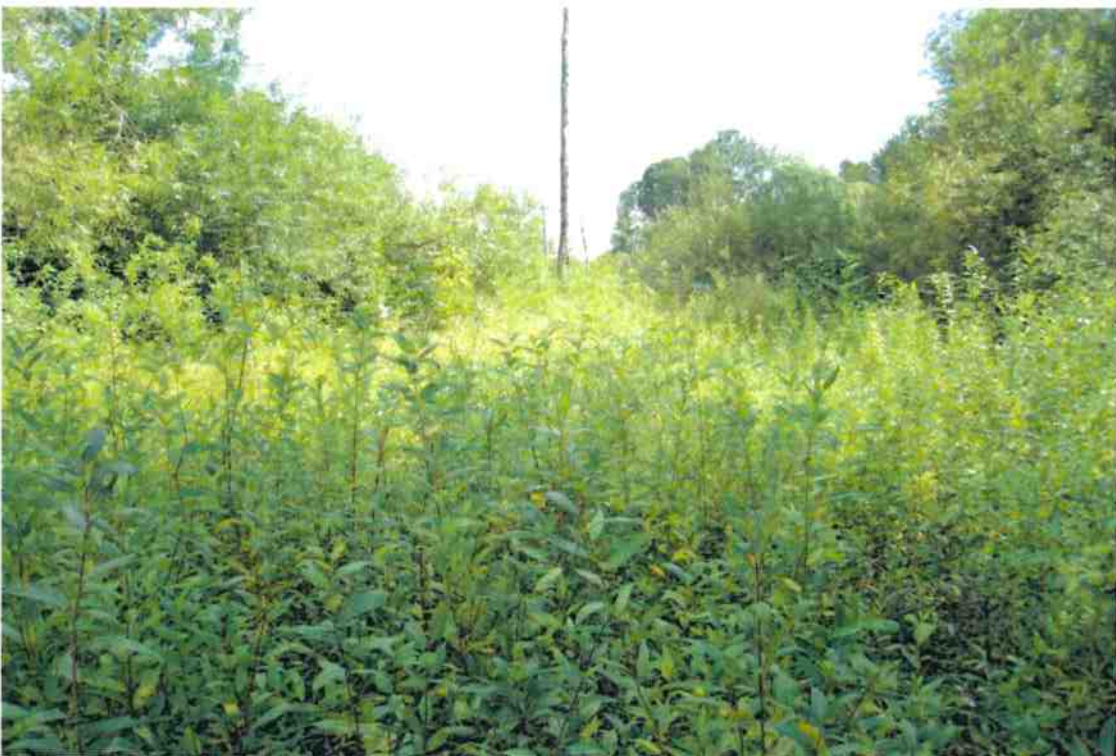
Photograph 2. View of the Emergent Wetland from Plot G-7 looking east.

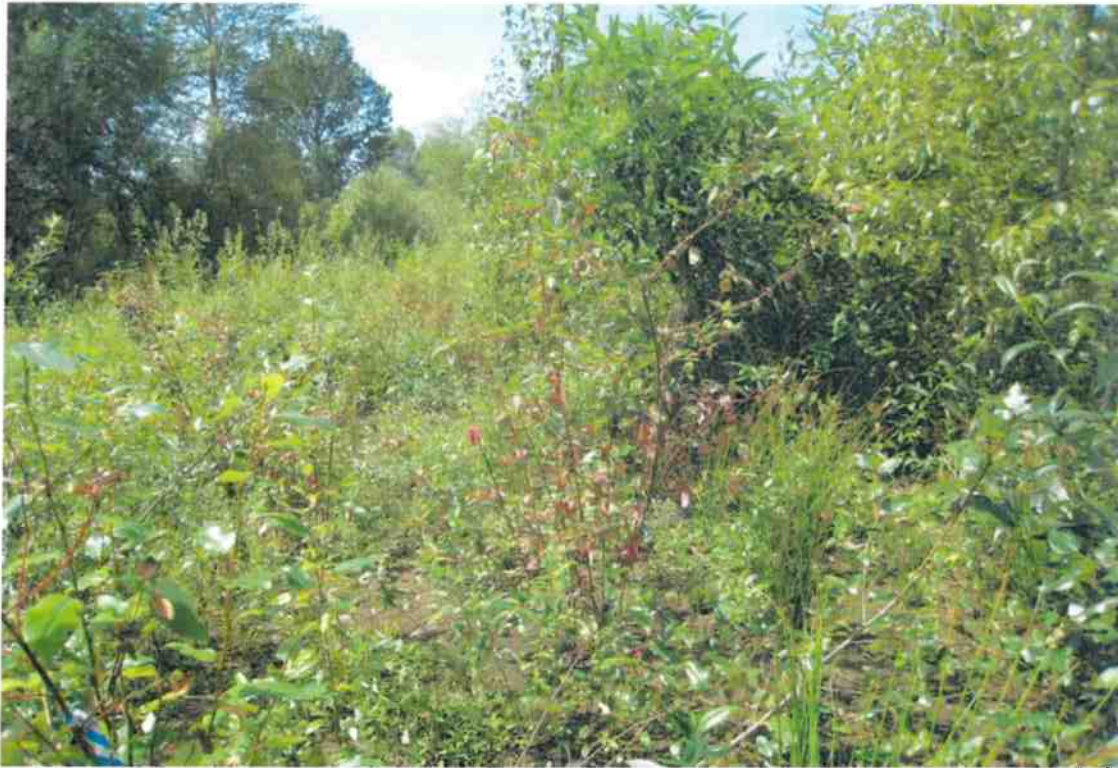
Photograph 3. View of the Scrub-Shrub Wetland from Plot G-109 looking west.

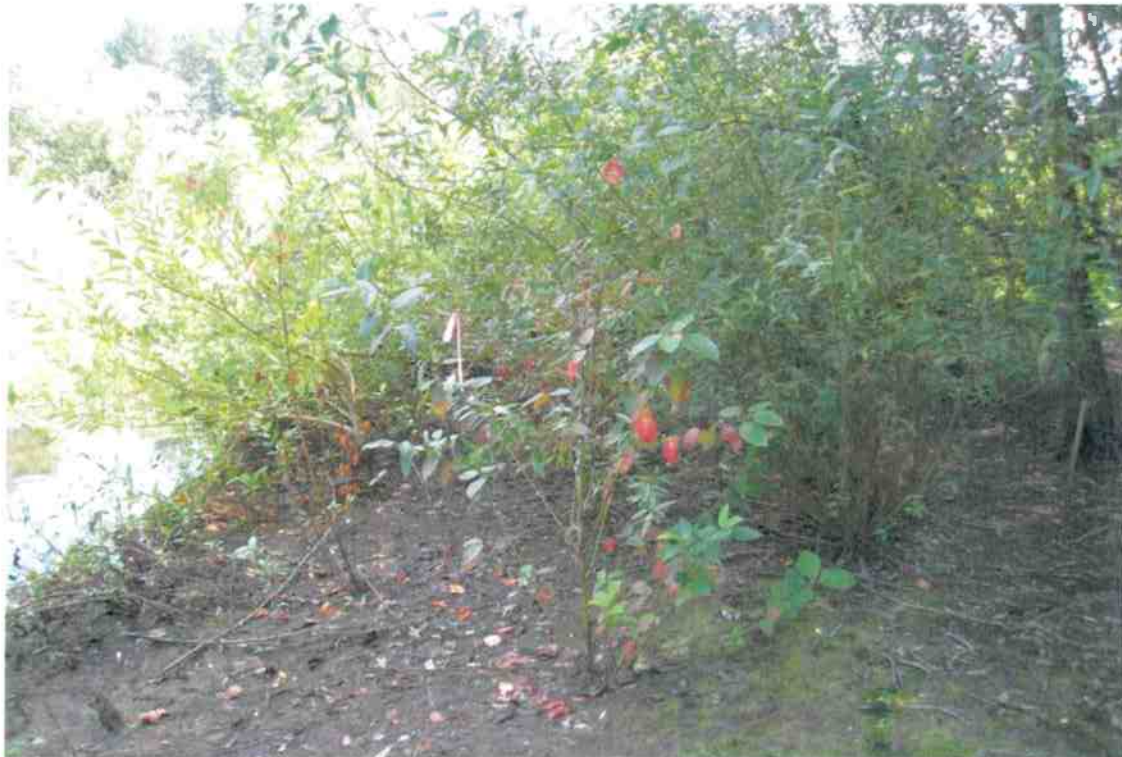
Photograph 4. View of the Scrub-Shrub Wetland from Plot G-8 looking east.

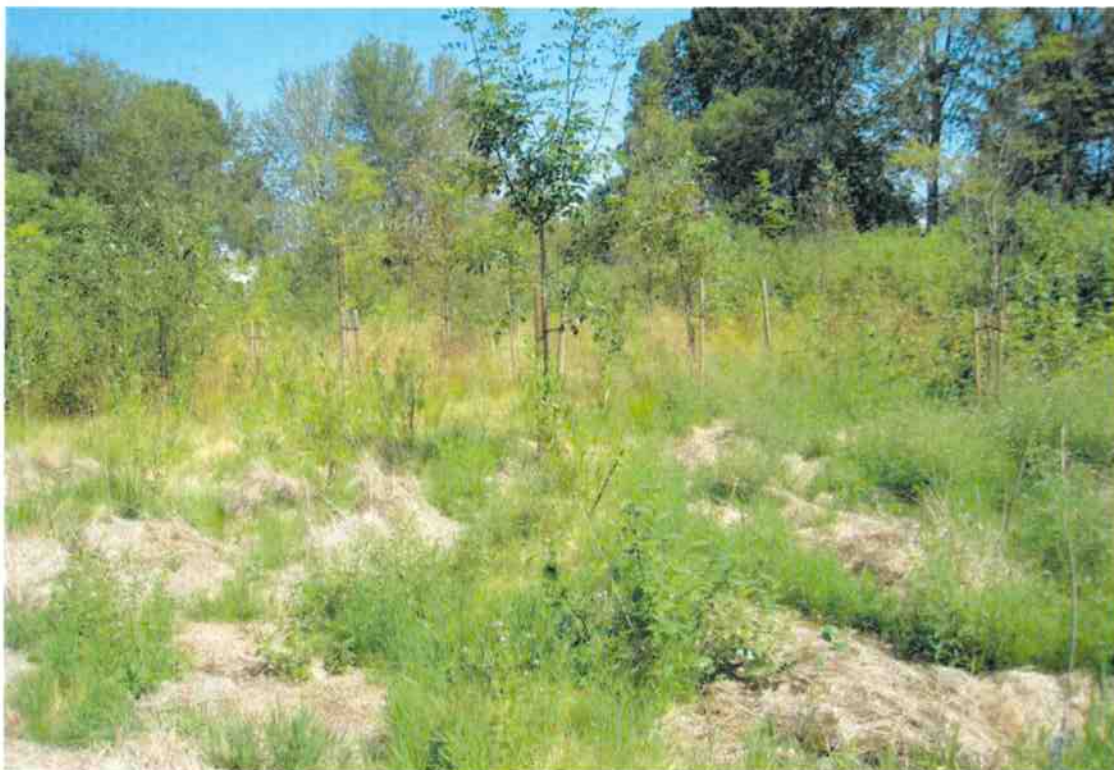
Photograph 5. View of the Scrub-Shrub Wetland from Plot G-115 looking northeast.

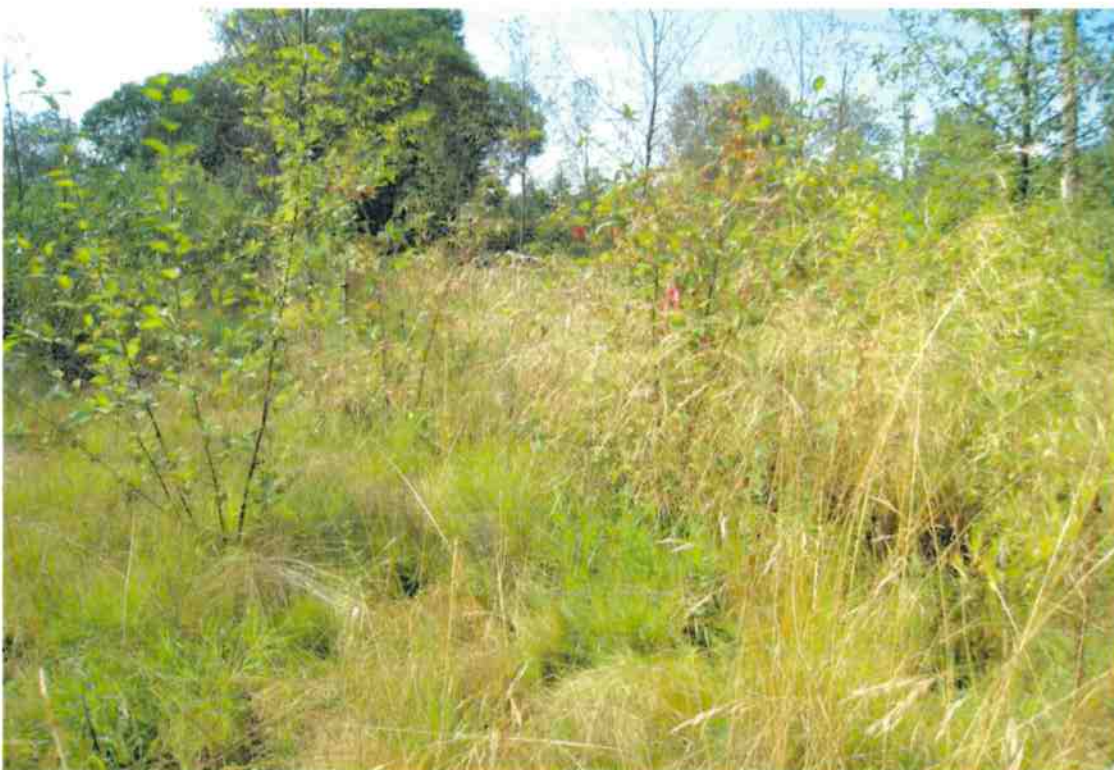
Photograph 6. View of the Forested Wetland from Plot G-105 looking southwest.

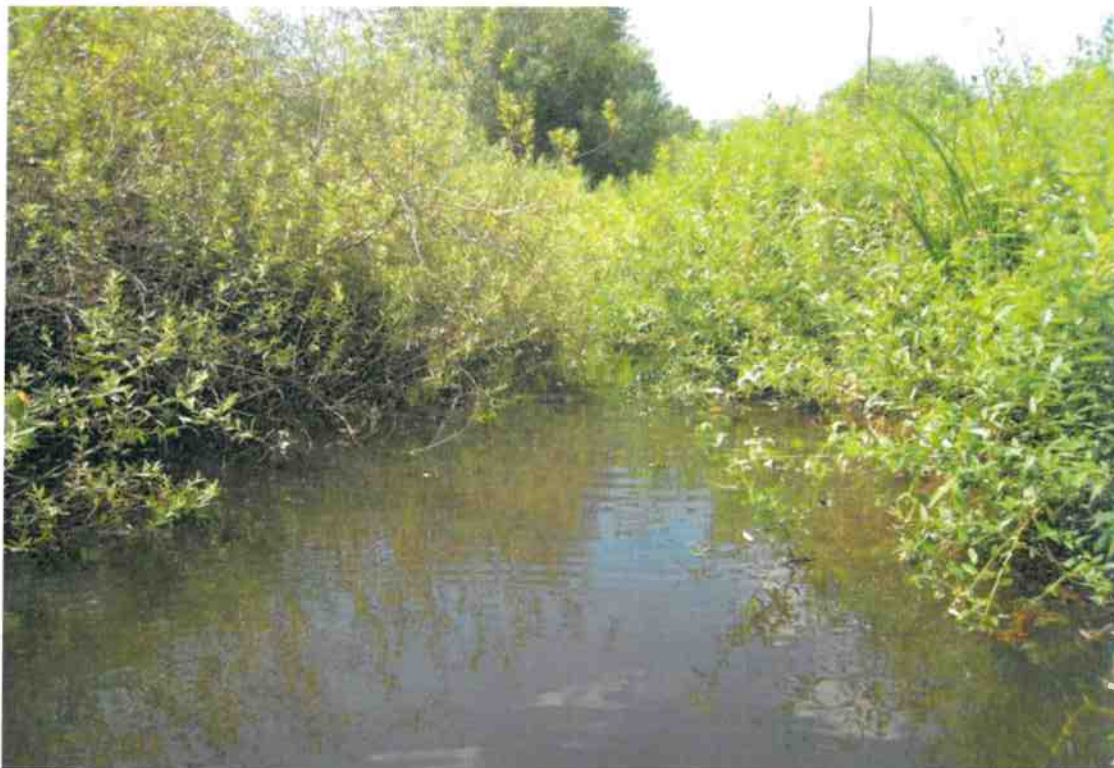
Photograph 7. View of the Open Water Wetland from Plot G-10 looking west.

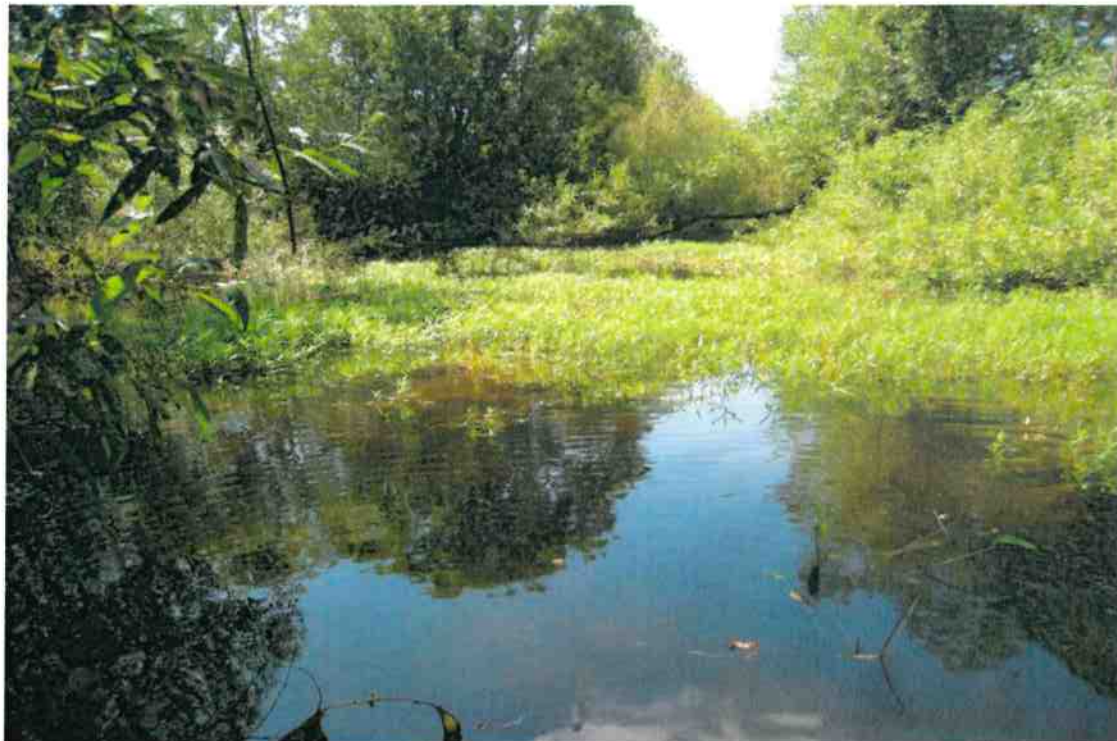
Photograph 8. View of the Open Water Wetland from Plot G-12 looking southwest.

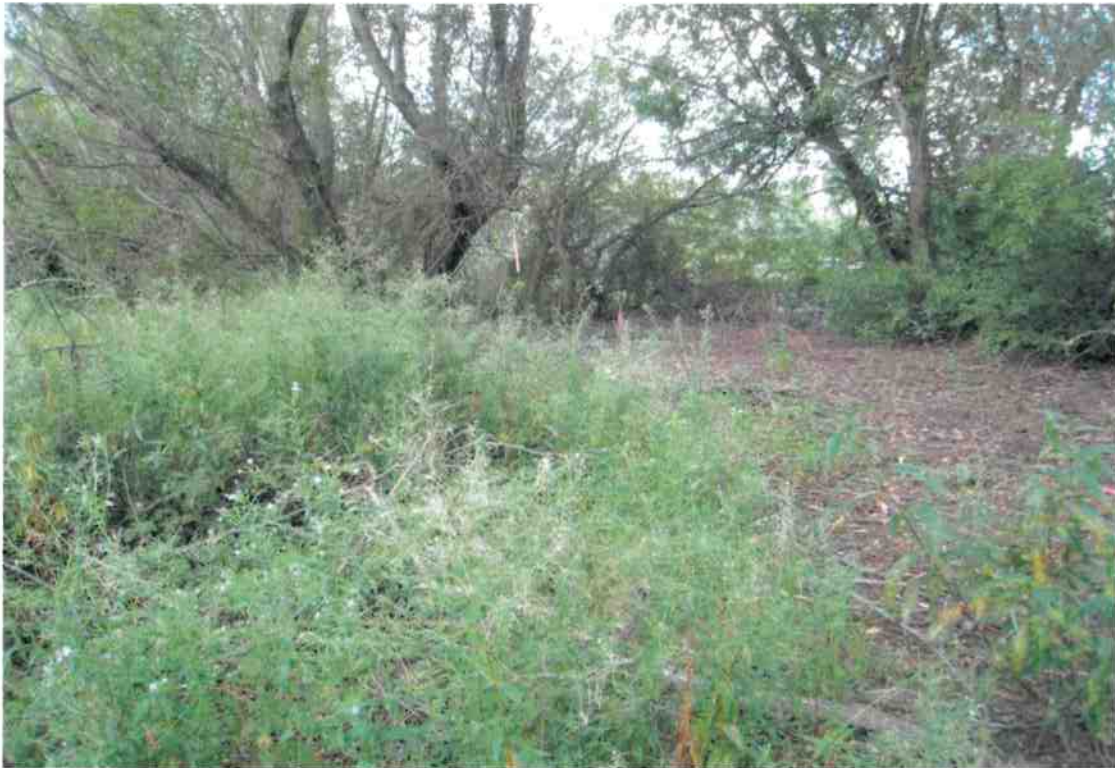
Photograph 10. View of the Existing Forested Wetland from Plot G-2 looking southwest.

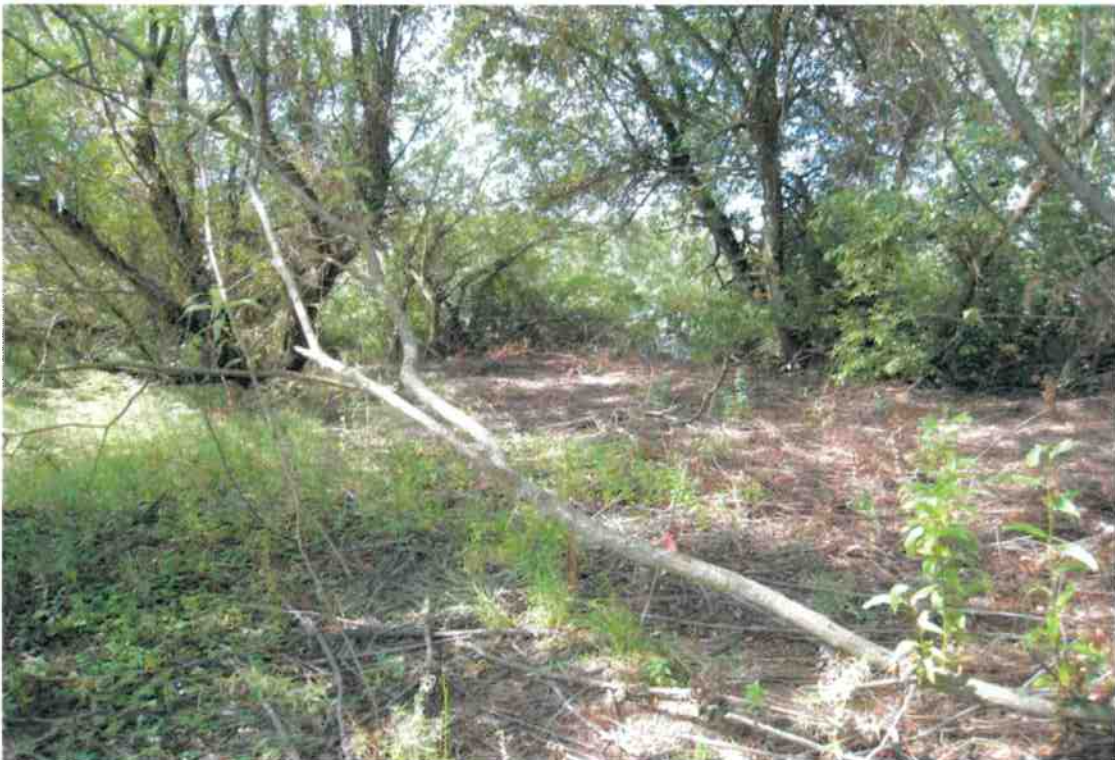
Photograph 10. View of the Existing Forested Wetland from Plot G-4 looking northwest.

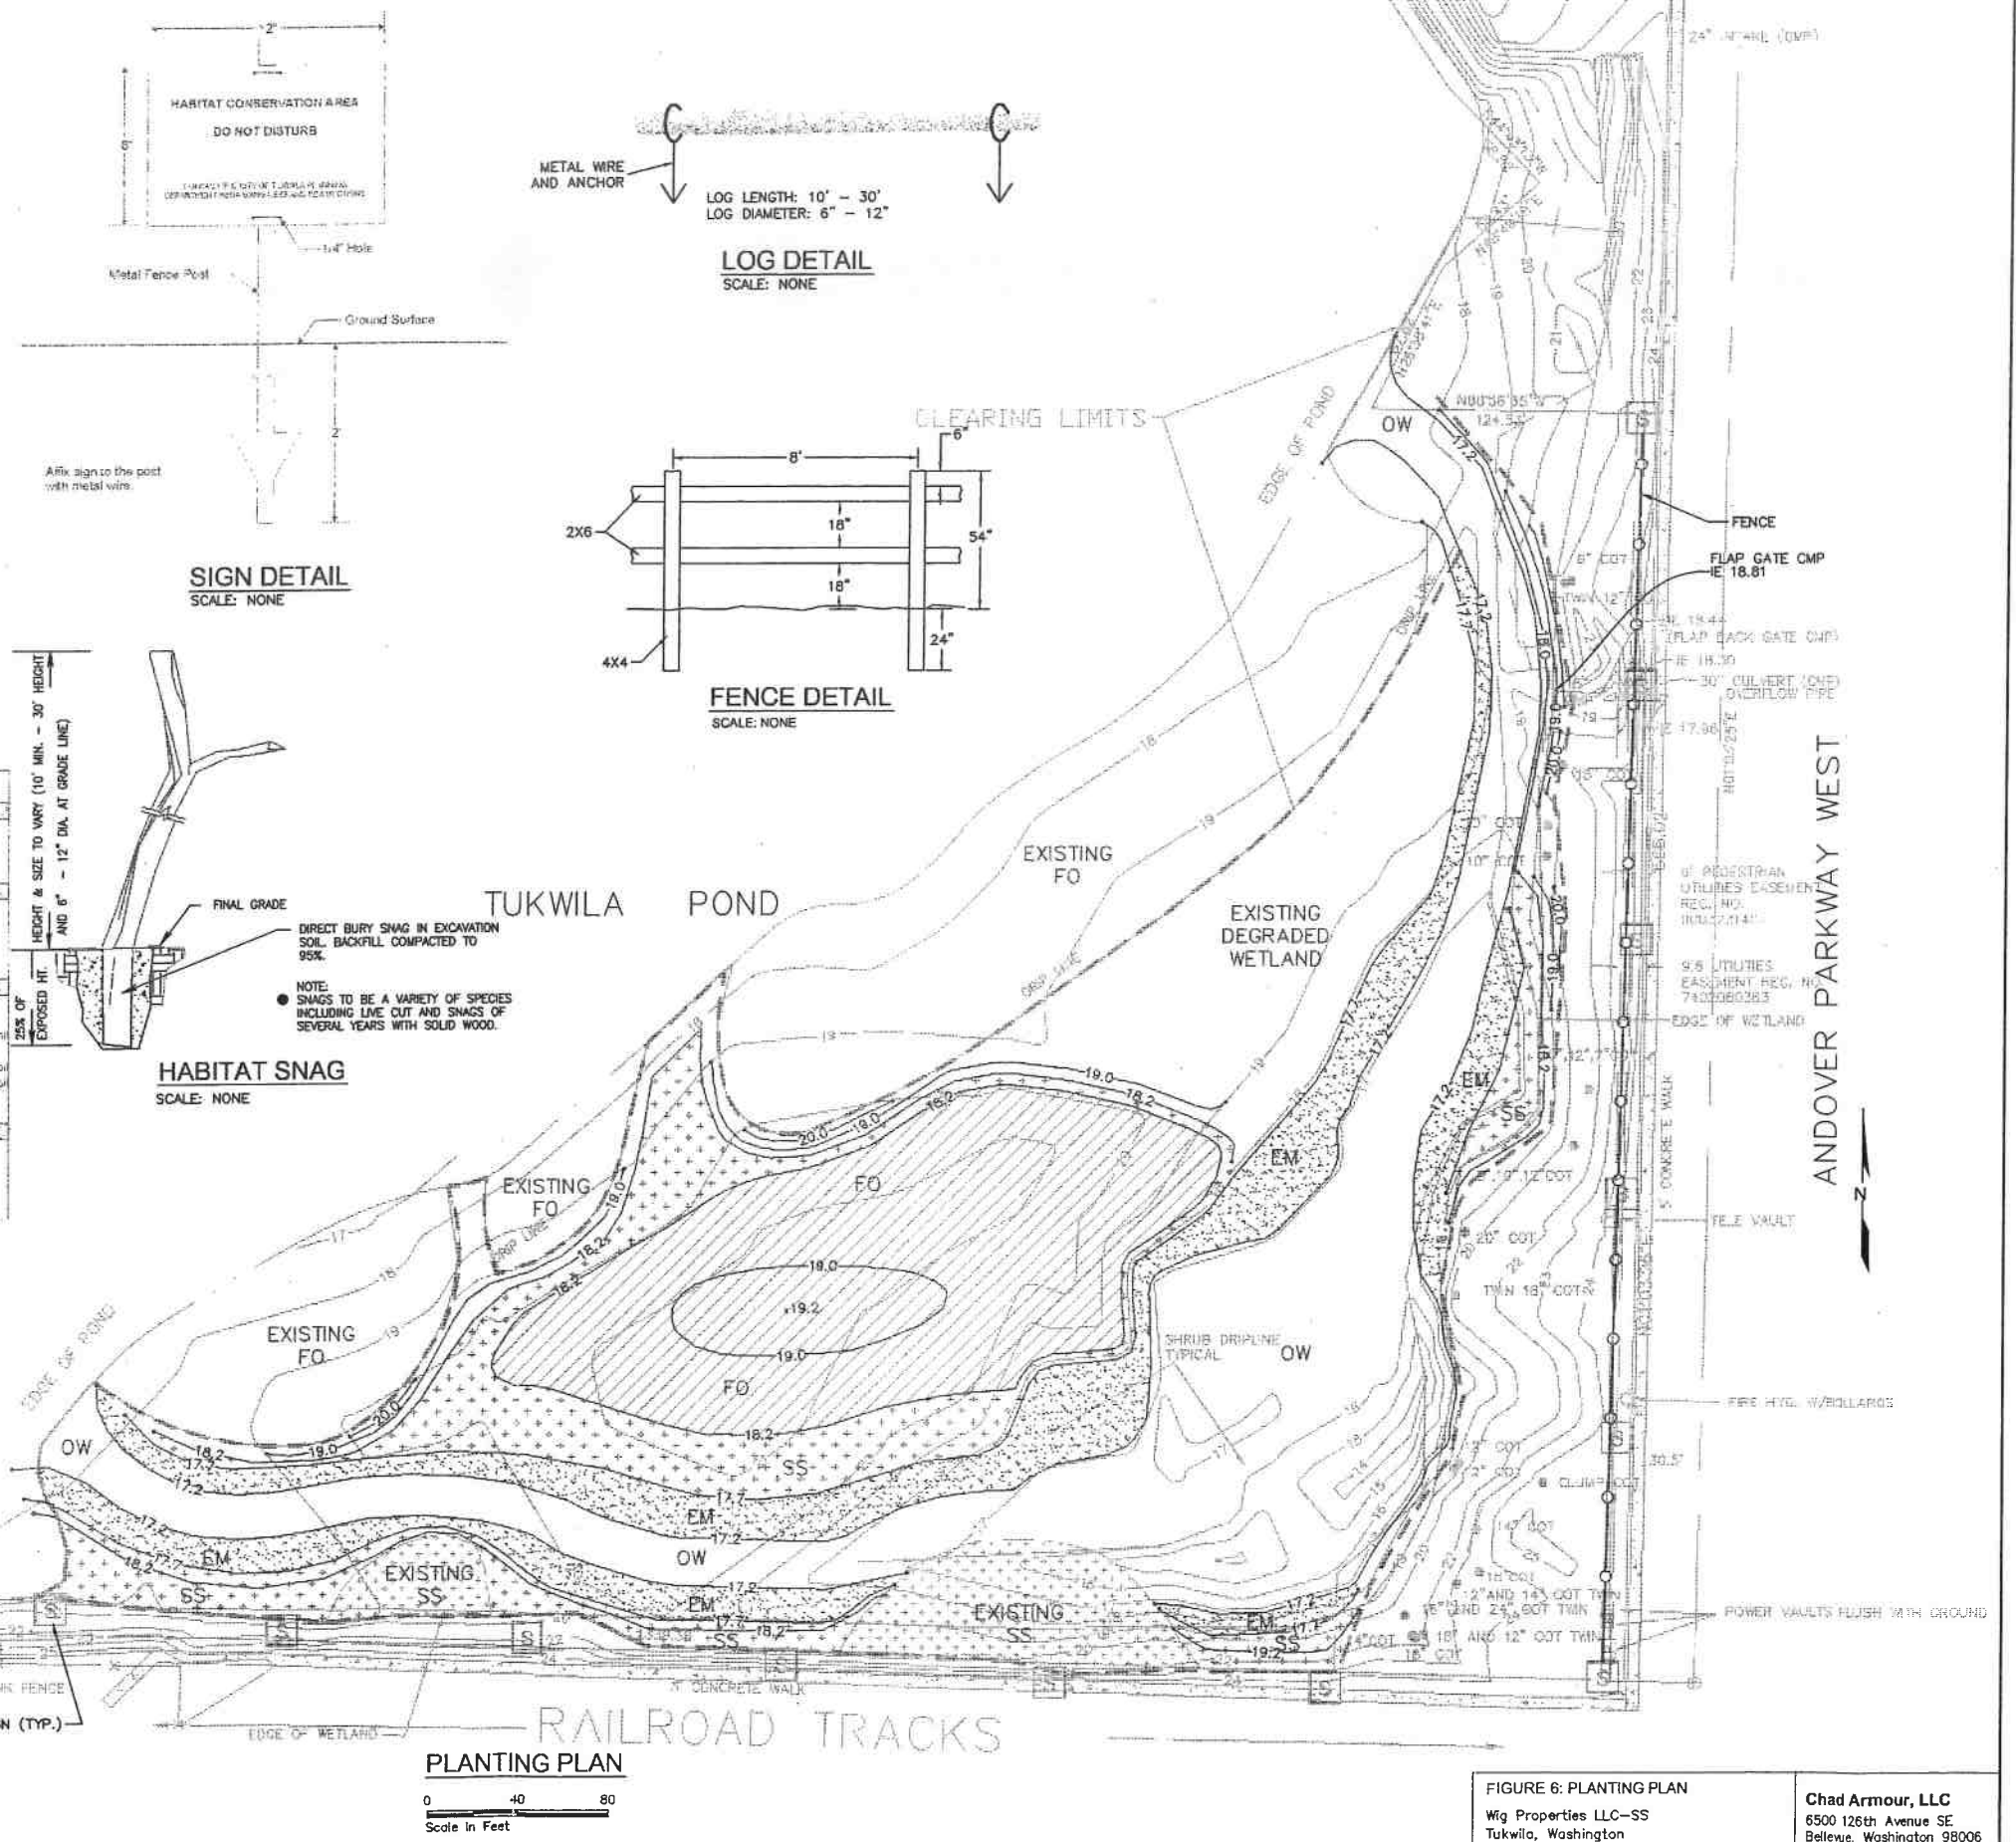
PLANTING PLAN

Wetland Class	Elevation Limits	Area (sf)	Area (acres)
Open Water (OW)	15.2'-17.2'	40,170	0.92
Existing Degraded Wetland	17.7'-20.0'	38,473	0.88
Emergent (EM)	17.2'-17.7'	22,779	0.52
Scrub-Shrub (SS)	17.7'-18.2'	22,152	0.51
Forested (FO)	18.2'-19.2'	28,157	0.65
Total		151,731	3.48

MITIGATION AREA
