**City of Tukwila
Transportation and
Infrastructure Committee**

TO: Transportation and Infrastructure Committee
FROM: Henry Hash, Public Works Director
BY: Ryan Larson, Senior Program Manager
CC: Mayor Allan Ekberg
DATE: March 15, 2019
SUBJECT: Surface Water Fund - 2019 Annual Small Drainage Program
Project No. 91941201
Design Consultant Selection and Agreement

The City of Tukwila Public Works

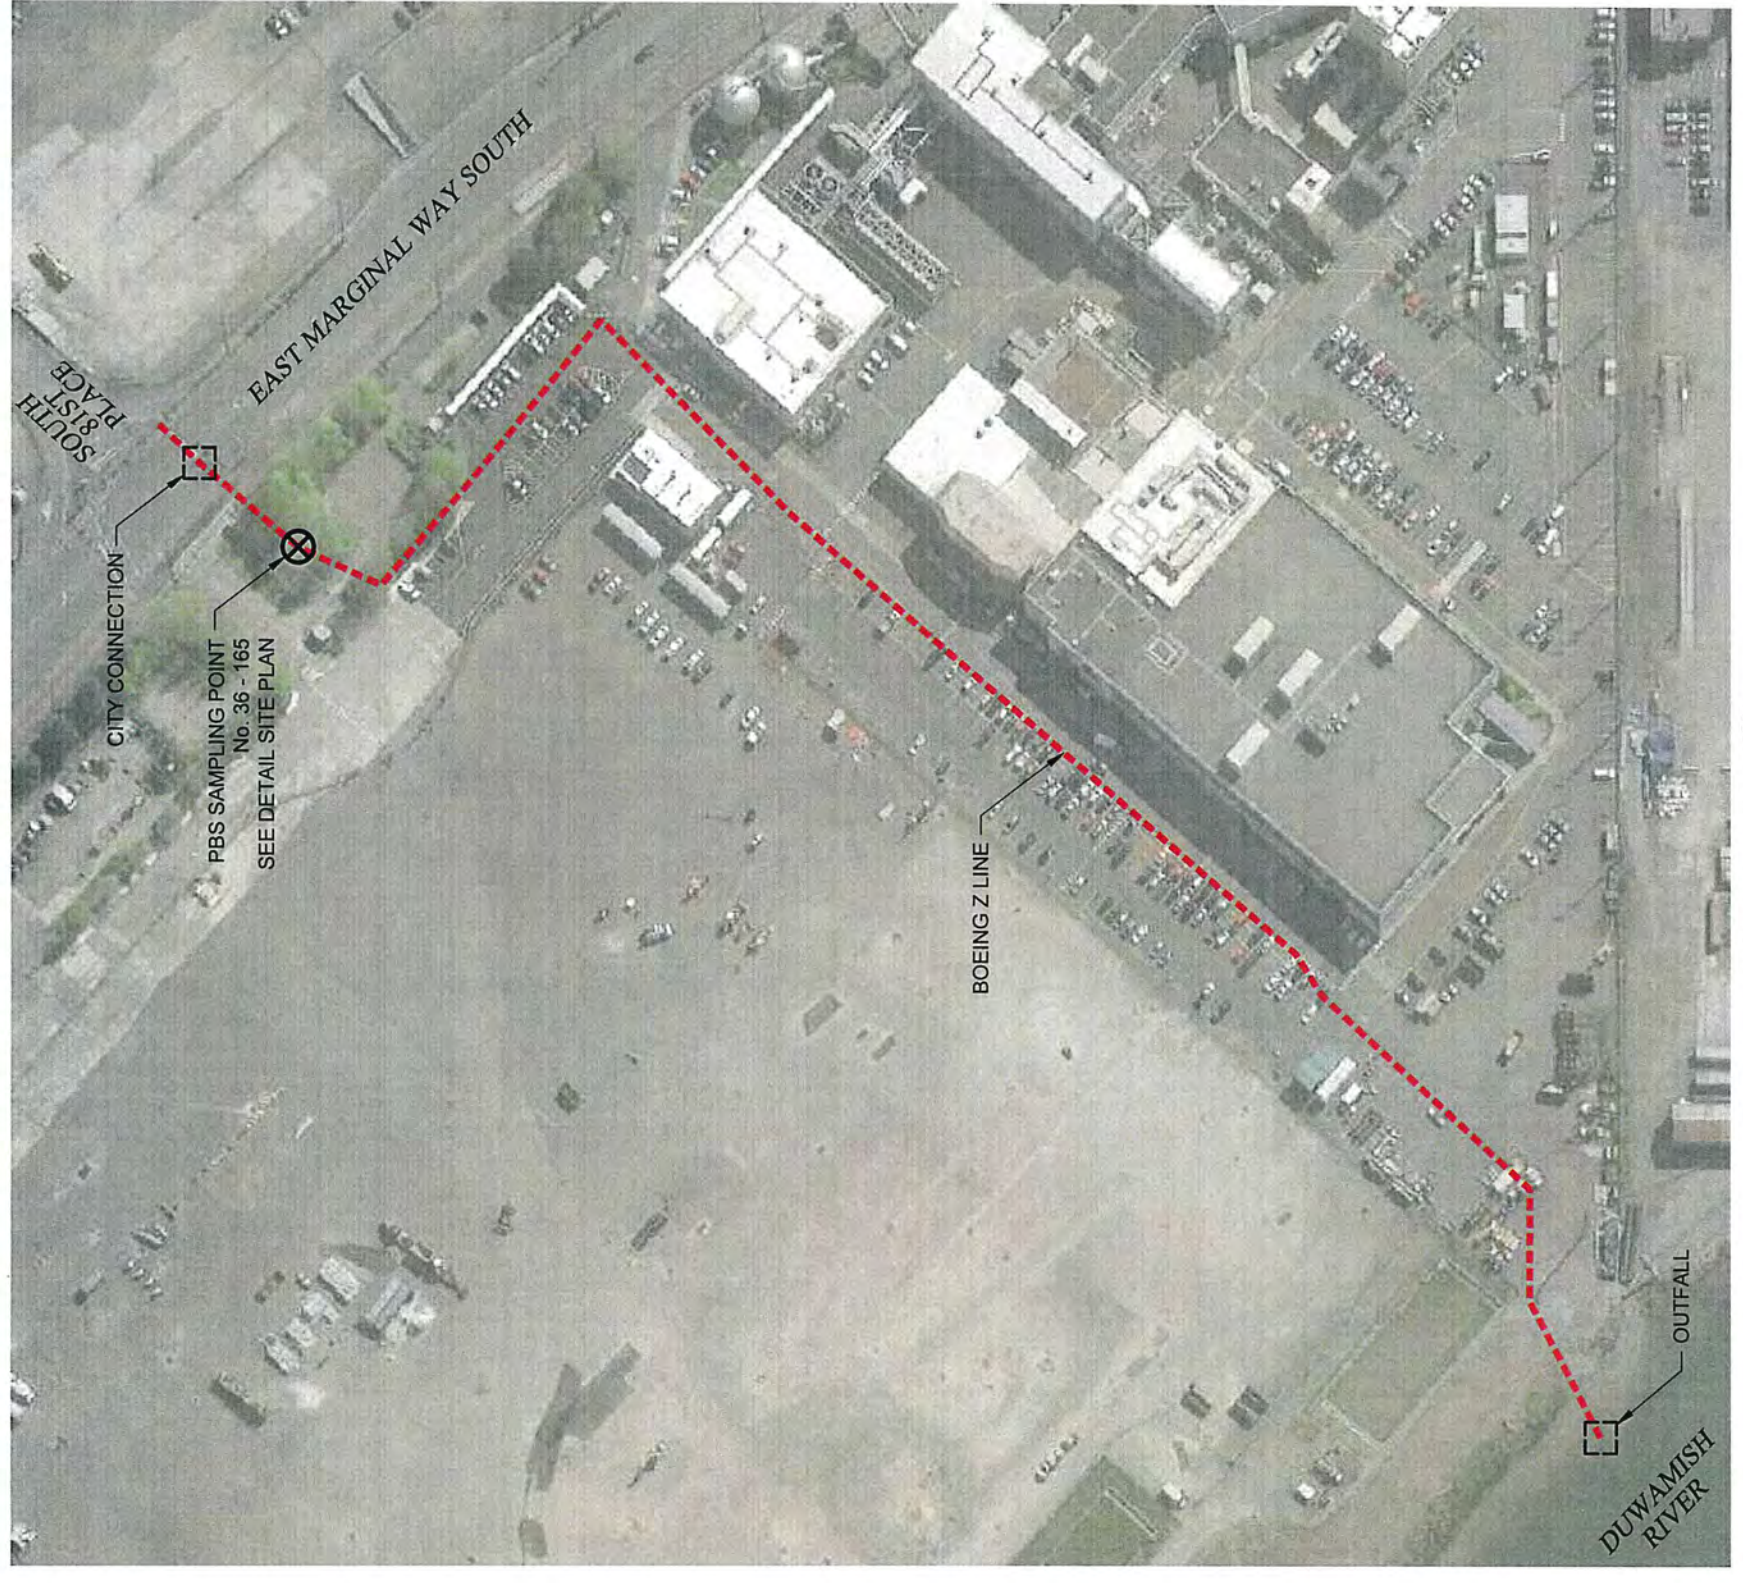
DETAIL SITE PLAN
 SCALE: 1" = 150'

- LEGEND**
- - - - - BOEING Z LINE
 - X STORMWATER MANHOLE NO. 36 - 165

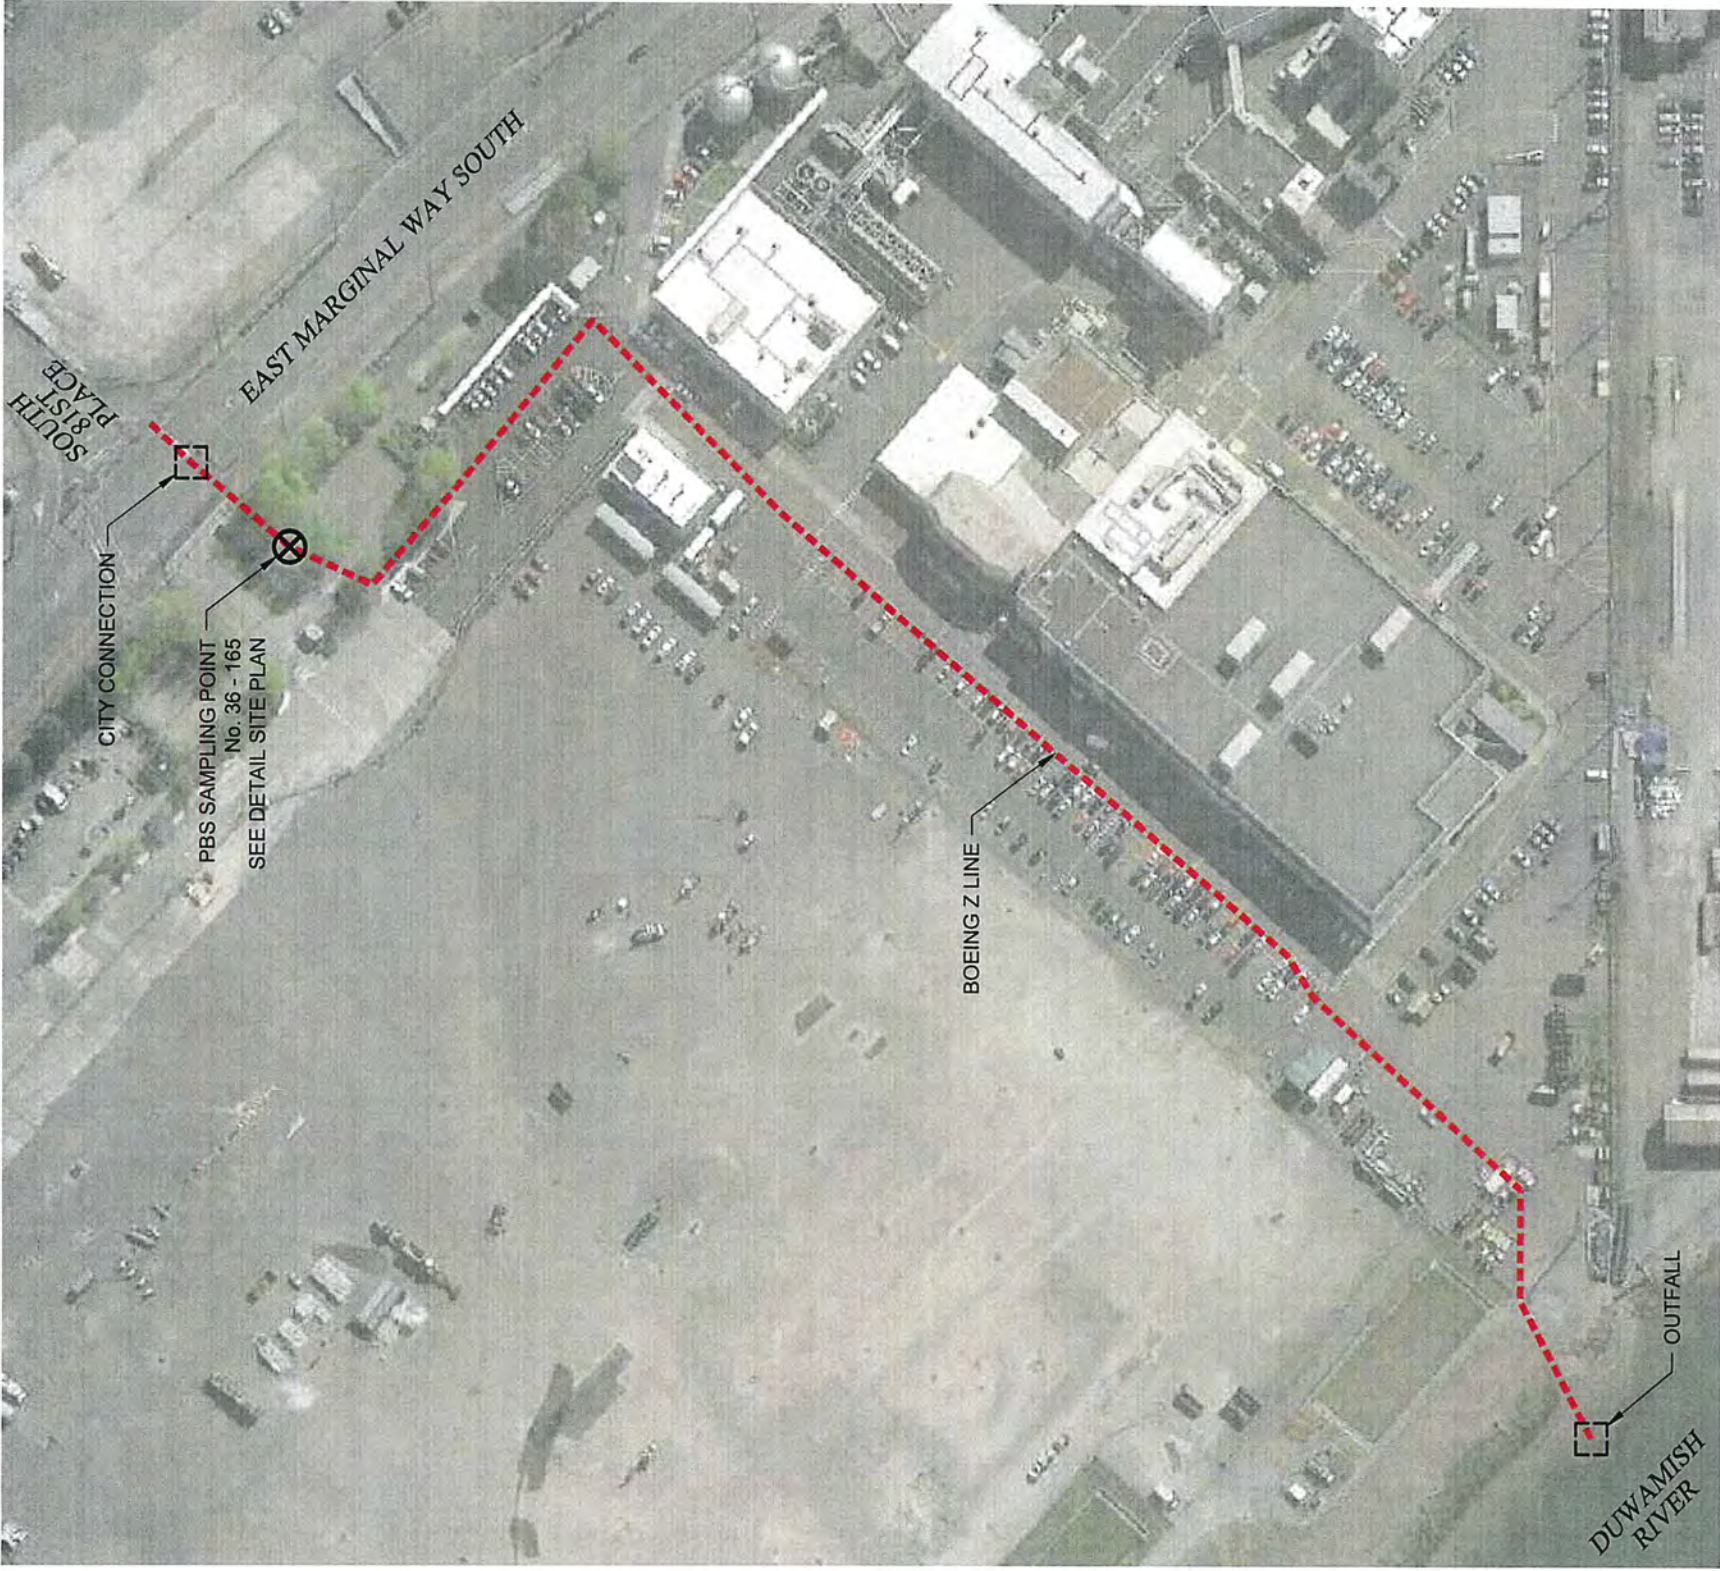
SITE PLAN
SCALE: 1" = 150'

- LEGEND**
- - - - - BOEING Z LINE
 - ⊗ STORMWATER MANHOLE NO. 36 - 165

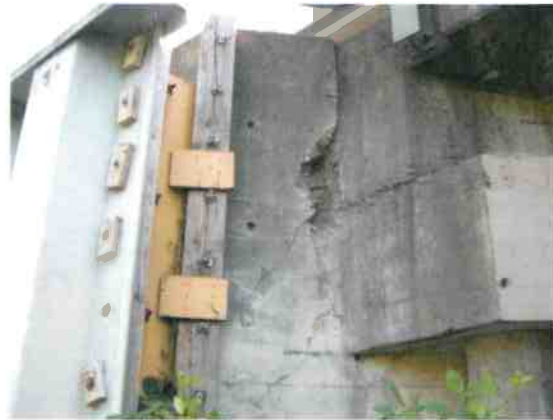
Since the rocker bearings located on the plinths are all completely frozen, there is a semi-rigid link allowing these high magnitude forces to be transmitted through Span 3 to the North Abutment, Pier 4. Again, due to the bridge's large skew, a concentration of force is toward the northwest side of the abutment as illustrated by the damage at this location. This concentration of force may play a role in the continued settlement issues of the north bridge approach roadway at the steel sheet pile wall repair mentioned above.
