TO: **Transportation and Infrastructure Services Committee**  
FROM: **Brandon Miles, Business Relations Manager**  
CC: **Mayor Allan Ekberg**  
DATE: **January 13, 2023**  
SUBJECT: **Public Works Campus, Phase 2**  
**Project No. 92230601**  
**Cost Estimate for Adapting the Existing Building vs. New Construction**

Regarding: Tukwila Public Works Maintenance & Engineering Building Test-to-fit  
Analysis of the Existing UPS Building

Photos of 11231 East Marginal Way South

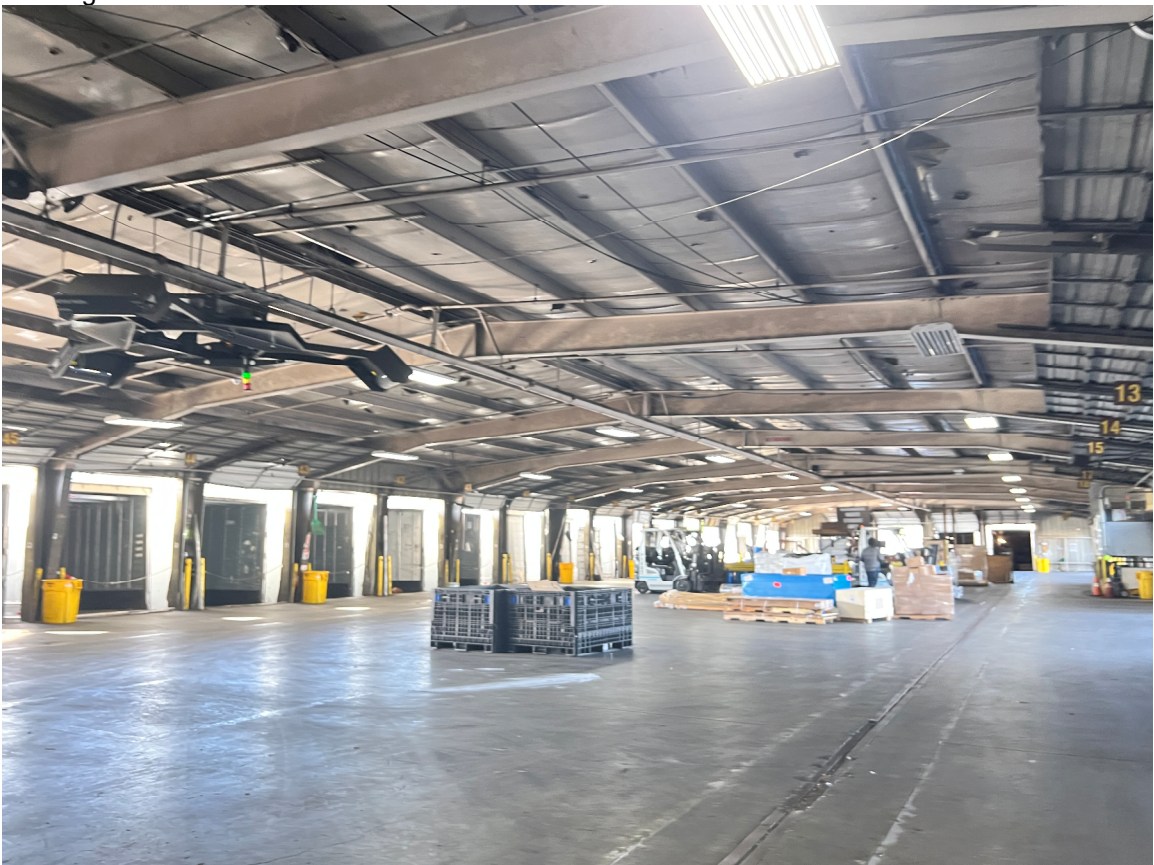
Loading dock area:

The following description and observations are based on a field visit conducted by a structural engineer on October 12, 2022. The one-story loading dock facility is framed with structural steel bents and cold formed steel purlins and girts with metal roofing and siding. The diaphragm consists of steel rods. The vertical lateral force resisting system in the north-south direction are the steel bents. There is no obvious vertical lateral force resisting system in the east-west direction. The loading bay structure is elevated approximately 4 feet above the first floor of a small two-story office area. Based on the age of the building it is expected that the building would be supported by conventional shallow reinforced concrete foundations. There is deterioration, distortion, or damage at structural elements throughout the loading bay area including many damaged purlins and girts.

Deterioration of the existing structure at the loading bay would require repair/replacement of a significant portion of the existing structure including the roof and the exterior walls.

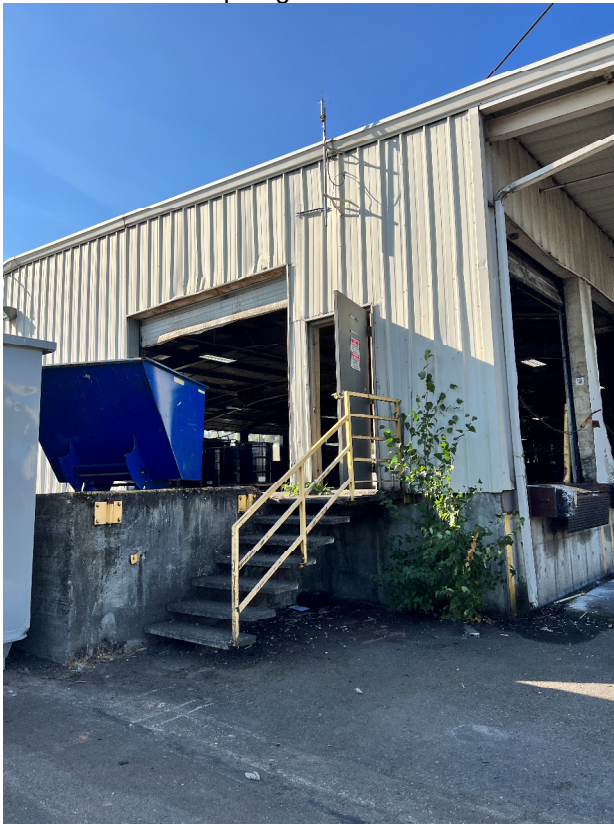
Exterior relationship to grade:

The existing building does not readily accommodate ADA access. New ramps and an elevator or lift would be required to navigate between the various levels.
