## INFORMATIONAL MEMORANDUM

TO: Transportation and Infrastructure Services Committee  
FROM: Pete Mayer, Interim Director  
BY: David Baus, Transportation Project Manager  
CC: Mayor Thomas McLeod  
DATE: April 25, 2025  
SUBJECT: 2024 Pavement Condition Index (PCI) Study Update  
Presentation on the 2024 PCI Study Results  
Contract No. 24-072

# Tukwila, WA

## Pavement Management Report December 2024

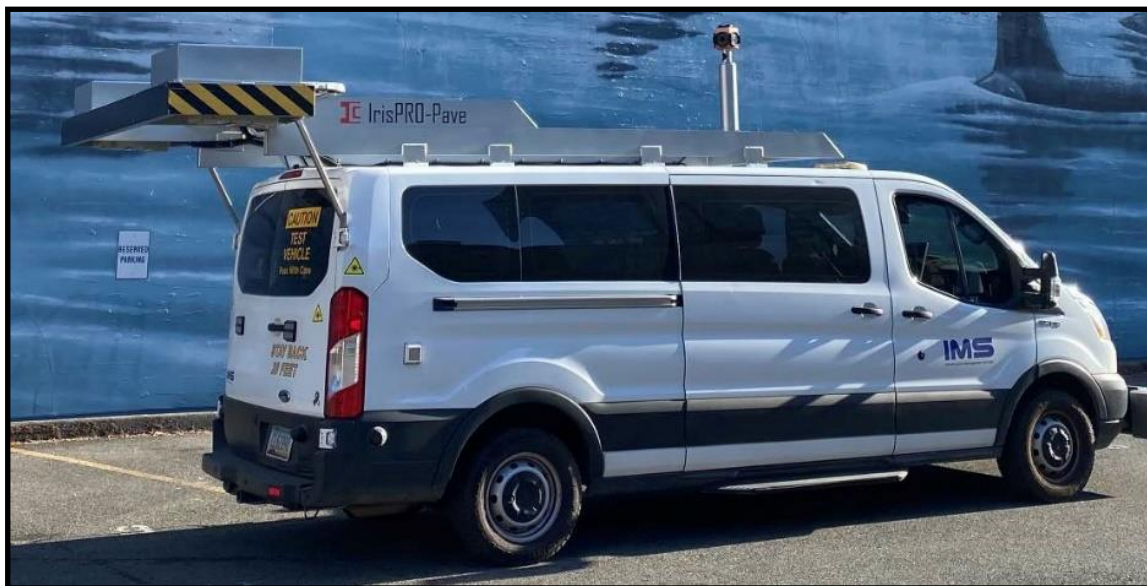
**Figure 1 - IMS Integrated Road Information System platform (IRISpro Pave)**

In July of 2024, IMS Infrastructure Management Services, LP (IMS) utilized a cutting-edge Integrated Road Information System (IRISpro Pave) (**Figure 1**) to capture continuous, high-resolution pavement images that were used to assess pavement cracking, rutting, and roughness on 82 centerline miles of predominantly asphalt roadways in Tukwila, WA (City). IMS followed the American Society for Testing and Materials (ASTM) D6433 standard to analyze the images and distress data collected by the IRISpro to determine the Pavement Condition Index (PCI) for each segment of the road. PCI values were recorded to provide an indication of the surface conditions and structural integrity of a pavement.

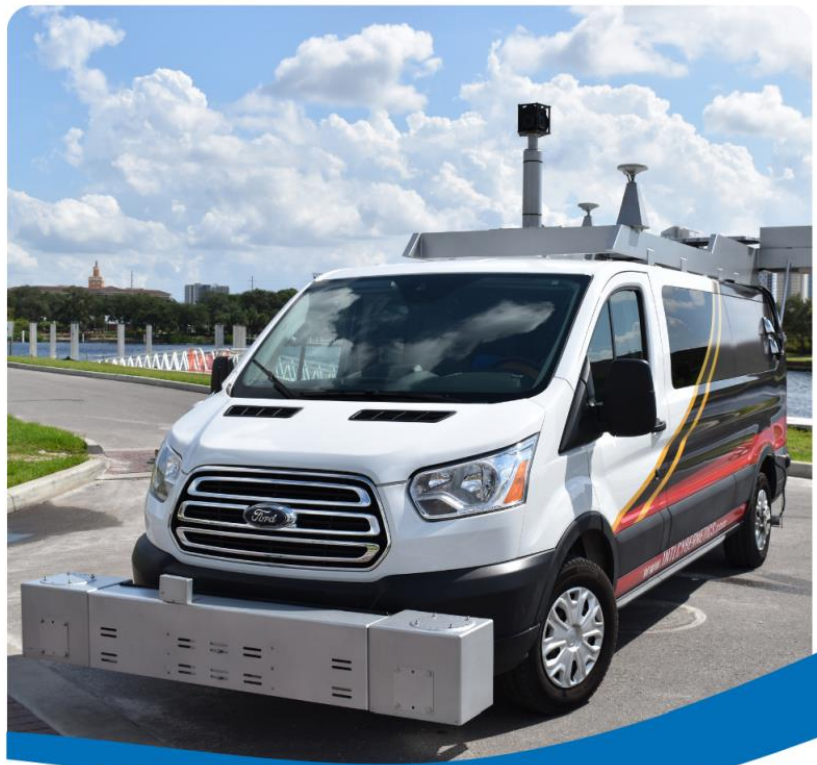
Figure 6 – LCMS-2 data collection vehicle

- ✓ **Teledyne FLIR Ladybug 5+**  
Captures 360° Imagery at Defined Intervals
- ✓ **ASTM Class 1 IrisPRO Pavement Profiler**  
Continuous Right and Left Wheel Path Roughness Measurements
- ✓ **Pavement Distress Imaging**  
LCMS-2 Continuous 3D Imaging, 1mm Resolution
- ✓ **Drive™**  
Automated Data Collection Paired with Field Observations
- ✓ **GPS Positioning**  
GPS with Integrated IMU, Sub Meter Positional Accuracy
- ✓ **Samsara Monitoring**  
Real-Time Tracking and Reporting
- ✓ **Texture**  
Continuous Surface Texture Measurements
- ✓ **Linear Distance Positioning**  
DMI for Precise Linear Distance Measurements
- ✓ **Safety Lighting**  
Front and Back Facing Flashing Lights Ensure High Visibility

The Laser Crack Measurement System (LCMS-2) captures continuous 2D and 3D images at 1 mm resolution in the lane of travel up to 4 m (13 ft) wide at highway speeds, allowing for the visualization and characterization of all features on the road surface. The system allows for collection rates up to 28,000 profiles per second, five times faster than the first edition of LCMS. This allows smaller cracks, especially transverse cracks, to be detected more consistently than in the past. The vertical accuracy has also improved from 0.50 mm to 0.25 mm.

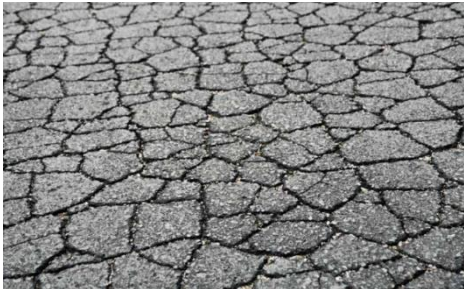
| Distress Type | Pavement Type | Description | Example |
|---|---|---|---|
| <b>Alligator Cracking</b> | Asphalt | <ul style="list-style-type: none"> <li>• Quantified by severity and square footage</li> <li>• Caused by the repeated bending from vehicle loads</li> <li>• Propagate from the bottom, meaning that structural failure has occurred</li> <li>• An LAD with significant impact on the condition score, even at low extents</li> </ul> | |

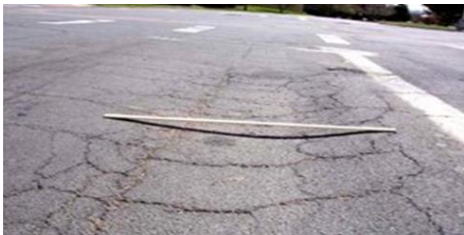
| Distress Type | Pavement Type | Description | Example |
|---|---|---|---|
| <b>Rutting</b> | Asphalt | <ul style="list-style-type: none"> <li>• Caused by the permanent deformation of the pavement and/or subgrade layers</li> <li>• Low densities can have a large impact on the final condition score due to their implication of possible structural failure</li> </ul> | |

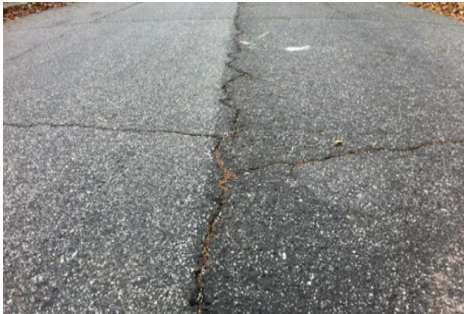
| Distress Type | Pavement Type | Description | Example |
|---|---|---|---|
| <b>Longitudinal &amp; Transverse Cracking</b> | Asphalt | <ul style="list-style-type: none"> <li>• Quantified by their length and width</li> <li>• Results from pavement shrinkage due to natural daily and seasonal temperature cycles, construction issues, or other factors</li> </ul> | |

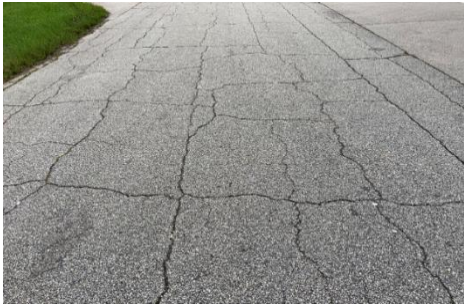
| <b>Block Cracking</b> | Asphalt | <ul style="list-style-type: none"> <li>• Quantified by their width and square footage</li> <li>• Form interconnected longitudinal and transverse cracks</li> <li>• Divides the pavement into rectangular pieces</li> <li>• Results from aging and environmental factors</li> </ul> | |

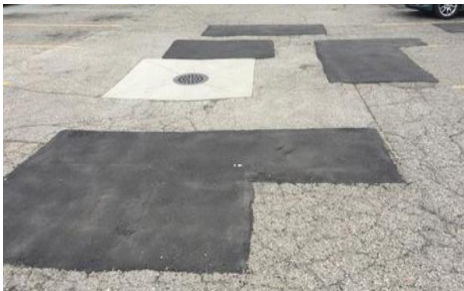
| <b>Patching</b> | Asphalt | <ul style="list-style-type: none"> <li>• Quantified by the square footage and severity</li> <li>• Always considered a surface defect</li> <li>• Affects ride quality and condition of a pavement</li> </ul> | |

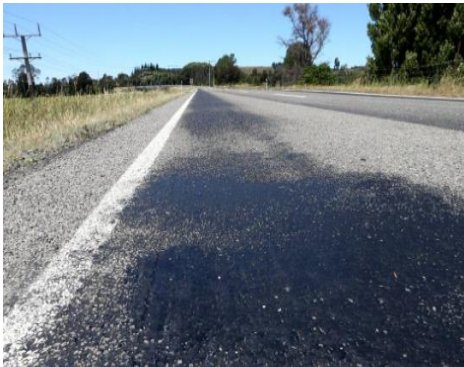
| <b>Bleeding</b> | Asphalt | <ul style="list-style-type: none"> <li>• Measured by severity and square footage</li> <li>• Presence of free asphalt binder on the roadway surface</li> <li>• Results in a pavement surface with reduced skid resistance</li> <li>• Caused by either an excess of asphalt in the pavement or insufficient voids in the matrix</li> </ul> | |

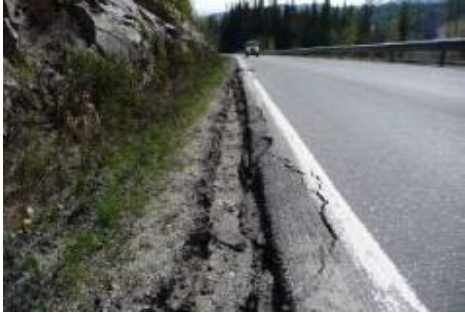
| <b>Edge Cracking</b> | Asphalt | <ul style="list-style-type: none"> <li>• Measured in linear feet</li> <li>• Caused by traffic loading and weakened base conditions resulting from poor drainage</li> <li>• Run parallel to the road, usually within 1 to 2 feet of the outer edge of the pavement</li> </ul> | |

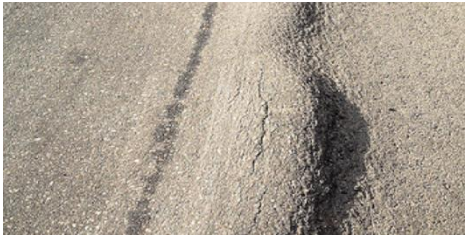
| <b>Distortion</b> | Asphalt | <ul style="list-style-type: none"> <li>• Bumps and sags, depressions, swell, corrugation, and shoving</li> <li>• Caused by several factors, such as construction issues, subgrade mixture failure, environmental influence, etc.</li> </ul> | |

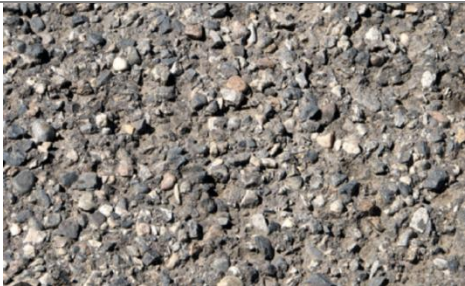
| <b>Weathering</b> | Asphalt | <ul style="list-style-type: none"> <li>• Wearing away of asphalt binder and fine aggregate matrix</li> <li>• Quantified by severity and square footage</li> </ul> | |

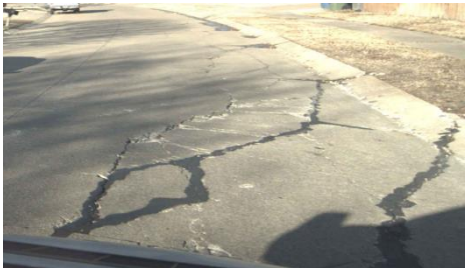
| <b>Divided Slab</b> | Concrete | <ul style="list-style-type: none"> <li>• Slab divided by cracks into four or more pieces</li> <li>• Caused by overloading, inadequate support, or both</li> <li>• Categorized as a severe corner break if all pieces or cracks are contained within a corner break</li> </ul> | |

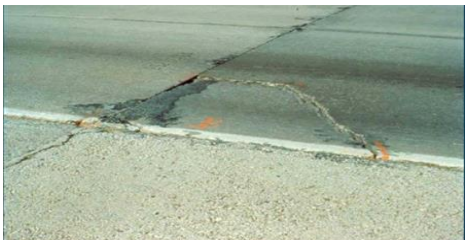
| <b>Corner Breaks</b> | Concrete | <ul style="list-style-type: none"> <li>• Crack that intersects with a joint at less than <math>\frac{1}{2}</math> the slab length</li> <li>• Caused by repeated load on a surface with a failing base</li> </ul> | |

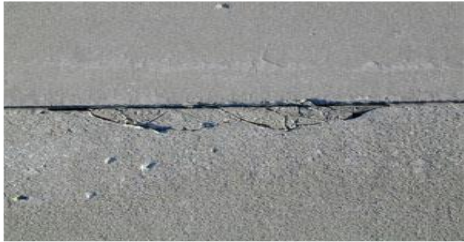
| <b>Joint Spalling</b> | Concrete | <ul style="list-style-type: none"> <li>• A breakdown of the edges of a slab within 2ft of a joint</li> <li>• The depth of the cracking and area affected determine the severity</li> </ul> | |

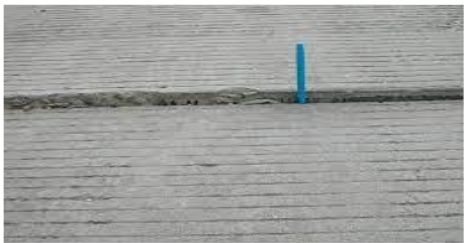
| <b>Faulting</b> | Concrete | <ul style="list-style-type: none"> <li>• Identified by a difference in elevation across a joint</li> <li>• Severe faults have a &gt;3/4 inch elevation difference between two adjacent concrete slabs</li> </ul> | |

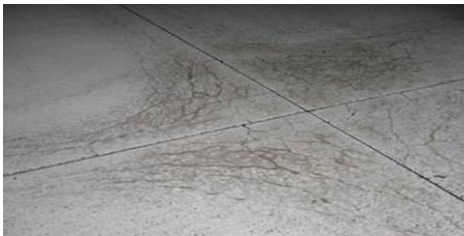
| <b>Durability Cracking</b> | Concrete | <ul style="list-style-type: none"> <li>• Caused by the freeze-thaw expansion of the large aggregate</li> <li>• Breaks down concrete over-time</li> <li>• Typically runs parallel to a joint or linear crack</li> <li>• A high severity "D" crack covers more than 15% of the overall slab</li> </ul> | |

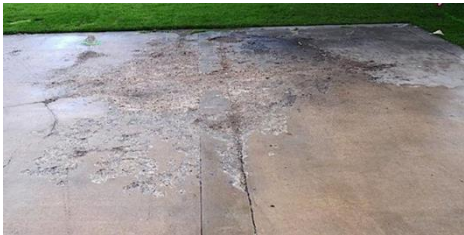
| <b>Scaling</b> | Concrete | <ul style="list-style-type: none"> <li>• A result of the surface layer of concrete being worn away over time by weathering</li> <li>• Measured by severity and total area affected</li> </ul> | |

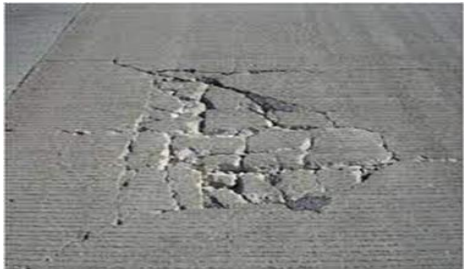
| <b>Punchouts</b> | Concrete | <ul style="list-style-type: none"> <li>• Caused by heavy and repeat loads, inadequate slab thickness, and a deterioration of the base foundation</li> <li>• Measured by severity and number of individual cracks within the distress</li> </ul> | |

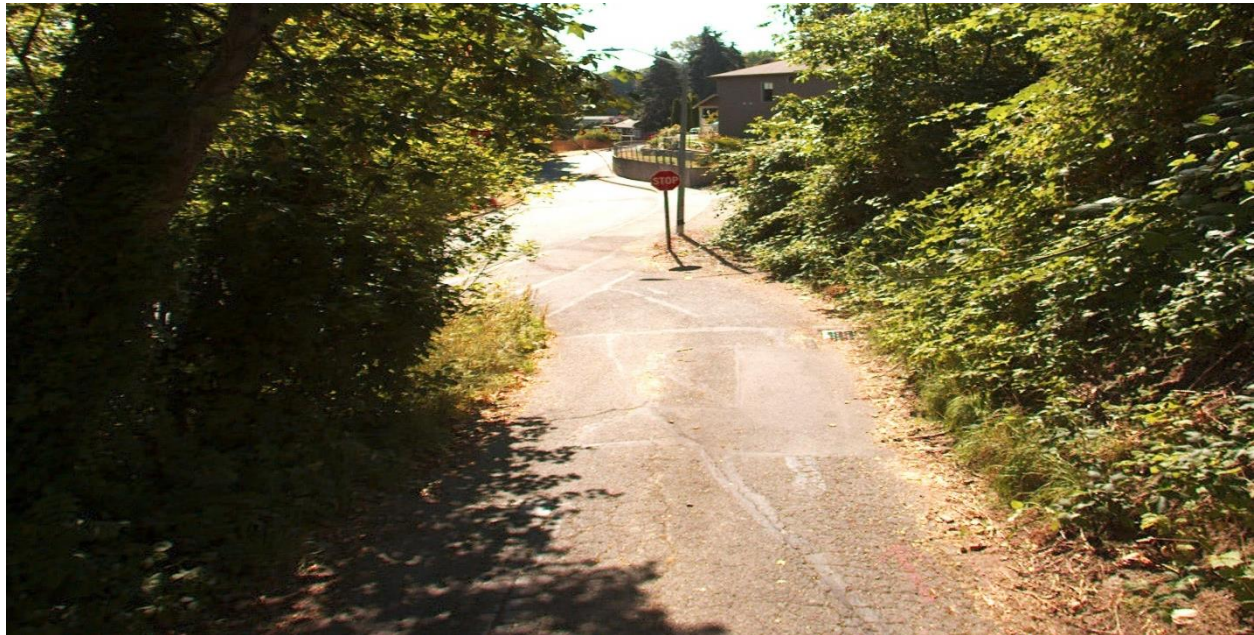
### Very Poor (PCI = 0 to 25) – Complete Reconstruction

**South 141<sup>st</sup> Street from 56<sup>th</sup> Avenue to 56<sup>th</sup> Place (GISID 1591, PCI = 22)** – Rated as Very Poor, this street displays a large quantity of alligator and edge cracking severe enough to suggest that the pavement structure is inadequate for current traffic loads. The rehabilitation of roads in this condition through a mill and overlay is generally ineffective, as the failures usually extend to the bottom of the pavement layer. Streets in this condition require rehabilitation that involves removal and replacement of the asphalt layer, base stabilization, or complete reconstruction based on design requirements.

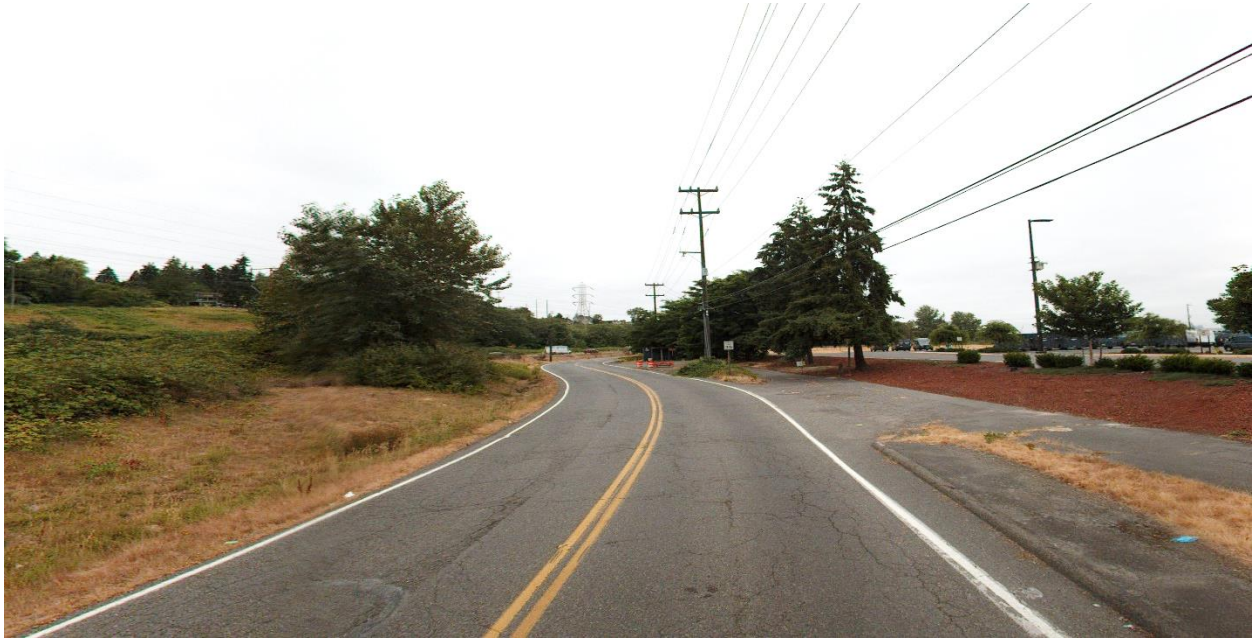
## Poor (PCI = 25 to 40) – Last Opportunity for Surface and Base Rehabilitation

**West Marginal Place from City Limit to South 102<sup>nd</sup> Street (GISID 1518, PCI = 26)** – Rated as Poor, this segment still has some remaining life before it becomes a critical reconstruction need. As evident in the imagery, a fair amount of the segment contains alligator cracking. There are also deep longitudinal and transverse cracks, particularly along the edges of the pavement. If left untreated, a partial to full reconstruction would be required within a short period of time.

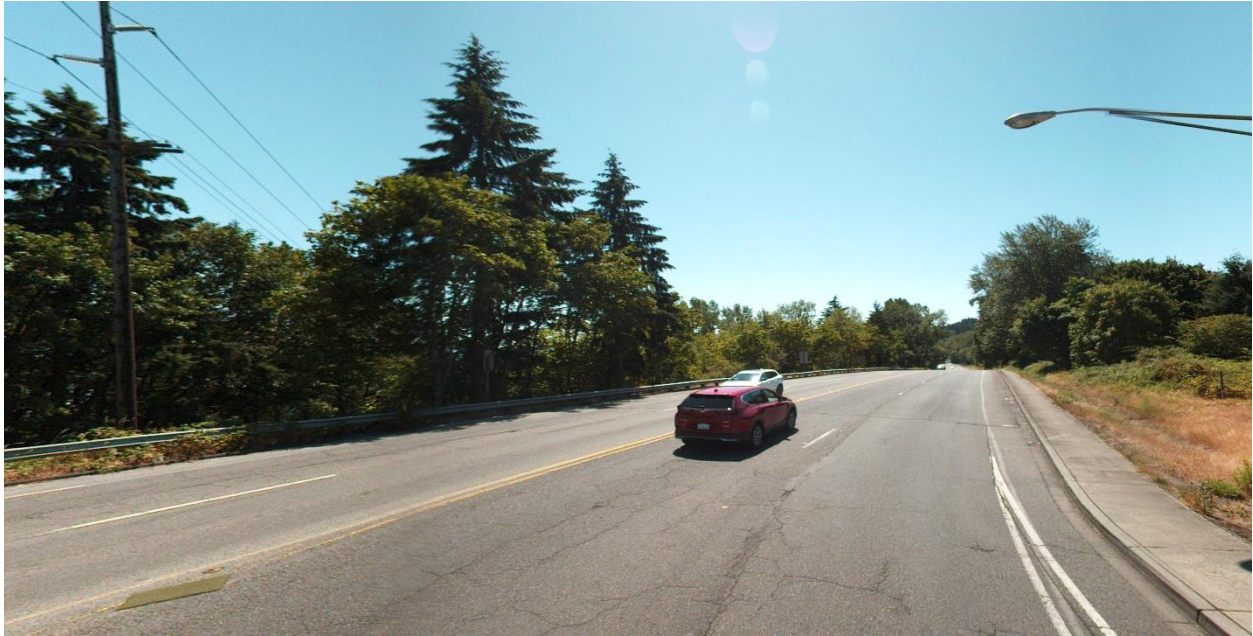
### Marginal (PCI = 40 to 50) – Thick Overlay

**Orillia Road from South 188<sup>th</sup> Street to South 200<sup>th</sup> Street (GISID 1371, PCI = 47)** – This street displays transverse and longitudinal cracking across the middle and edges of the pavement. There are sections of alligator cracking dispersed along the segment as well.

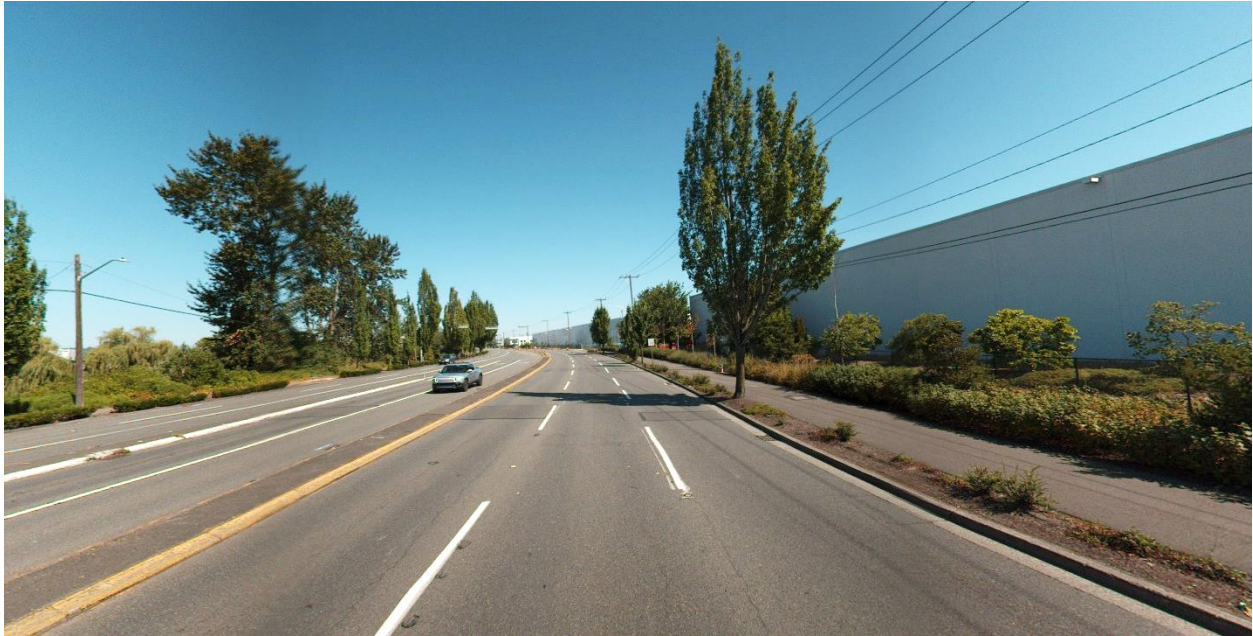
### **Fair (PCI = 50 to 60) – Moderate Overlay**

**East Marginal Way from Tukwila Boulevard to Boeing Access Road (GISID 1423, PCI = 55) – Fair** streets have similar characteristics to Marginal streets in that the distresses present tend to be localized and moderate in severity; however, the distresses will predominately be non-load related (i.e., caused by environmental or other factors). This street displays block cracking towards the middle of the pavement. There are moderate amounts of longitudinal and transverse cracking, with some cracks being deep but localized.

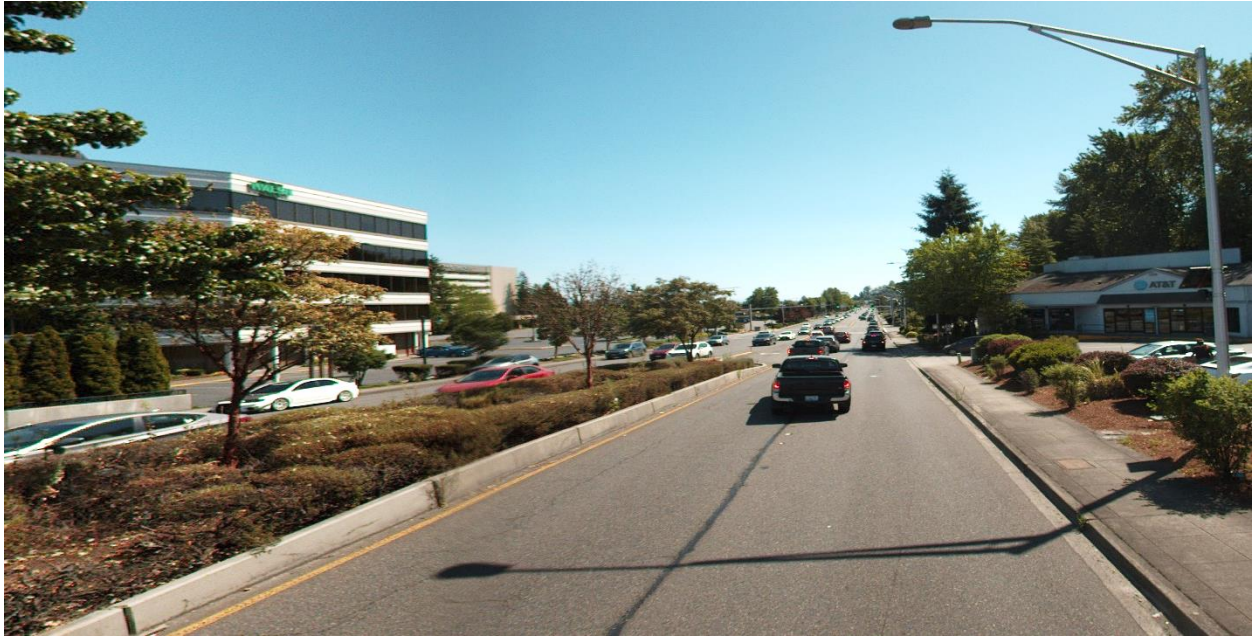
## Good (PCI = 60 to 70) – Surface Treatments

**Southcenter Parkway from Strander Boulevard to South 168<sup>th</sup> Street (GISID 1775, PCI = 66) –** Rated as Good, the primary cause of deterioration for this street is the longitudinal and transverse cracking. The pavement surface could be restored with spot patching to remedy the more heavily distressed areas.

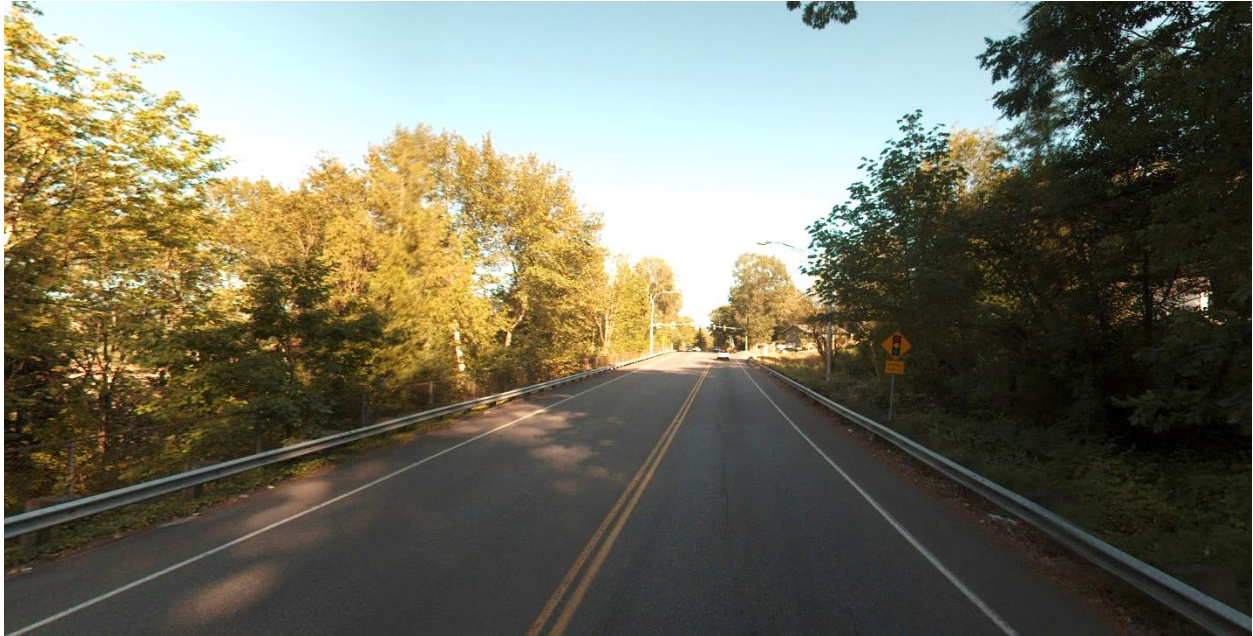
## Very Good (PCI = 70 to 85) – Surface Treatments and Localized Rehabilitation

**Klickitat Drive from 51<sup>st</sup> Avenue to 53<sup>rd</sup> Avenue (GISID 1397, PCI = 77)** – Rated as Very Good, this street displays minor amounts of longitudinal cracking. It is an example of a candidate for preventive maintenance to extend the life of the roadway.

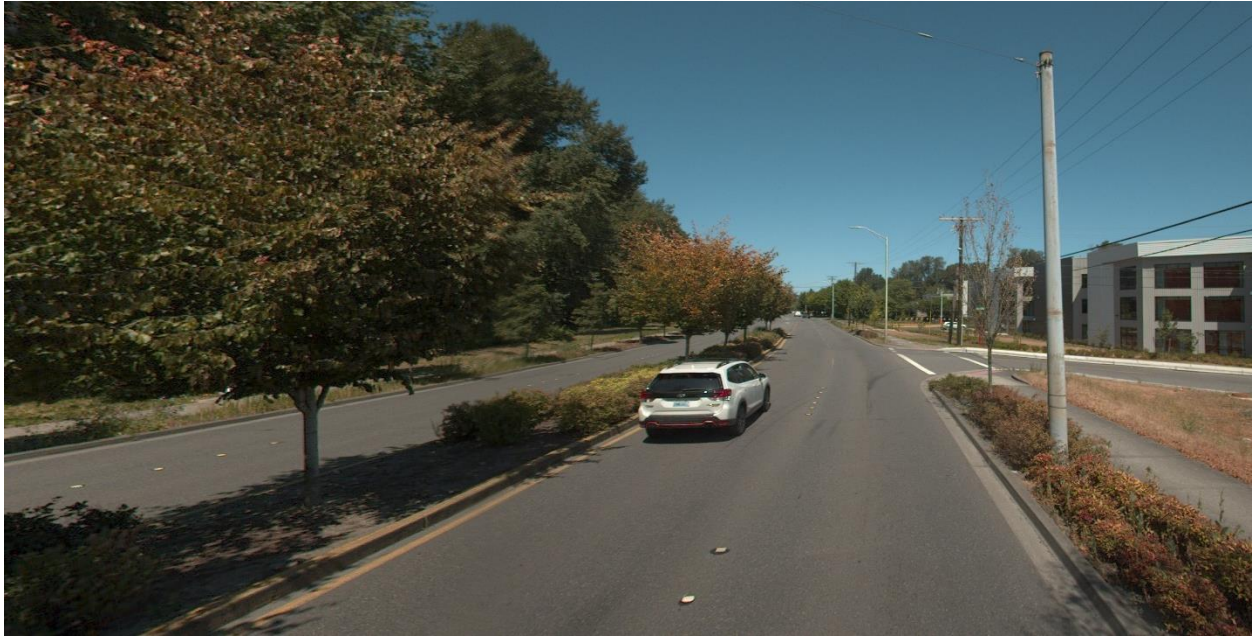
## Excellent (PCI = 85 to 100)

**Inerurban Avenue from 143<sup>rd</sup> Place to 144<sup>th</sup> Street (GISID 1424, PCI = 91)** – Rated as Excellent, this pavement displays little to no surface distresses. The ride is smooth, and the surface and the base are intact. Excellent roads should be periodically assessed for crack development that would trigger routine maintenance activities.
