SUBJECT: 2024 Pavement Condition Index (PCI) Study Update

Contract No. 24-072

Tukwila, WA

Pavement Management Report
December 2024

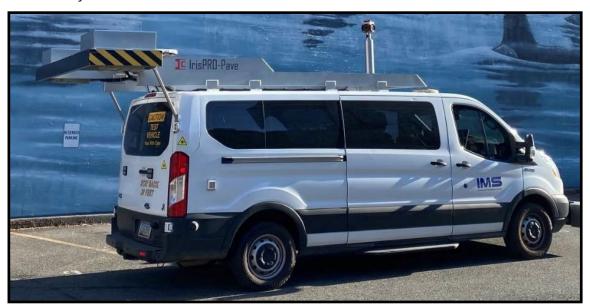
Figure 1 - IMS Integrated Road Information System platform (IRISPro Pave)

In July of 2024, IMS Infrastructure Management Services, LP (IMS) utilized a cutting-edge Integrated Road Information System (IRISpro Pave) (**Figure 1**) to capture continuous, high-resolution pavement images that were used to assess pavement cracking, rutting, and roughness on 82 centerline miles of predominantly asphalt roadways in Tukwila, WA (City). IMS followed the American Society for Testing and Materials (ASTM) D6433 standard to analyze the images and distress data collected by the IRISpro to determine the Pavement Condition Index (PCI) for each segment of the road. PCI values were recorded to provide an indication of the surface conditions and structural integrity of a pavement.

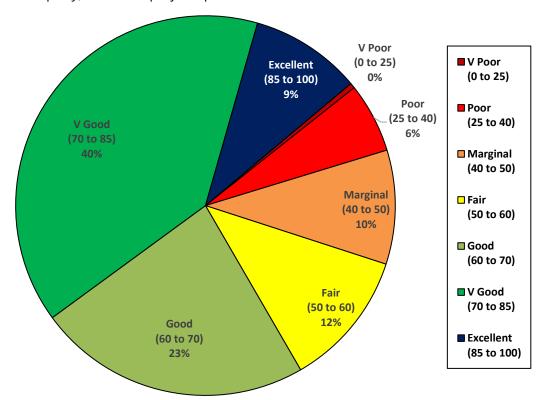
Figure 2 - Distribution of the City's Pavement System on a Condition Scale

The City's roadways were generally found to be in *Good* condition **with an average PCI of 67**. **Figure 2** provides a visual breakdown of the distribution of pavement area across different PCI categories at the time of analysis. Approximately 49% of the City's roadways were found to be in *Excellent* or *Very Good* condition. If structurally sound, these pavements are often suitable candidates for cost-effective preventive maintenance treatments. On the other hand, pavements with a PCI below 40 (i.e., pavements in *Poor* or *Very Poor* condition) comprise the City's "backlog" of M&R. The **City's backlog was found to be 6%.** These pavements typically require full or partial reconstruction. Pavements falling within the middle categories, such as *Fair* or *Marginal* condition, often benefit from mill and overlay projects. It's important to note that these are general recommendations, and the specific M&R strategy may vary based on factors such as distress types, soil conditions, structural adequacy, and other project-specific details.

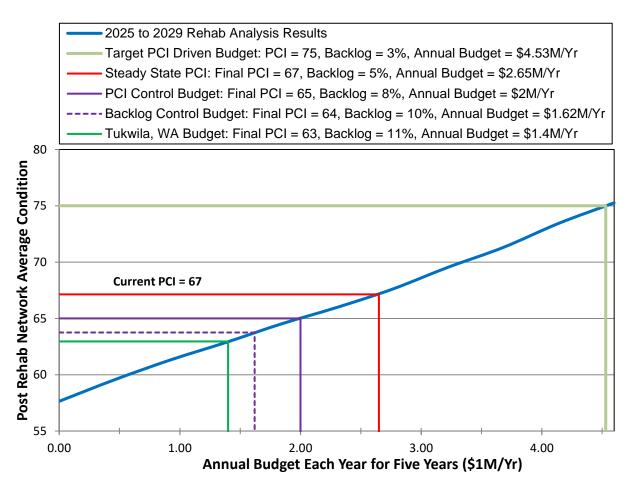
Figure 3 - PCI Based on Five-Year Annual Budget Funding Models

The analysis conducted by IMS using the ESA pavement management system has provided the City with valuable insights into the condition of its roadways. To assess the effect of annual budget on PCI over a five-year period, **Figure 3** has been generated to depict the anticipated PCI in five years relative to different annual budget allocations. The blue line allows the user to assess the effect of a given annual budget on the PCI in five years, serving as a valuable tool for understanding the potential effects of budget decisions on future pavement conditions.

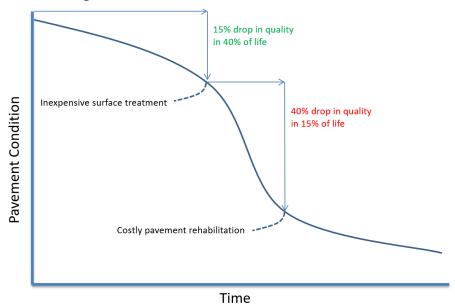
Figure 4 - Pavement Deterioration and Life Cycle Costs

Pavement management is the process of assessing, prioritizing, and preserving or rehabilitating pavements through a logical system that attempts to use available funds in the most cost-effective manner possible. The process is iterative, and as more data becomes available, prediction models are refined to improve accuracy. **Figure 4** illustrates that pavements typically start deteriorating rapidly once they hit a specific threshold. Therefore, it is more cost-effective to invest in cheaper surface treatments during the first 40% of a pavement's lifespan than to defer maintenance until heavier overlays or reconstruction is required just a few years later. Streets that are repaired while in good condition will have an extended lifespan and will cost less to maintain over their lifetime than those left to deteriorate to a poor condition. Without an adequate routine pavement maintenance program, streets will require more frequent reconstruction, thereby requiring significantly greater funding.

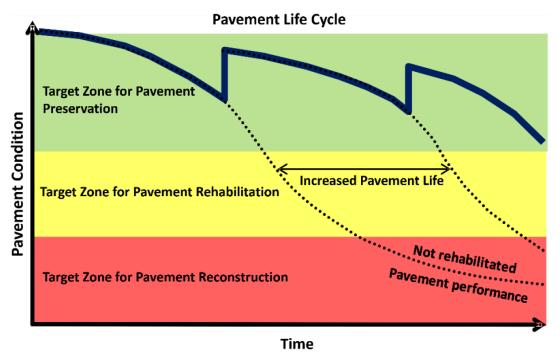
Figure 5 - Pavement Life Cycle Curve

When completed within the target zone for preventative maintenance, a pavement's lifespan can be conveniently extended. The dashed curves in **Figure 5** show the typical lifespan of a pavement that does not undergo any preventive maintenance. Major reconstruction becomes necessary after approximately 20 years. The blue curves show the benefits of preventive maintenance during the first 40% of a pavement's lifespan. Eventually, all pavements will need to undergo reconstruction; however, proactive maintenance and rehabilitation can delay this process for up to an additional 40 years.

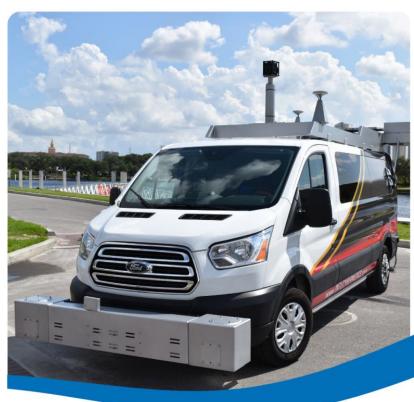
Figure 6 - LCMS-2 data collection vehicle

- ✓ Teledyne FLIR Ladybug 5+ Captures 360° Imagery at Defined Intervals
- ASTM Class 1 IrisPRO
 Pavement Profiler
 Continuous Right and Left Wheel
 Path Roughness Measurements
- Pavement Distress Imaging LCMS-2 Continuous 3D Imaging, 1mm Resolution
- ✓ **Drive**[™] Automated Data Collection Paired with Field Observations
- ✓ GPS Positioning
 GPS with Integrated IMU, Sub
 Meter Positional Accuracy
- Samsara Monitoring Real-Time Tracking and Reporting
- Texture Continuous Surface Texture Measurements
- Linear Distance Positioning DMI for Precise Linear Distance Measurements
- Safety Lighting
 Front and Back Facing Flashing
 Lights Ensure High Visibility

The Laser Crack Measurement System (LCMS-2) captures continuous 2D and 3D images at 1 mm resolution in the lane of travel up to 4 m (13 ft) wide at highway speeds, allowing for the visualization and characterization of all features on the road surface. The system allows for collection rates up to 28,000 profiles per second, five times faster than the first edition of LCMS. This allows smaller cracks, especially transverse cracks, to be detected more consistently than in the past. The vertical accuracy has also improved from 0.50 mm to 0.25 mm.

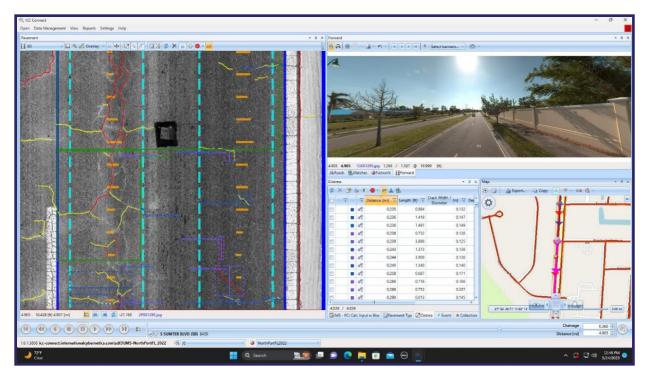
Figure 7 - QC Image from Connect™ Software

To ensure the accurate determination of PCI scores, the field data undergoes a rigorous series of processing phases and quality checks. These checks encompass synchronized assessment of both processed and raw data streams. The automatic distress identification and classification process involves various steps: First, different rules and processing parameters are applied on different pavement types; next, the auto detected lane markings are manually adjusted to exclude non-pavement areas and limit the assessment area for cracking and rutting to between the lane markings and invalidation rules are applied to exclude additional anomalies (e.g. near railroad crossing or bridge decks) from the assessment area. Finally, a team of pavement raters who are well-versed in both the distress standards and the data in its digital format review images and make the necessary corrections on areas with gross under/over detection.

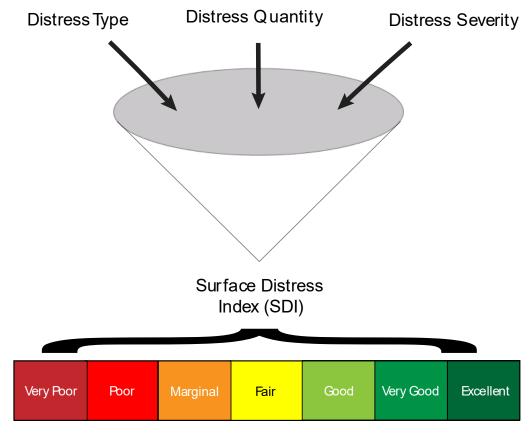
Figure 8 - SDI Inputs and Detailed Scale

ASTM D6433 provides a method of categorizing surface distress observations for both asphalt and concrete pavements, based on the extent and severity of distresses along the roadway. The Surface Distress Index (SDI) is used to represent the observed pavement defects on a scale from 0 to 100. However, not all surface distresses are given equal weight. Load-associated distresses (LAD), such as rutting or alligator cracking on asphalt streets, and divided slabs on concrete streets, have a greater impact on the SDI than non-load associated distresses (NLAD), such as raveling or longitudinal and transverse cracking. Even when present in low extents and moderate severity, LAD can significantly decrease the SDI. The SDI inputs are shown in **Figure 8**.

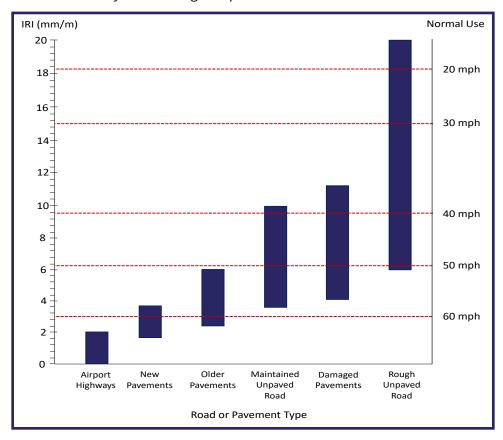
Figure 9 - IRI Scale Definitions

The Roughness Index (RI) provides a quantifiable measure of ride quality, which is determined using the industry-standard ASTM E1926 for calculating the IRI. This value is derived from the longitudinal profile captured by the LCMS as it records the change in elevation over a distance. Once calculated, it is expressed as a slope and reported in millimeters per meter (mm/m). Typical IRI levels for new, older, and damaged pavements are displayed in **Figure 9.** The IRI is lower on average for roads or pavements that are normally used for higher speed travel.

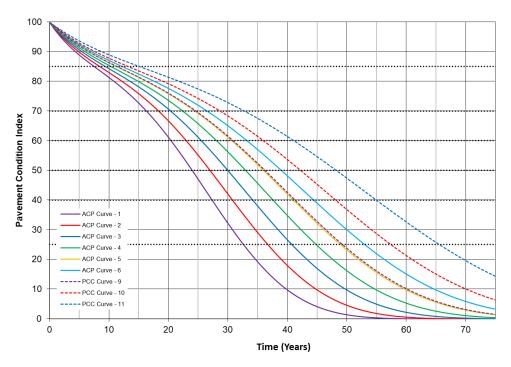
Figure 10 - Asphalt Concrete Pavement (ACP) and Portland Cement Concrete (PCC)

Inspection data by itself is only capable of representing conditions at the time of collection. Nevertheless, within ESA there are customizable curves that can predict the rate of pavement deterioration based on a streets functional class, pavement type, and strength rating. These deterioration curves are critical in predicting future pavement conditions and determining appropriate rehabilitation strategies. The model assumes that pavements with similar attributes and usage will deteriorate at similar rates. For instance, high volume asphalt arterials that are already in poor condition are expected to deteriorate faster and are represented in **Figure 10** by a purple line. In contrast, low volume concrete local streets are expected to deteriorate slowly and are represented by a blue dashed line.

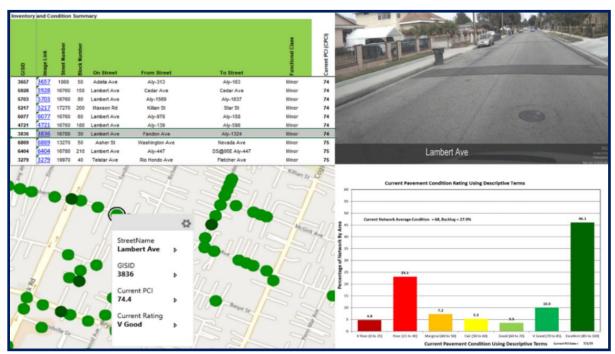
Figure 11 - Example of ESA City Data

ESA has the ability to generate basic reports for common data requests through a set of predefined layouts. This allows for quick access to section condition summaries, inspection data, budget scenario summaries, and data charts. The GIS data used to generate this report is also linked to the section summary information to allow for quick and easy visualizations of the data if imported into a GIS utility. An example of data, as presented in ESA, can be seen in **Figure 11**.

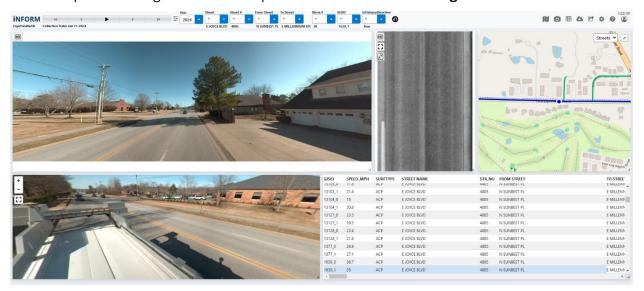
Figure 12 - ICC Inform Image Viewer

Included with every IMS pavement management project is an out-of-the-box, user friendly, browser-based image and condition viewer toll called ICC Inform. Inform provides a convenient medium through which the City may view the imagery collected during the pavement survey. This includes a forward view of the pavement, the downward LCMS view, and a panoramic 360-degree view allowing the City to view each pavement observation from several perspectives. Lastly, a complete map of the City will track the location of every pavement image, providing additional context to the individual pavement segments. An example of Inform can be seen in **Figure 12** below.

The "play" button in the top left of the Inform application provides the user a means to follow the RST as it drives the City streets. The drop-down menus in the top-center portion of the screen allow the user to quickly search for a particular street segment by GISID, and to even compare images from multiple years of surveys _if data is available from previous survey years).

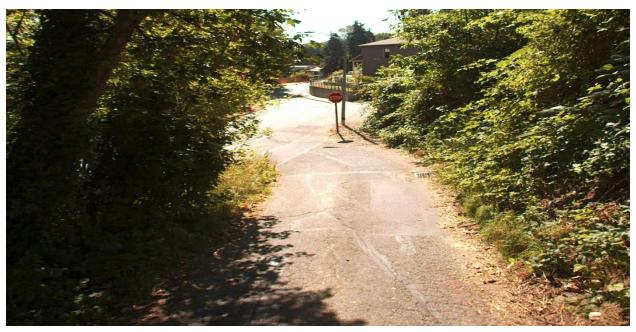
South 141st Street from 56th Avenue to 56th Place (GISID 1591, PCI = 22) – Rated as Very Poor, this street displays a large quantity of alligator and edge cracking severe enough to suggest that the pavement structure is inadequate for current traffic loads. The rehabilitation of roads in this condition through a mill and overlay is generally ineffective, as the failures usually extend to the bottom of the pavement layer. Streets in this condition require rehabilitation that involves removal and replacement of the asphalt layer, base stabilization, or complete reconstruction based on design requirements.

Deferral of reconstruction of streets rated as Very Poor will not cause a substantial decrease in overall pavement quality. The streets have passed the opportunity for overlay-based strategies, meaning that reconstruction, which can be expensive, is the most suitable solution. Thus, Very Poor streets are often deferred in favor of rehabilitating more streets at lower costs, resulting in a greater net benefit to the City. This strategy, however, must be sensitive to citizen complaints that may demand the prioritization of these street repairs. In addition, this type of street can pose a safety hazard for motorists since severe potholes and distortions may develop. It is important to consistently monitor these streets and check for potholes or other structural deficiencies until the street is eventually rebuilt.

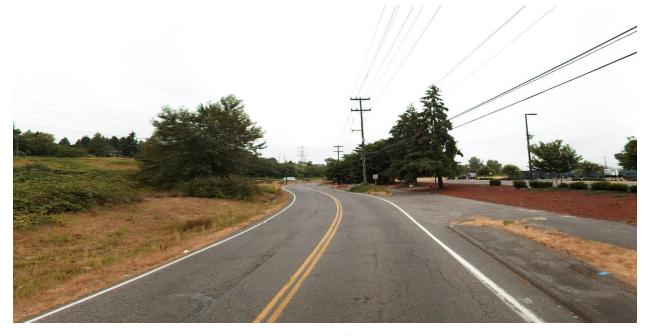
West Marginal Place from City Limit to South 102nd **Street (GISID 1518, PCI = 26)** – Rated as Poor, this segment still has some remaining life before it becomes a critical reconstruction need. As evident in the imagery, a fair amount of the segment contains alligator cracking. There are also deep longitudinal and transverse cracks, particularly along the edges of the pavement. If left untreated, a partial to full reconstruction would be required within a short period of time.

On heavily trafficked roadways, Poor streets often require partial to full reconstruction. On local roadways, they generally require removal of the pavement surface through grinding or excavation, base repairs, restoration of the curb line and drainage, and then placement of a new surface.

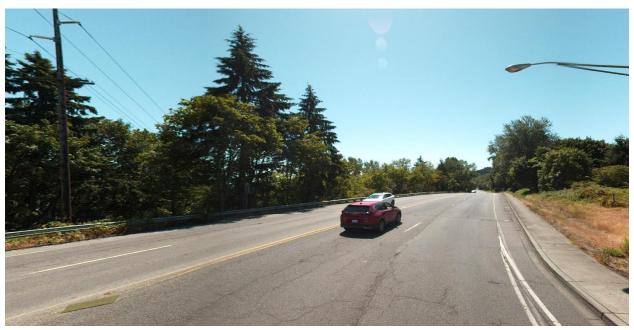
Orillia Road from South 188th **Street to South 200**th **Street (GISID 1371, PCI = 47**) – This street displays transverse and longitudinal cracking across the middle and edges of the pavement. There are sections of alligator cracking dispersed along the segment as well.

Marginal streets that display high amounts of load associated distresses (LAD) are selected as a high priority for rehabilitation as they generally provide the best cost/benefit ratio to the City. If left untreated, Marginal streets with high amounts of LAD will deteriorate to become partial reconstruction candidates. Marginal streets that are failing due to materials issues or non-load associated failures may become suitable candidates for thick overlays if deferred, without a significant cost increase.

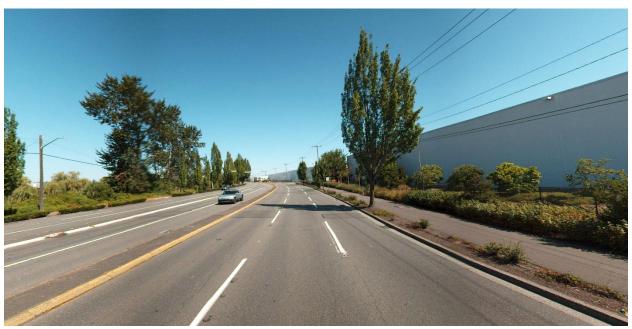
East Marginal Way from Tukwila Boulevard to Boeing Access Road (GISID 1423, PCI = 55) – Fair streets have similar characteristics to Marginal streets in that the distresses present tend to be localized and moderate in severity; however, the distresses will predominately be non-load related (i.e., caused by environmental or other factors). This street displays block cracking towards the middle of the pavement. There are moderate amounts of longitudinal and transverse cracking, with some cracks being deep but localized.

Like Marginal streets, Fair streets can provide a good cost/benefit ratio to an agency if addressed with an adequate rehabilitation technique. Stretching the application for surface treatments into this range can pose a cheap alternative to overlays but does not provide the appropriate renewal to the structural capacity of the pavement and may allow load related deterioration to continue unabated.

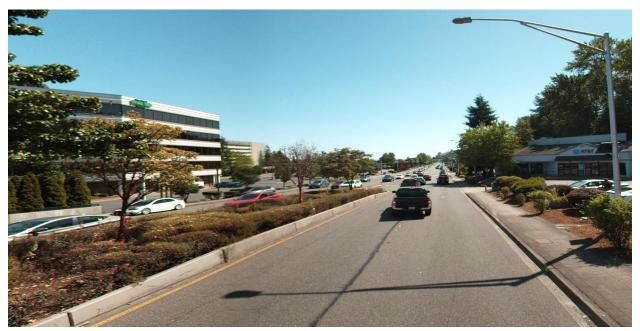
Southcenter Parkway from Strander Boulevard to South 168th **Street (GISID 1775, PCI = 66)** – Rated as Good, the primary cause of deterioration for this street is the longitudinal and transverse cracking. The pavement surface could be restored with spot patching to remedy the more heavily distressed areas.

Preventive measures on streets considered Good can have a positive impact on the City's funding needs. While the expected life of a slurry seal is not as long as that of an overlay, its ability to slow deterioration and relatively low cost can free up funding for streets in worse condition.

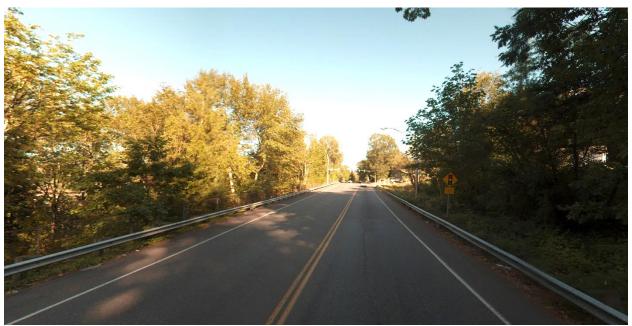
Klickitat Drive from 51st **Avenue to 53**rd **Avenue (GISID 1397, PCI = 77)** – Rated as Very Good, this street displays minor amounts of longitudinal cracking. It is an example of a candidate for preventive maintenance to extend the life of the roadway.

Also, routine maintenance prevents water intrusion by sealing and slowing crack growth. By keeping water out of the base layers, the pavement life is extended without the need for heavier rehabilitations.

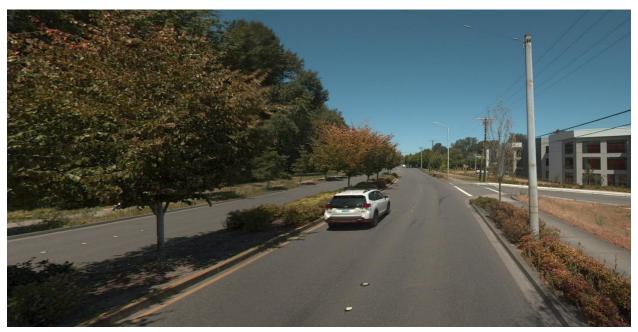
Inerurban Avenue from 143rd **Place to 144**th **Street (GISID 1424, PCI = 91)** – Rated as Excellent, this pavement displays little to no surface distresses. The ride is smooth, and the surface and the base are intact. Excellent roads should be periodically assessed for crack development that would trigger routine maintenance activities.

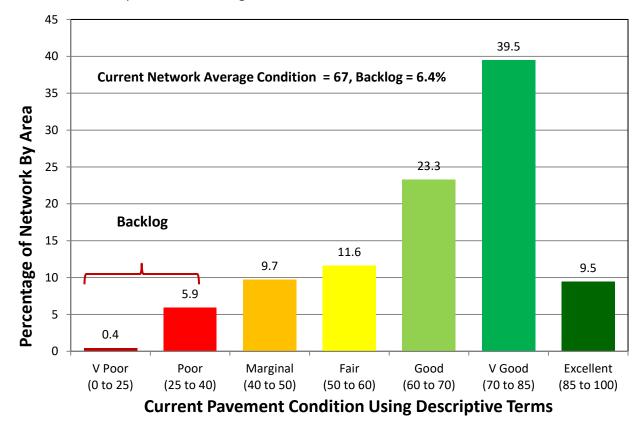
Figure 13 - Roadway Network Present Status Using Descriptive Terms

Figure 13 shows the distribution of pavement condition for the roadway network in Tukwila.

- Less than six percent (6.4%) of the network is rated as *Poor* or *Very Poor*, meaning these roadways have deteriorated to the point where surface rehabilitation can no longer restore the pavement to a point of structural adequacy. Rehabilitation of the entire pavement structure is required for these segments.

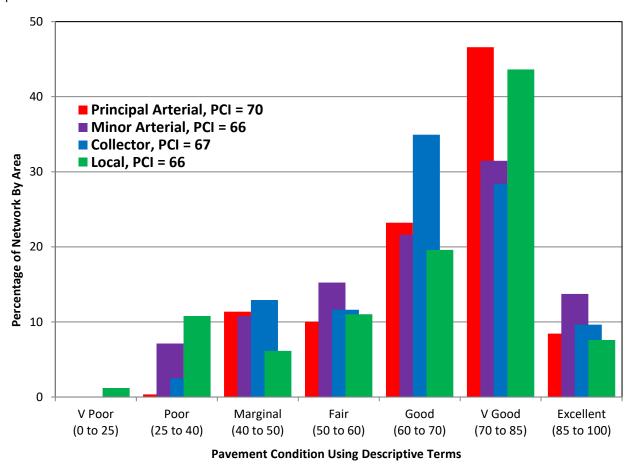
Figure 14 - Condition Rating by Functional Classification

Analyzing subsets of data in addition to the overall pavement condition can provide a better understanding of where an agency should focus its resources. **Figure 14** displays the distribution of pavement conditions for each functional class.

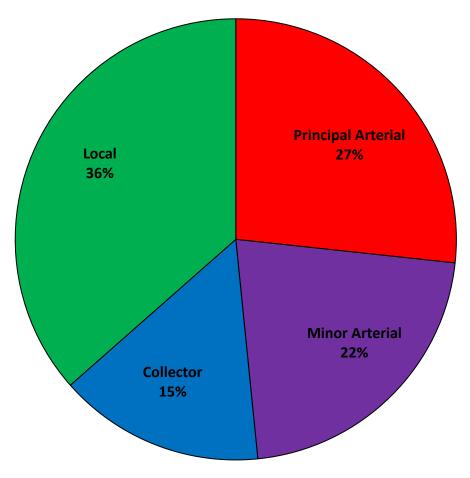
Figure 15 - Functional Classification Distribution By Area

When evaluating the condition of pavement based on the percentage of network it covers, the proportion of each class in the overall network must also be considered. This distribution is illustrated in **Figure 15**.

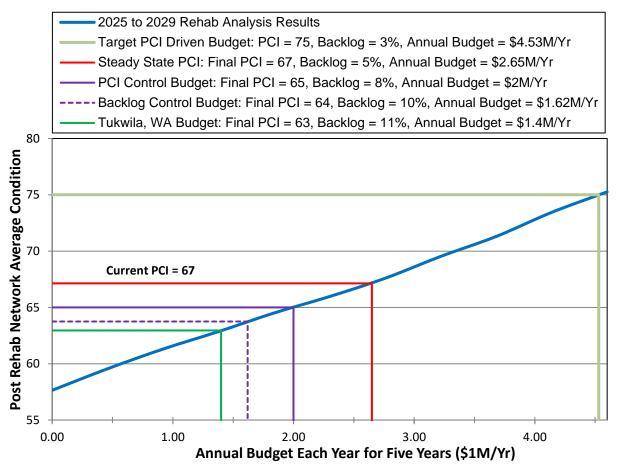
Figure 16 - Five-year Post Rehab Network PCI Analysis Results

The results of the analysis are summarized in **Figure 16**. The x-axis highlights the annual budget, while the y-axis plots the five-year Post Rehab Network Average PCI values. The diagonal blue line is the network trend model developed to show estimated PCI along with a funding range up to \$4.6M/Yr.

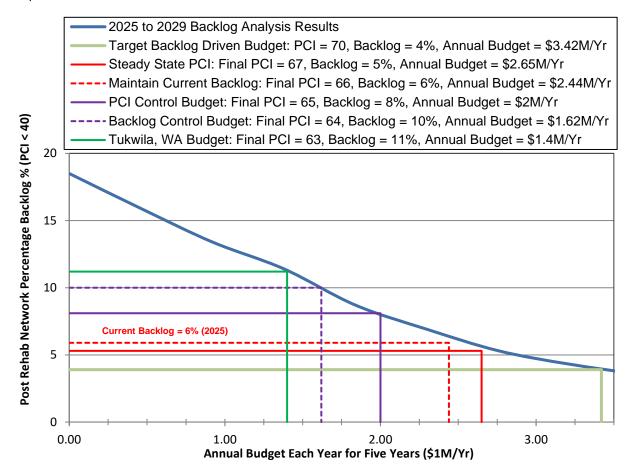
Figure 17 - Five-year Post Rehab Network Backlog Results

Figure 17 presents the resultant network backlog against the annual budget. It is similar to **Figure 16**, but instead of plotting the average PCI score, it displays the total backlog after five years with a blue diagonal line. The City currently maintains a backlog of 6%. As the backlog grows, the funding required to return to the current level will increase.

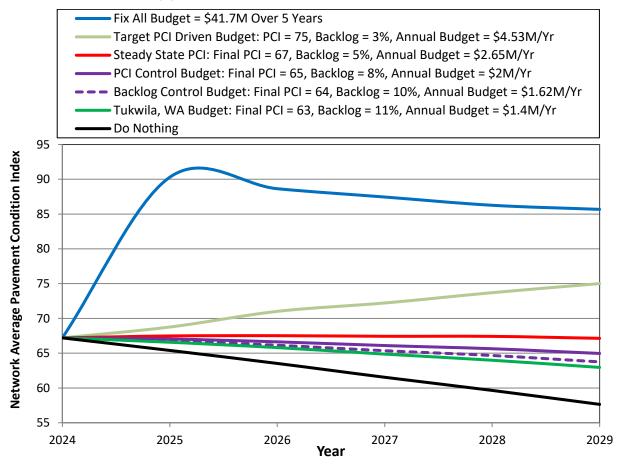
Figure 18 - Five-year Annual PCI

Figure 18 presents the analysis results on an annual basis. This shows that if the budget falls below \$2.65M/Yr. (Steady State PCI Budget), over time the overall condition of the roads is expected to deteriorate as the backlog grows.

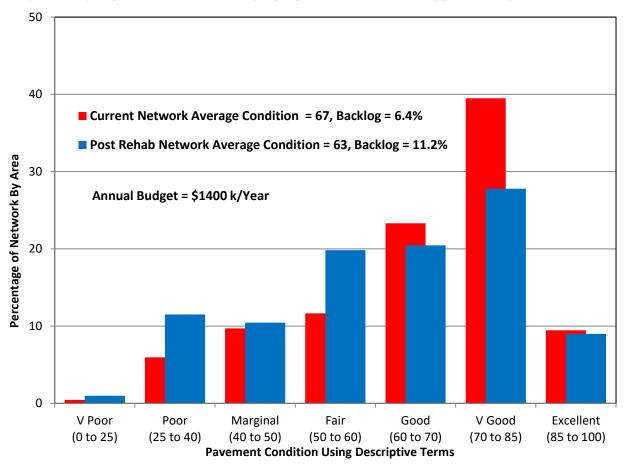
Figure 19 - Comparison of Pavement Condition (Current to 5-year Projection)

Figure 19 compares the percentage of the City's network area separated into each pavement condition category for two scenarios: the current network average condition (shown in red) and the projected condition in five years with the City's budget (shown in blue). The analysis shows that if the City's current budget is maintained, the average PCI is expected to decrease to 63 by the end of the five-year analysis period, and the backlog is projected to increase to approximately 11%.
