# PROPERTY CONDITION ASSESSMENT

## Fire Station 52

5900 South 147<sup>th</sup> Street, Tukwila, WA 98168

**April 26, 2021**

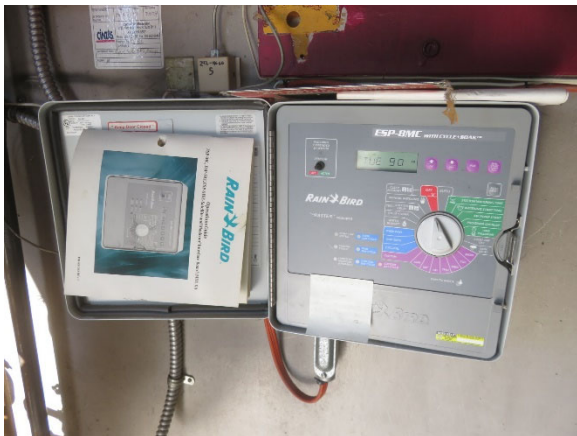
Generally, landscaping and irrigation systems are maintained via the operating budget. There was an irrigation system on this property; however, this system was not tested.

Irrigation System Control Panel

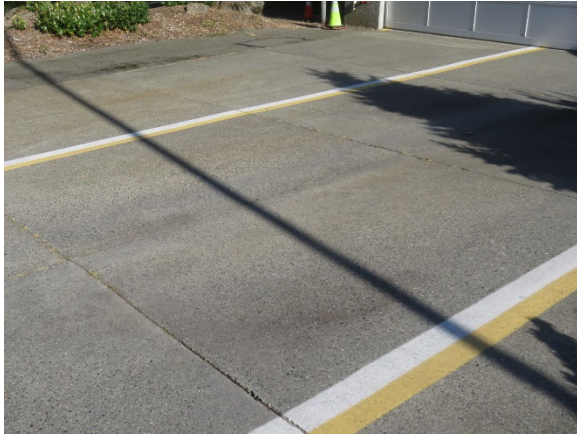
There is a concrete garage slab and a south concrete slab at the south side of the property in front of the garage doors. There is also a concrete sidewalk on the east side of the building. The concrete flatwork on this property is generally in good condition.

Concrete Parking Lot at the South Side of the Property

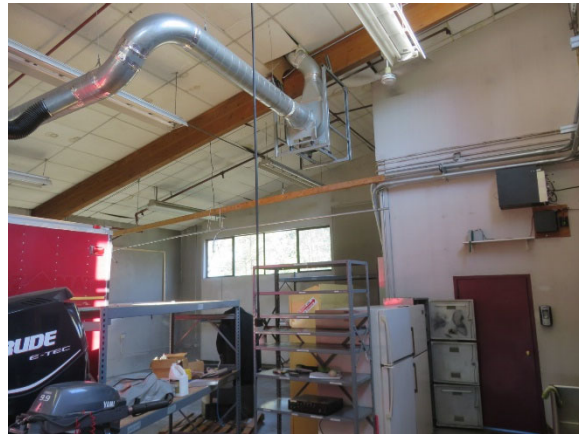
Glue-Laminated Beams Supporting the Roof

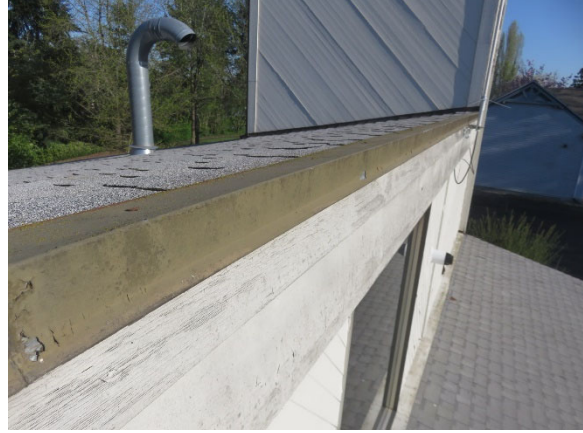
Clerestory Flashing

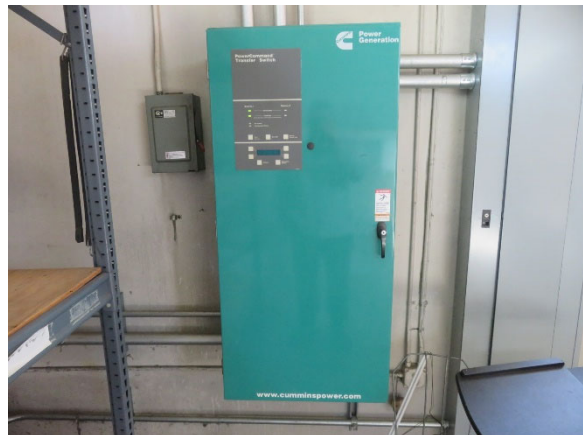
There is a Cummins Generator at the north side of the building that appears to be relatively modern. This generator and the generator transfer switch should have a lifespan well beyond the 12-year duration of this study.

Generator Transfer Switch

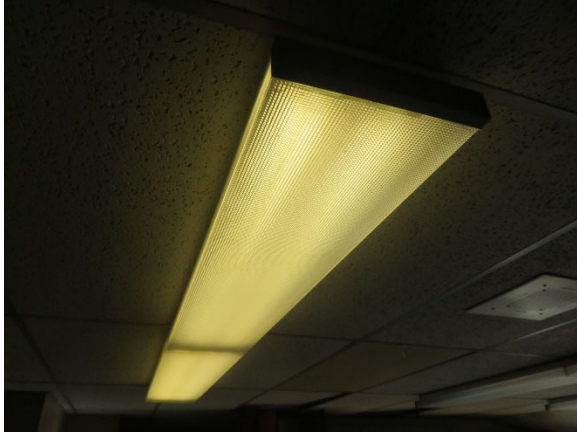
The interior lighting in this building consists of typical hanging fluorescent lights.

Typical Hanging Fluorescent Light in the Office/Sleeping Quarters

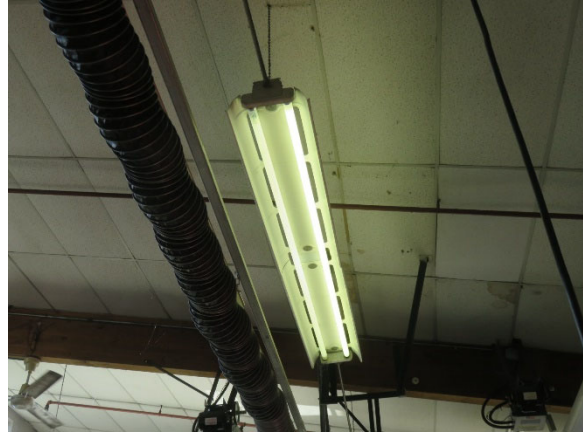
Typical Hanging Fluorescent Light in the Engine Garage Bays
