SUBJECT: **Disposition of former Fire Station 52 building and property**

PROPERTY CONDITION ASSESSMENT

Fire Station 52

5900 South 147th Street, Tukwila, WA 98168

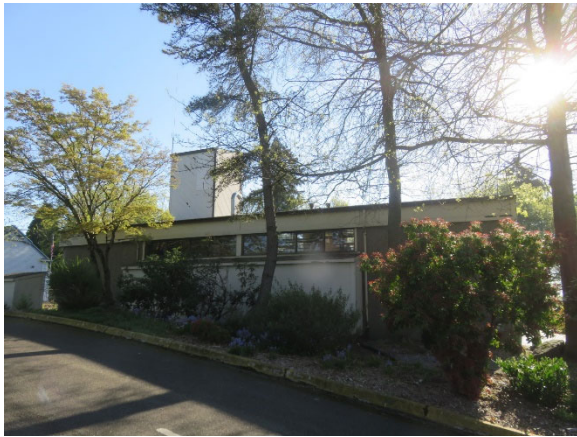
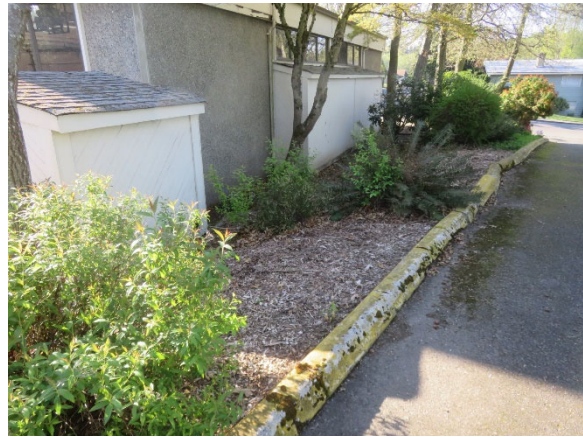
Trees and Bushes at the West Side of the Building

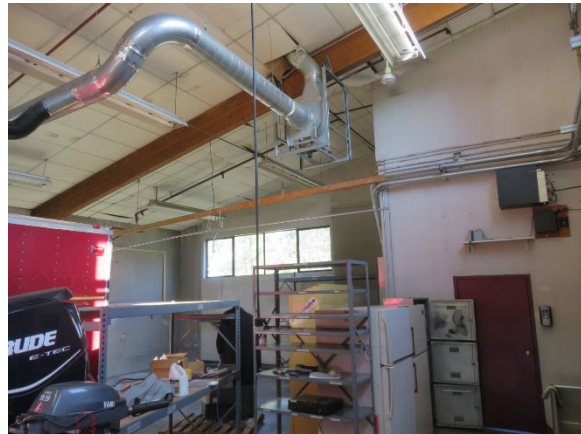
Glue-Laminated Beams Supporting the Roof

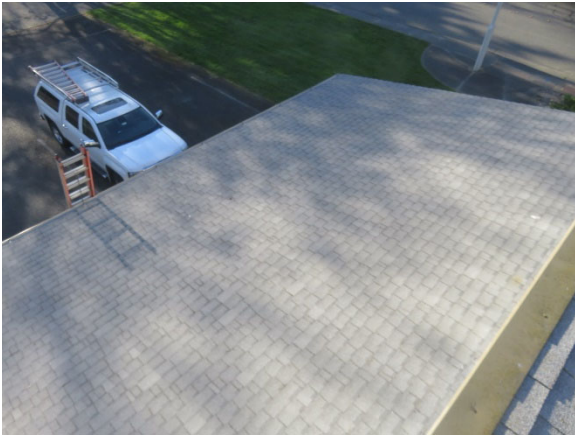
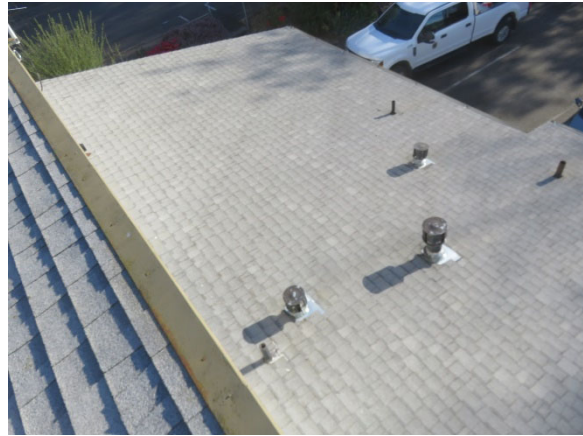
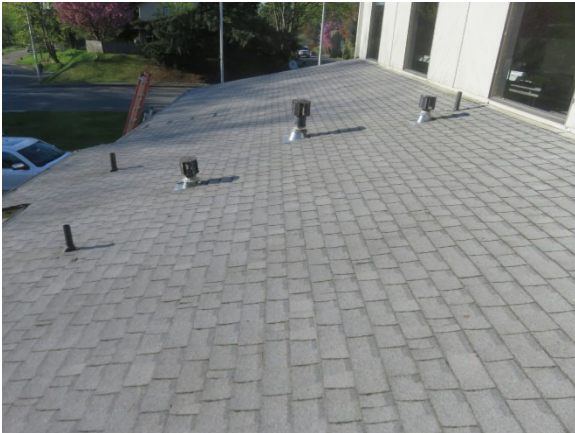
Lower Roof of the Building

3.3	STRUCTURE						
	<i>No structural expenditures budgeted</i>						
3.4	ROOFING						
	Resurface roofs	40	SQ	\$675	1	30	\$27,000
	Replace gutters and downspouts	172	LF	\$8.75	1	30	\$1,505

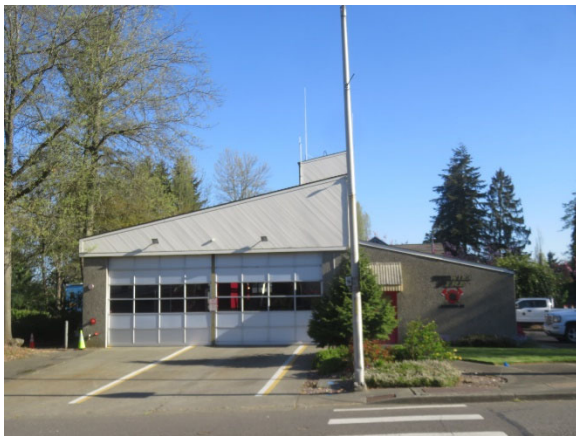
South Side of the Building

3.5	EXTERIOR						
	Replace all exterior siding, trim, windows, and pedestrian doors	2,860	SF	\$28.50	1	50	\$81,510
	Paint exterior of building	2,860	SF	\$2.95	1	8	\$8,437

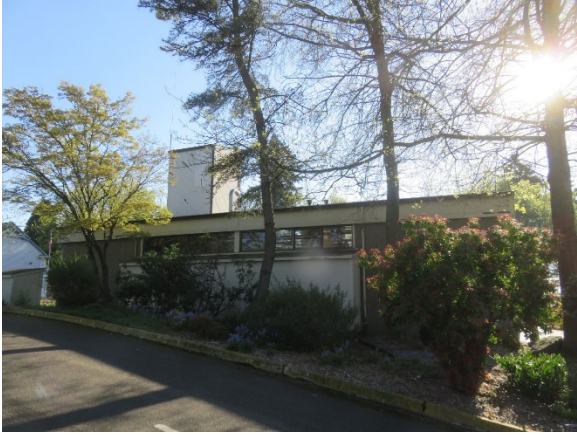
West Side of the Building

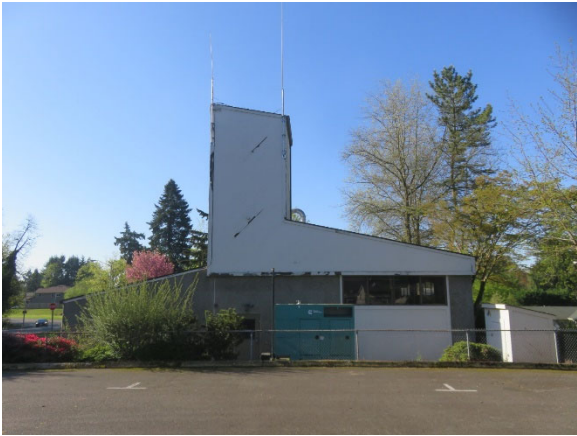
North Side of the Building

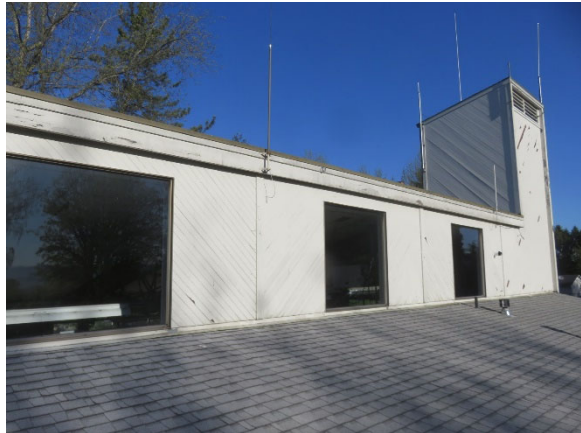
Clerestory at the East Side of the Building

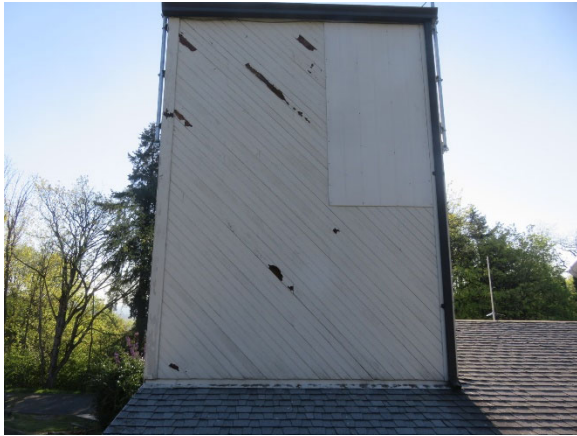
West Side of the Tower

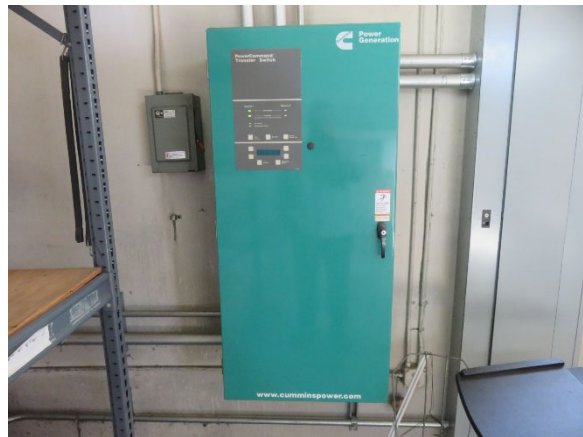
There is a Cummins Generator at the north side of the building that appears to be relatively modern. This generator and the generator transfer switch should have a lifespan well beyond the 12-year duration of this study.

Generator Transfer Switch

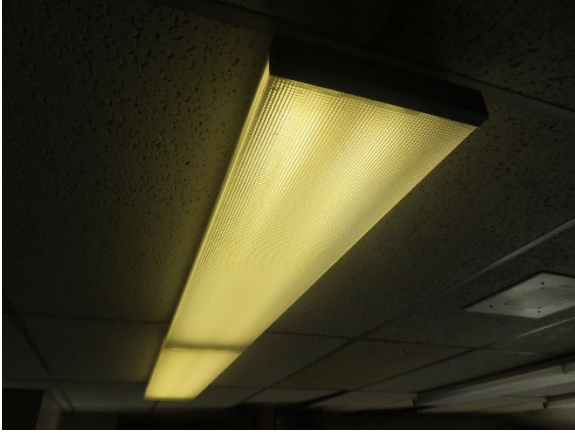
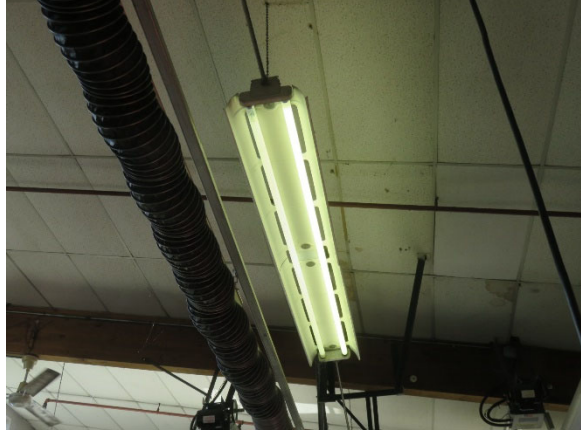
The interior lighting in this building consists of typical hanging fluorescent lights.

Typical Hanging Fluorescent Light in the Office/Sleeping Quarters

Typical Hanging Fluorescent Light in the Engine Garage Bays

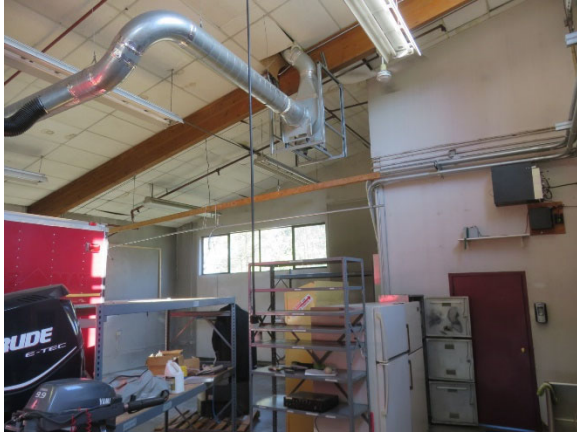
Acoustic Ceiling Tiles

There are some stained and damaged acoustic ceiling tiles that will need to be replaced. Beyond this, there is nothing that must be done on the interior of this building, as we did not identify any areas of the interior that needs work at this time. We assume that future upgrades and renovations will occur after a future use is determined for this building.

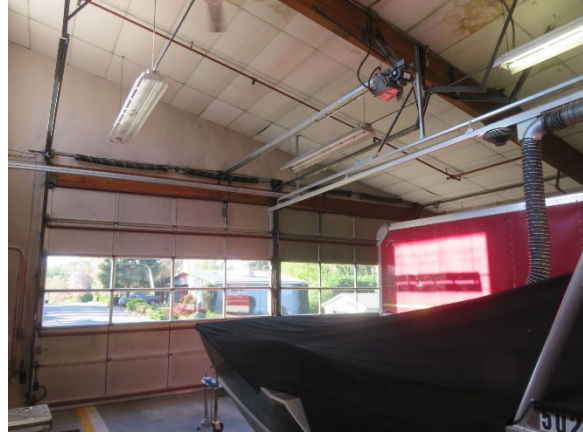
Engine Garage Bay

There are 2 garage doors at the south side of this building. Both of these garage doors were operating effectively at the time of our inspection. Due to the frequent use of the garage doors, we recommend budgeting for replacing these garage doors every 16 years and the garage door openers every 8 years.

We also recommend a full maintenance contract be in place for these garage doors with a door technician such as Cressy Door or Davis Door.
