INFORMATIONAL MEMORANDUM

TO: Transportation & Infrastructure Committee
FROM: Bob Giberson, Public Works Director
BY: Pat Brodin, Operations Manager
CC: Mayor Ekberg
DATE: January 20, 2017
SUBJECT: Purchase of Water Hydrant Saver

HYDRANT SAVER

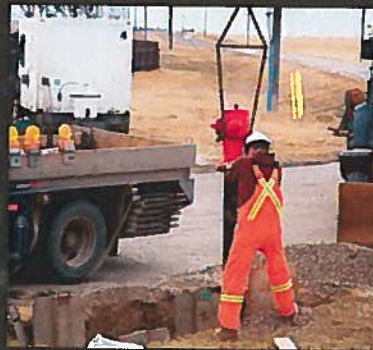
NO HYDRANT REPLACEMENT

Out-of-service hydrant
restricts fire/rescue service.

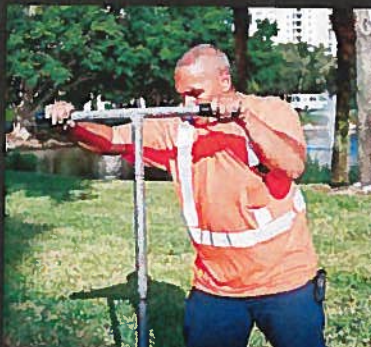
NO MANUAL REMOVING OF VALVE SEAT

Hydrant repaired with large
crew to manually remove
valve seat.

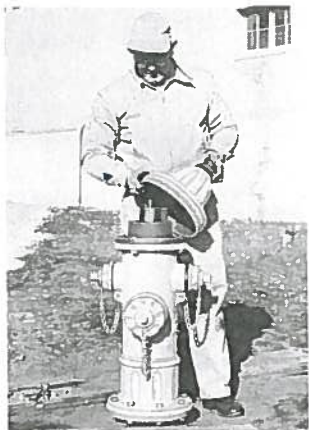
1. Remove four bonnet bolts and turn operating nut in the **opening** direction until free of the stem. Remove bonnet.

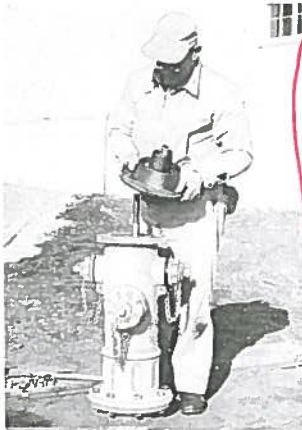
2. Remove four bolts in stuffing box. Lubricate A-24099 Brass Sleeve. Slide Sleeve over threaded area of stem to protect "O" rings from damage by threads. Lift stuffing box off carefully. Remove brass sleeve.

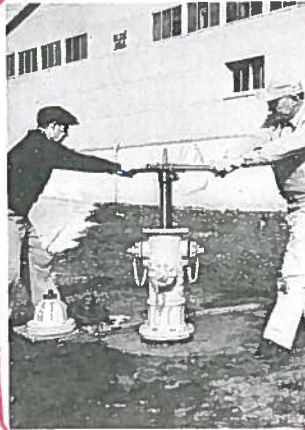
3. Insert seat wrench so it engages lugs on seat ring. Screw seat wrench stem extension on to hydrant stem until pin engages top of seat rings wrench. (If non-adjustable type, use operating nut instead of seat wrench stem extension.) Shut off water at the gate valve. Turn wrench **counter-clockwise** to unscrew seat ring.

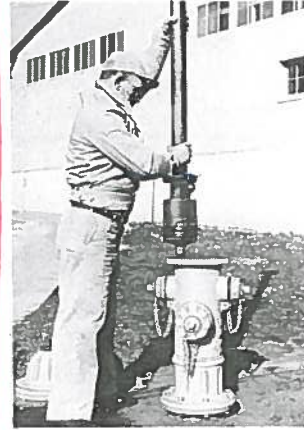
4. Lift stem, complete valve mechanism, and seat wrench as a unit from hydrant barrel.

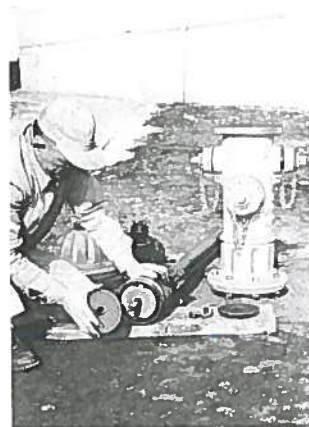
5. Remove lower stem nuts while stem and valve assembly is still in seat wrench. Replace damaged or worn parts.

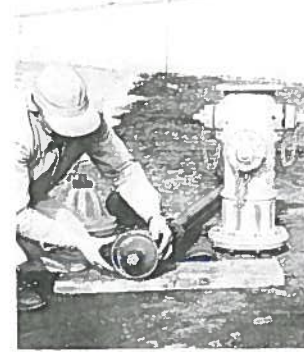
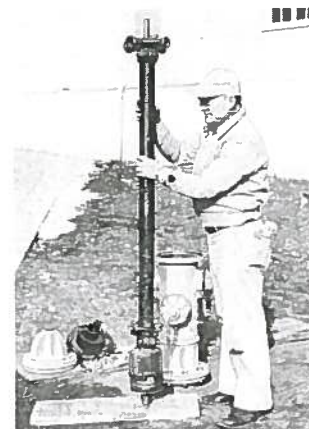
6. Reassemble and use seat wrench to hold valve assembly while tightening lower stem nuts firmly to stem. Put on a new copper-asbestos gasket. To do this, place gasket in one side of ring with seam of gasket facing outward. Working in both directions with the thumbs, push the gasket outward and downward until gasket is snugly seated into groove.

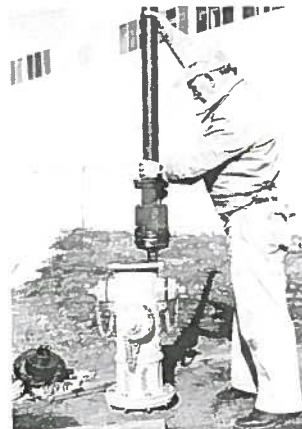
7. Loosen seat wrench extension (or operating nut) so seat ring has some float in seat wrench. Replace complete working parts and seat wrench assembly in hydrant barrel.

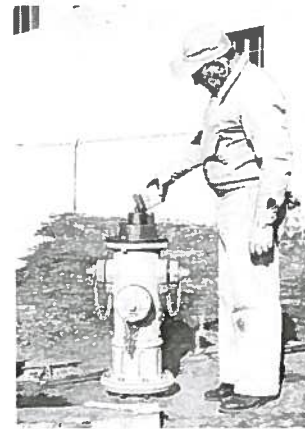
8. Screw seat ring in place by turning seat wrench **clockwise**. Turn water on at gate valve. Remove seat wrench.

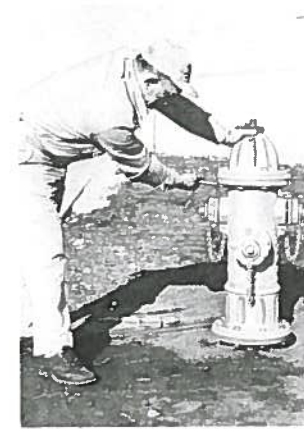
9. Check stuffing box gasket. Lubricate A-24099 Brass Sleeve. Slide Sleeve over threaded area of stem to protect "O" rings from damage by threads. Place stuffing box in position and bolt to barrel. Remove Brass Sleeve. Pour Mueller Hydrant Lubricant into oil reservoir until **THREE-QUARTERS** of an inch from top.
