PLANNING COMMISSION WORK SESSION
February 28, 2019 - 6:30 PM
TUKWILA CITY HALL COUNCIL CHAMBERS

- I. CALL TO ORDER
- II. ATTENDANCE
- III. ADOPT MINUTES
- IV. WORK SESSION ON CRITICAL AREAS REPORT
- V. ADJOURN

Consider policy options identified above and identify any additional research needed. Staff will then prepare an underline strike out of the code that addresses the gaps identified by the review of best available science. The Planning Commission will then hold a public hearing and send a recommended draft to the City Council for review and adoption.

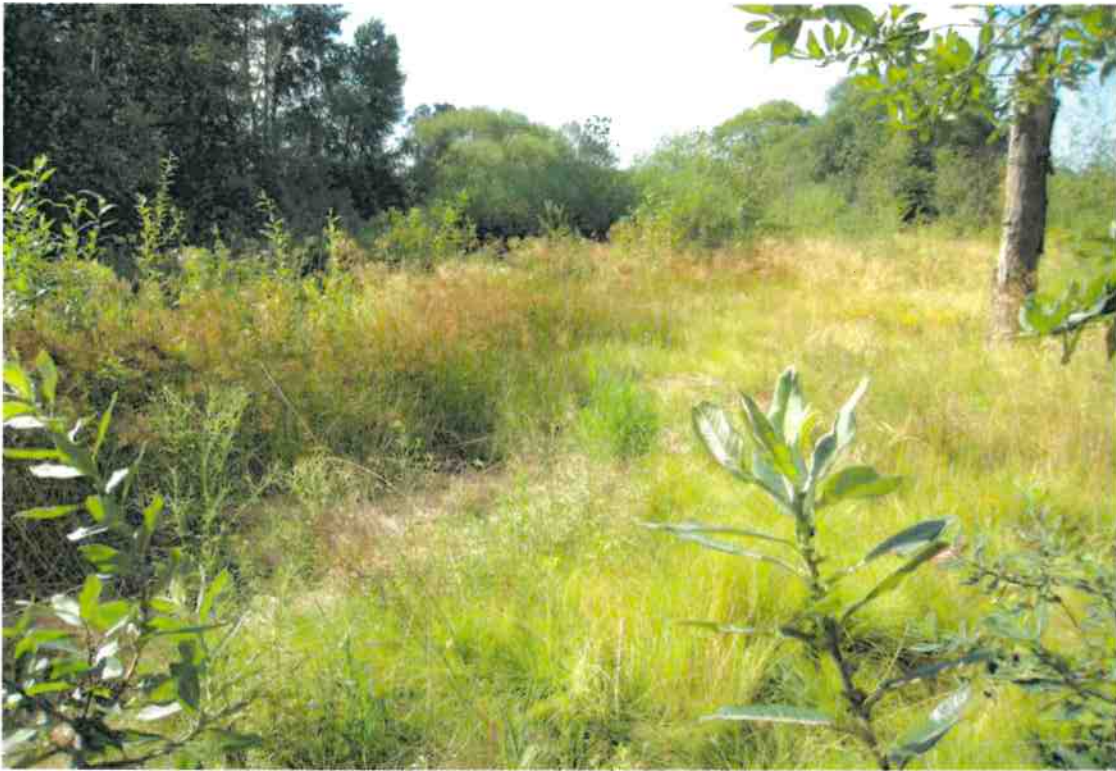
Photograph 1. View of the Emergent Wetland from Plot G-101 looking southeast.

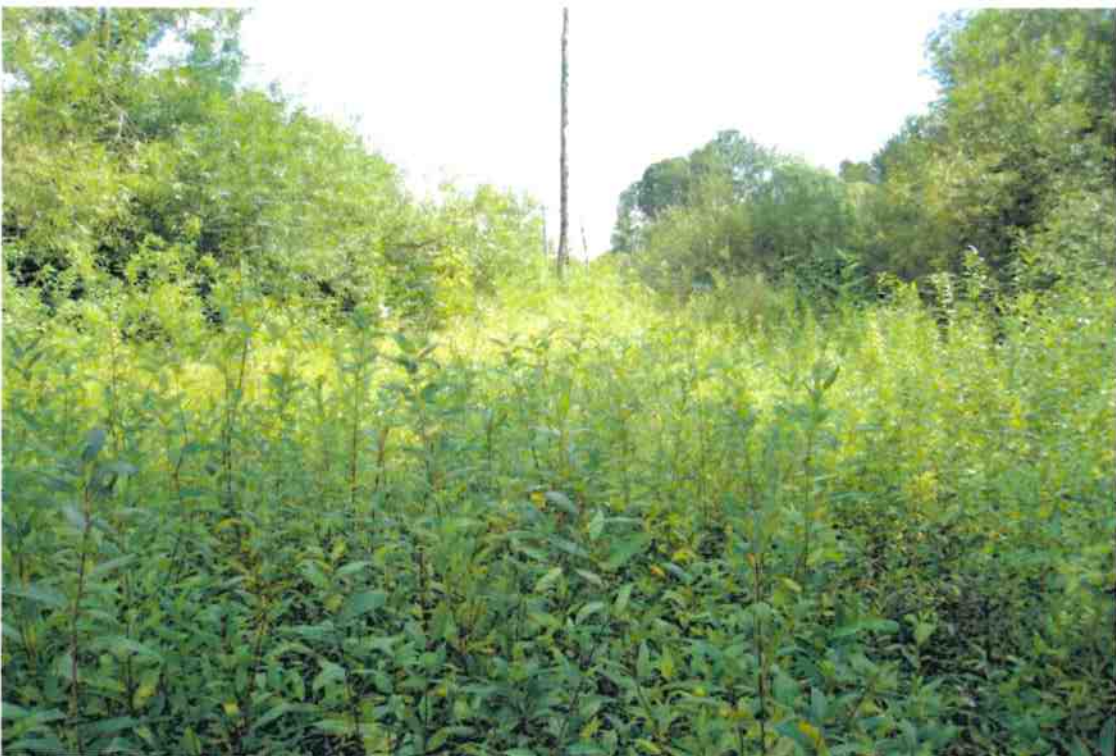
Photograph 2. View of the Emergent Wetland from Plot G-7 looking east.

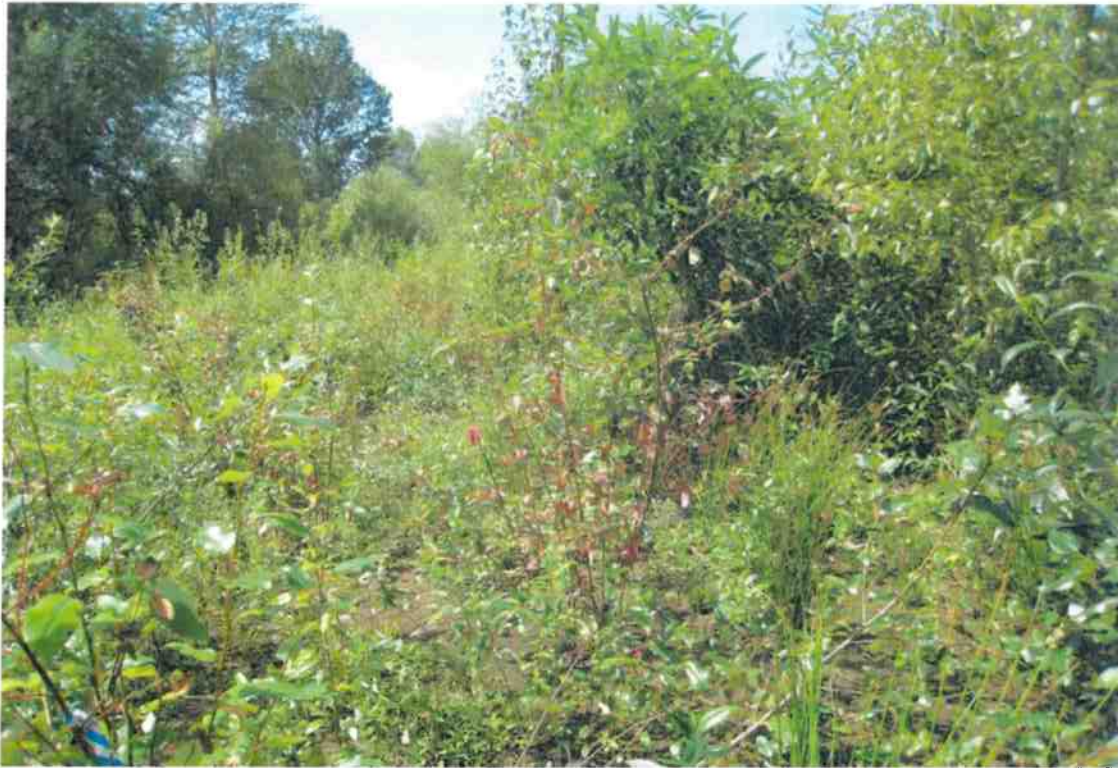
Photograph 3. View of the Scrub-Shrub Wetland from Plot G-109 looking west.

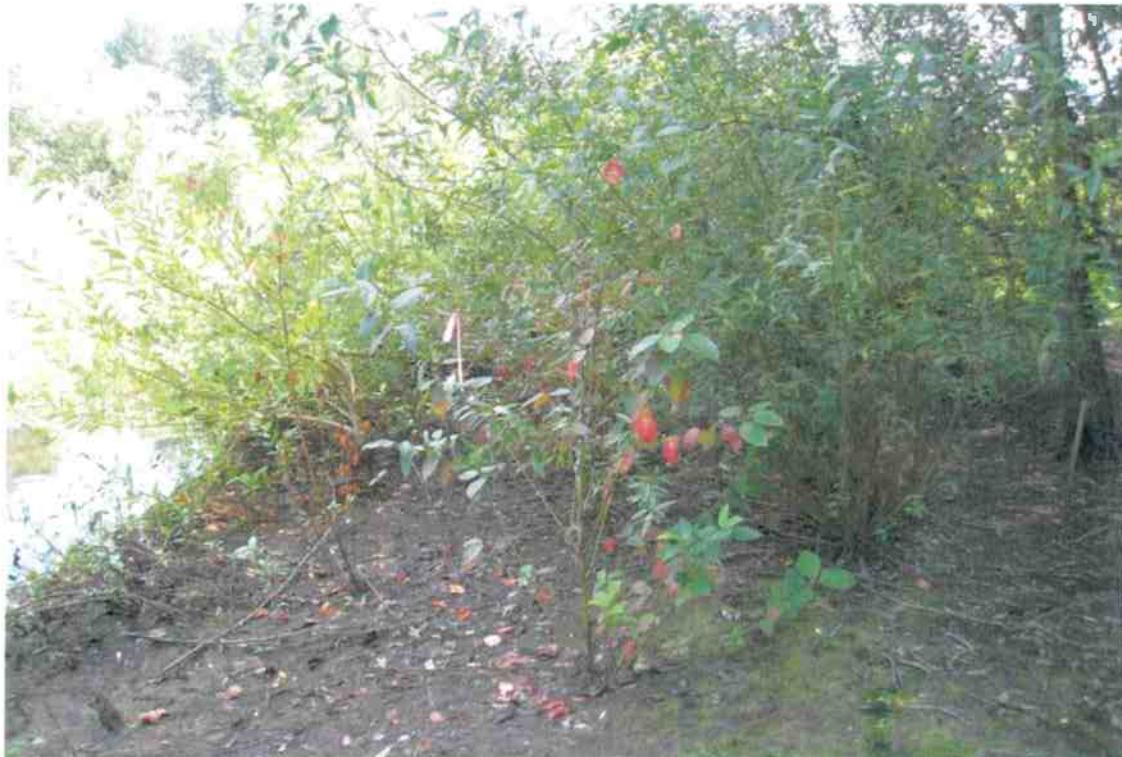
Photograph 4. View of the Scrub-Shrub Wetland from Plot G-8 looking east.

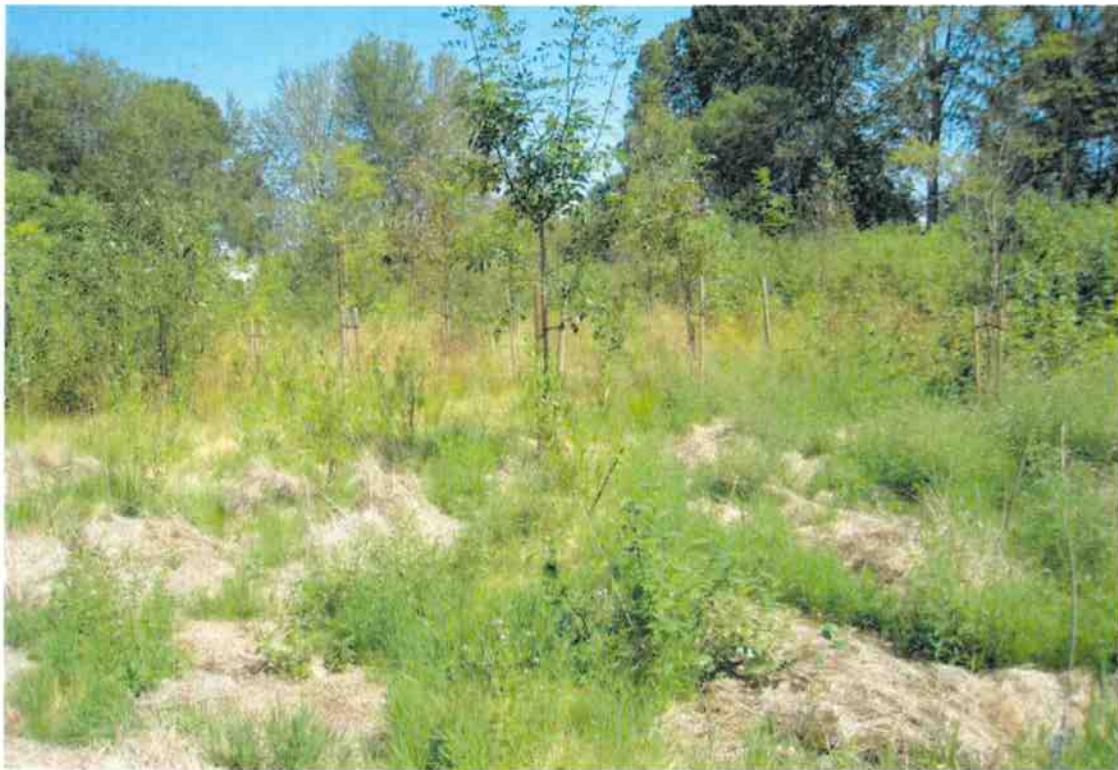
Photograph 5. View of the Scrub-Shrub Wetland from Plot G-115 looking northeast.

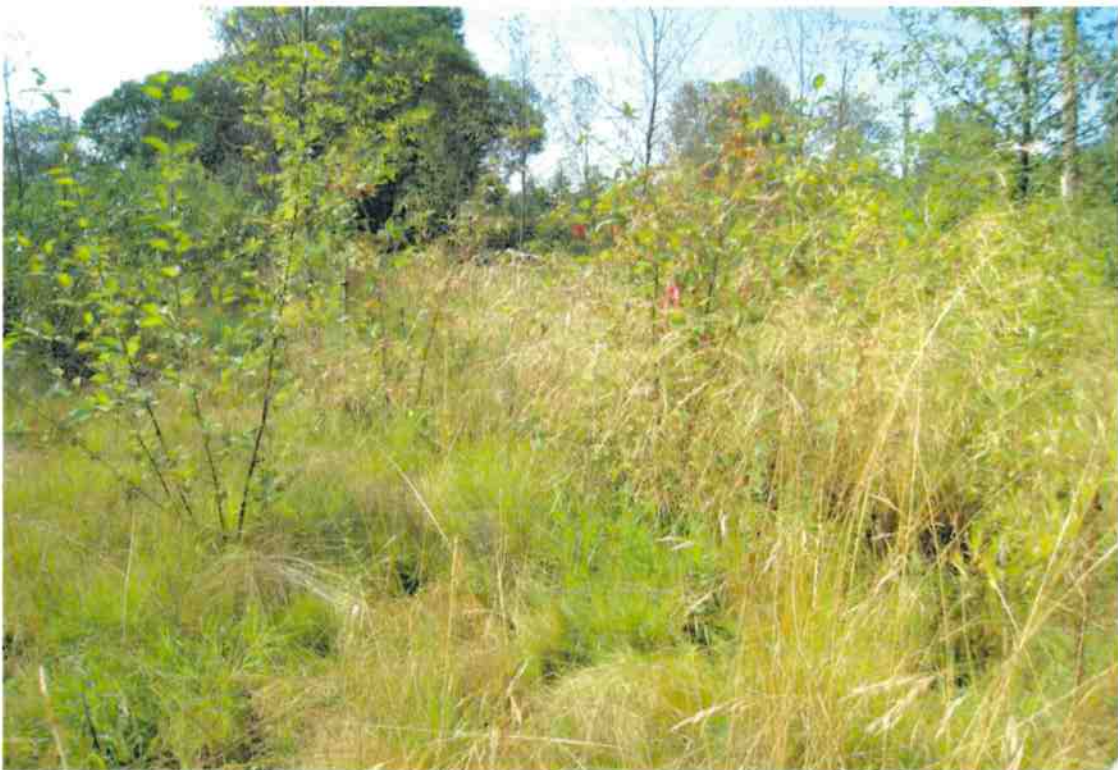
Photograph 6. View of the Forested Wetland from Plot G-105 looking southwest.

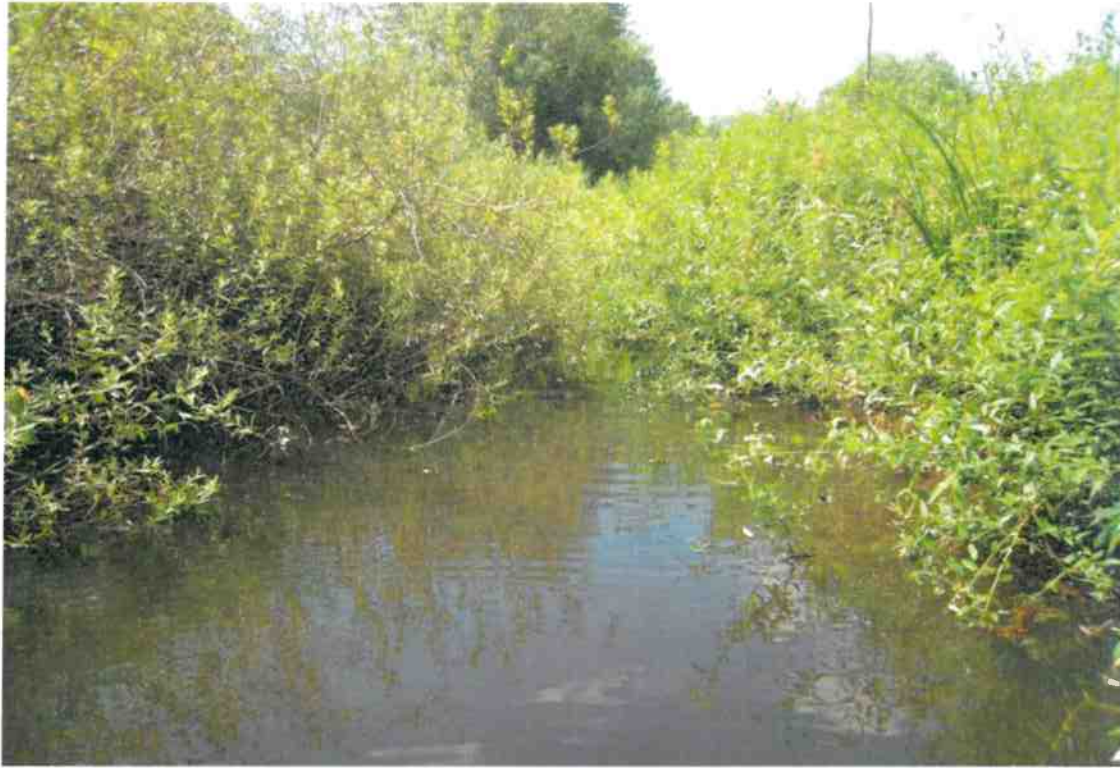
Photograph 7. View of the Open Water Wetland from Plot G-10 looking west.

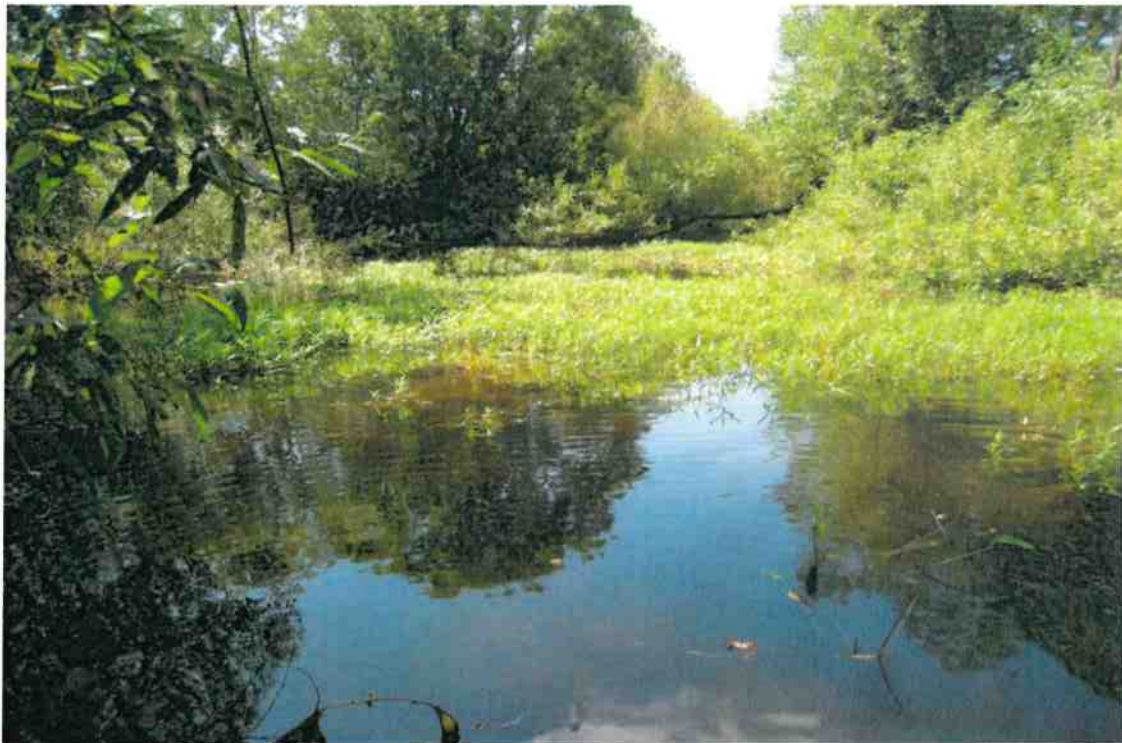
Photograph 8. View of the Open Water Wetland from Plot G-12 looking southwest.

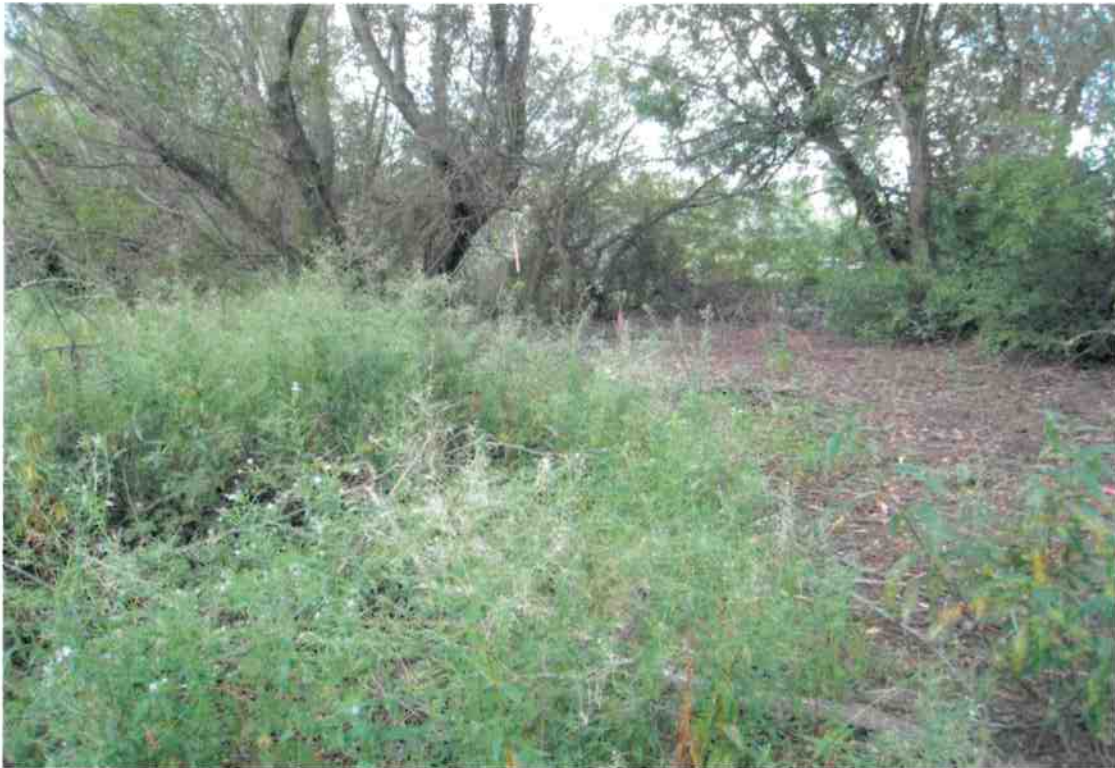
Photograph 10. View of the Existing Forested Wetland from Plot G-2 looking southwest.

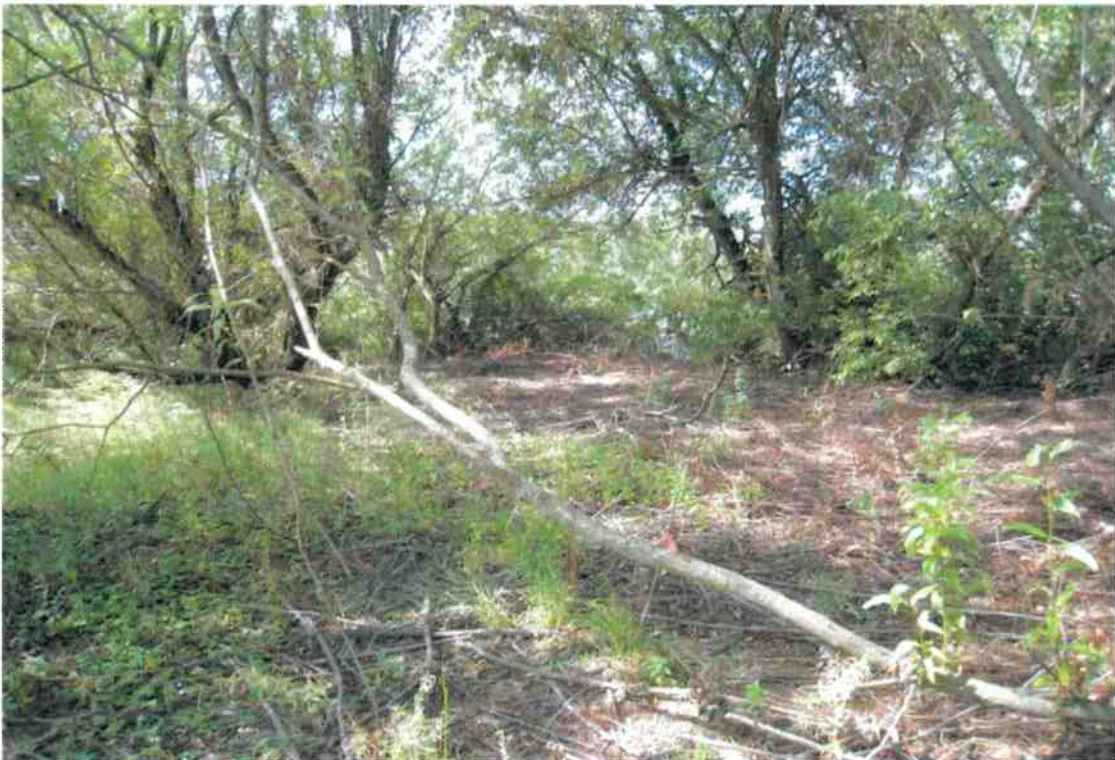
Photograph 10. View of the Existing Forested Wetland from Plot G-4 looking northwest.

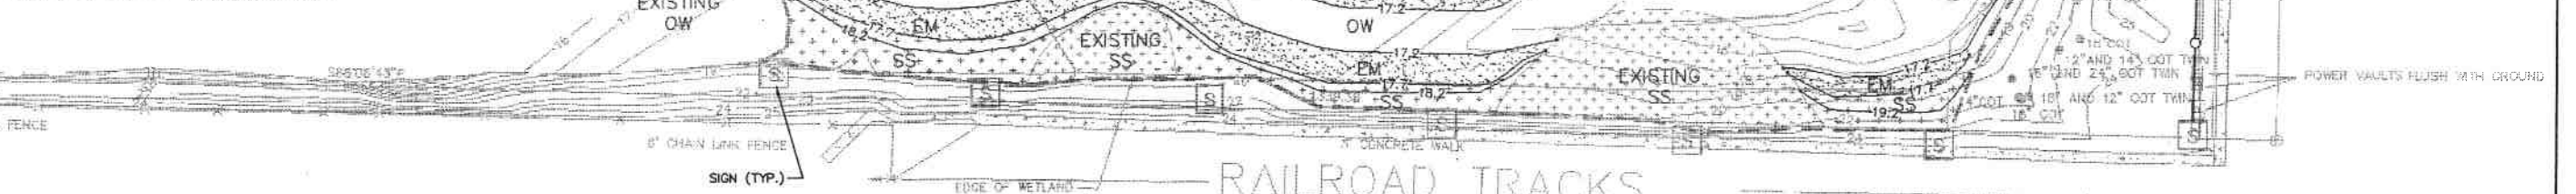
PLANTING PLAN

Wetland Class	Elevation Limits	Area (sf)	Area (acres)
Open Water (OW)	15.2'-17.2'	40,170	0.92
Existing Degraded Wetland	17.2'-20.0'	38,473	0.88
Emergent (EM)	17.2'-17.7'	22,779	0.52
Scrub-Shrub (SS)	17.7'-18.2'	22,152	0.51
Forested (FO)	18.2'-19.2'	28,157	0.65
Total		151,731	3.48
