TO: Finance and Governance Committee
FROM: David Cline, City Administrator
BY: Hari Ponnekanti, Public Works Director/ City Engineer
Rachel Bianchi, Deputy City Administrator
CC: Mayor Allan Ekberg
DATE: July 22, 2022
SUBJECT: City Facilities Overview and Seismic Update for City Hall, 6300 building and TCC

MULTI-BUILDING SEISMIC ASSESSMENTS UPDATE

June 2022

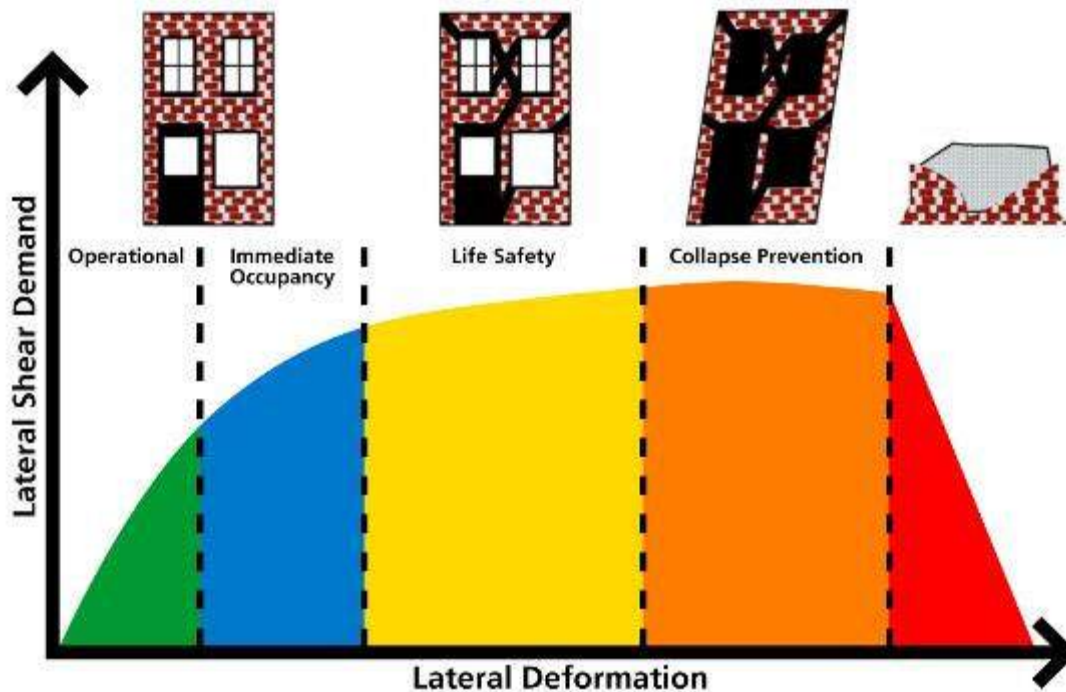
Figure 2-1. Building Performance Levels.

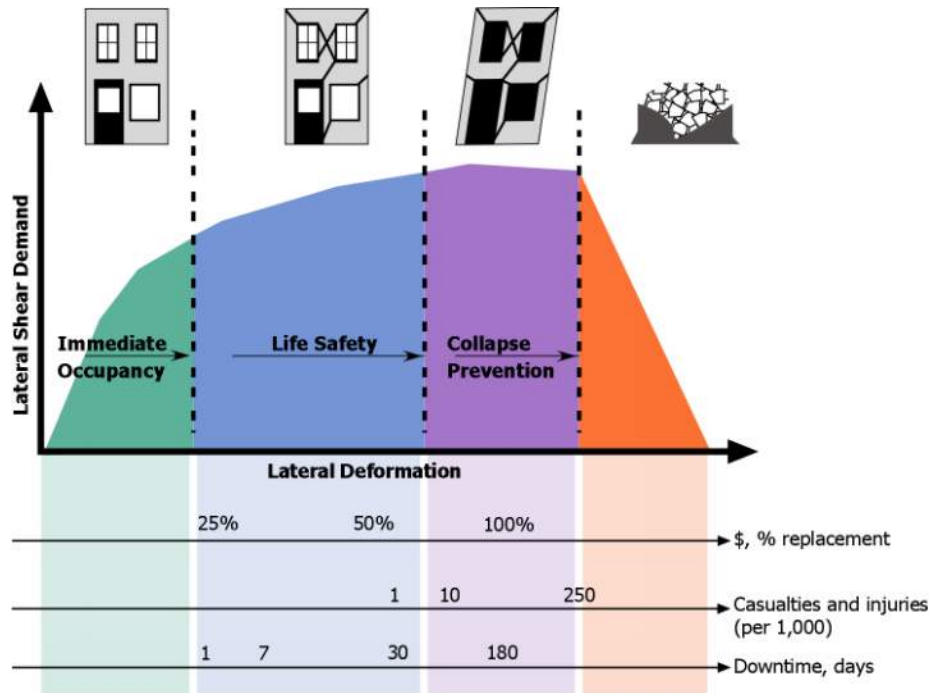
Figure 2-2 shows estimated performance-related consequences compared with different increasing post-earthquake structural damage states (which correspond to the design Structural Performance Levels for a given seismic hazard).

Figure 2-2. Estimated Performance-Related Consequences at Different Structural Performance Levels³.

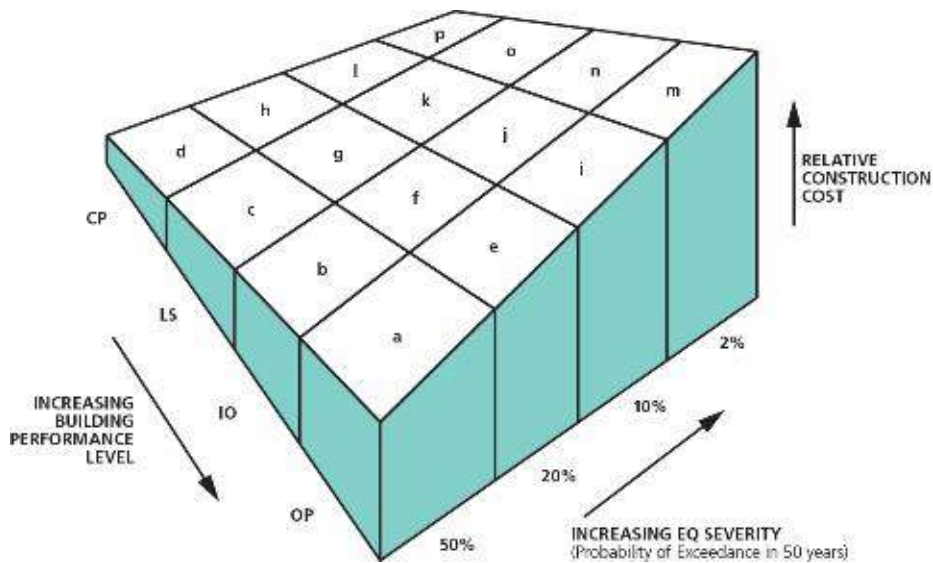
Figure 2-3 presents the schematic relationship between different retrofit building performance objectives and probable retrofit program cost.

Figure 2-3. Surface Matrix of ASCE 41 Building Performance Levels Compared with Construction Cost⁴.

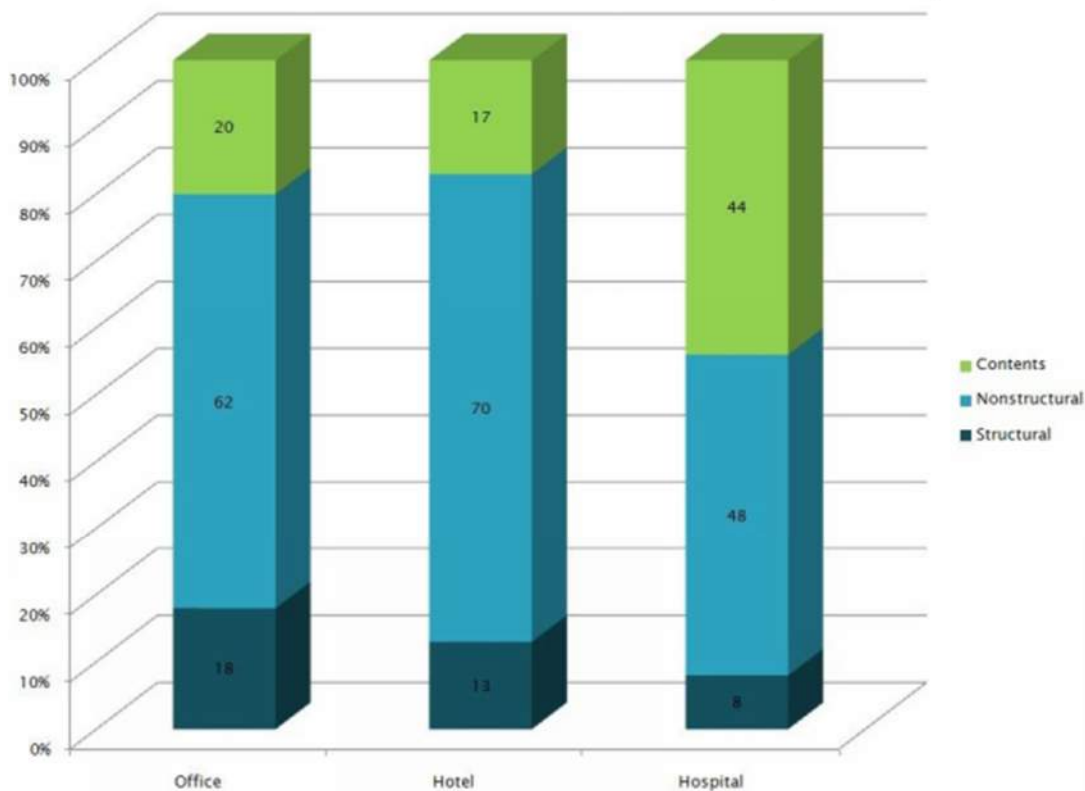
In addition to the life safety hazards posed by nonstructural components, the cost to repair nonstructural components following an earthquake can be high. In many cases, the cost to repair or replace nonstructural components can be higher than the cost of repairing structural components following an earthquake. The relative monetary importance of nonstructural components can be seen in Figure 2-4, comparing the relative construction costs of the contents, nonstructural components, and the structural components of three types of typical new buildings. In offices and hotels, the building nonstructural components cost the most to construct, by a significant margin. In hospitals, the costs of constructing the building contents and nonstructural components are similar, but still far exceed the cost of the building structural systems.

Figure 2-4. Typical Construction Costs for Different Building Components.⁵

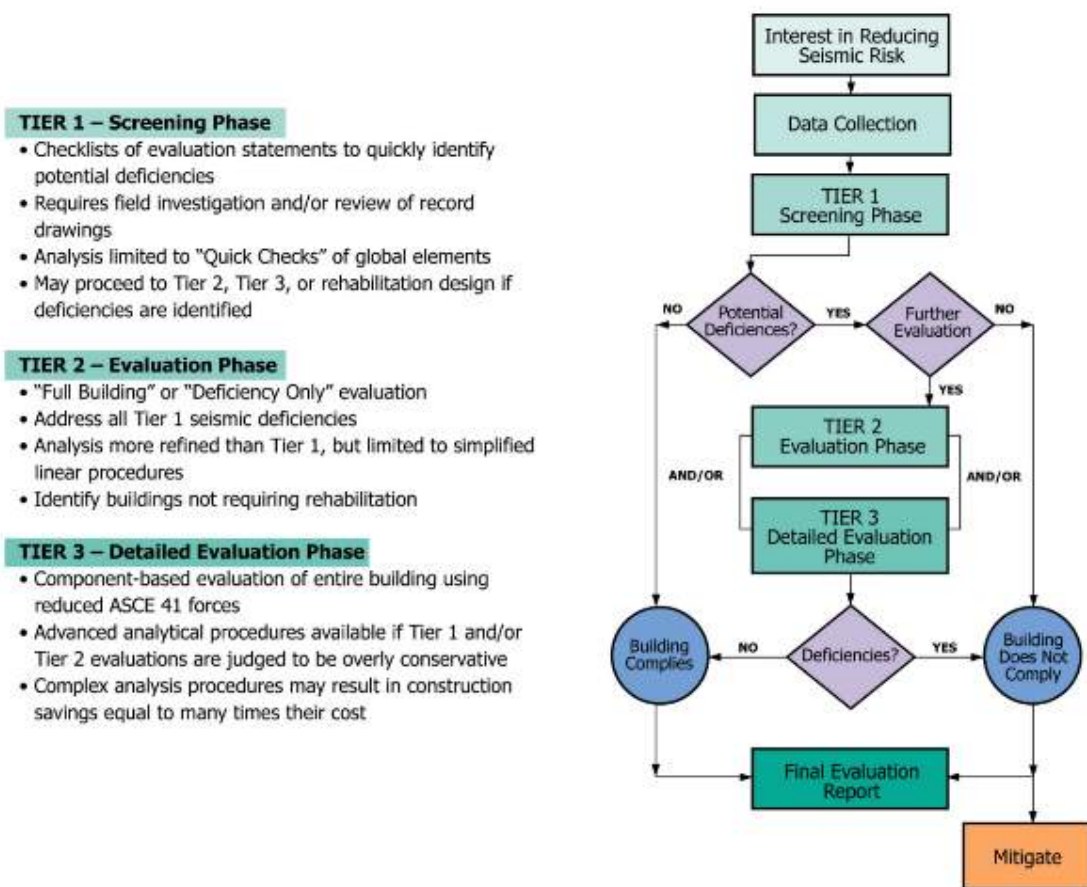
ASCE 41-17 provides a three-tiered evaluation procedure using performance-based criteria. The process for seismic evaluation is depicted in Figure 2-5. The evaluation process consists of the following three tiers: Screening Phase (Tier 1), Evaluation Phase (Tier 2), and Detailed Evaluation Phase (Tier 3). A summary of each phase follows.

Figure 2-5. Flow Chart and Description of ASCE 41-17 Seismic Evaluation Procedure.

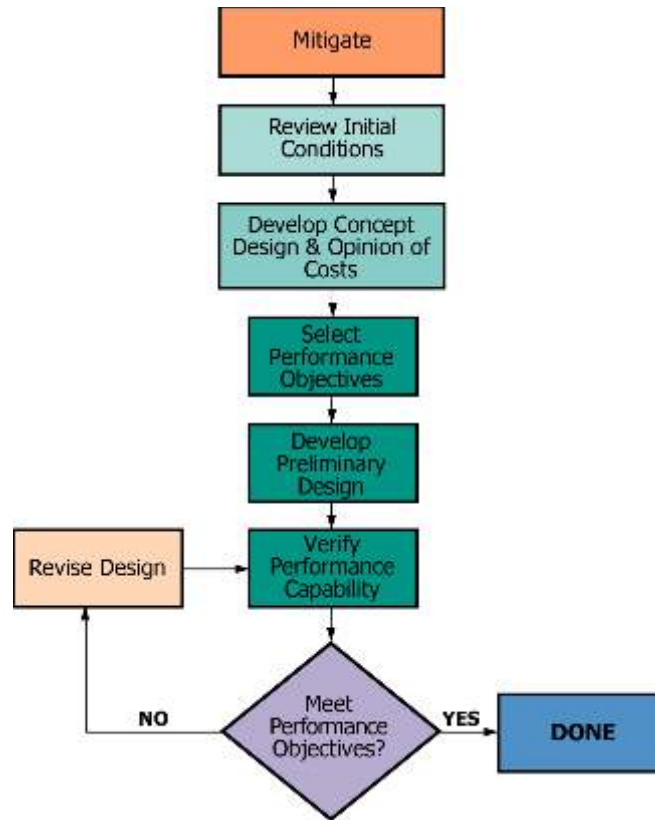
If seismic deficiencies are identified in the evaluation process, the owner and design team should review all initial conditions before proceeding with the hazard mitigation. Many conditions may affect the retrofit design significantly, such as results of the seismic evaluation and seismic hazard study, building use and occupancy requirements, presence of hazardous materials, and other anticipated building remodeling. The basic process for performance-based retrofit design is illustrated in Figure 2-6.

Figure 2-6. Seismic Rehabilitation Flow Diagram.

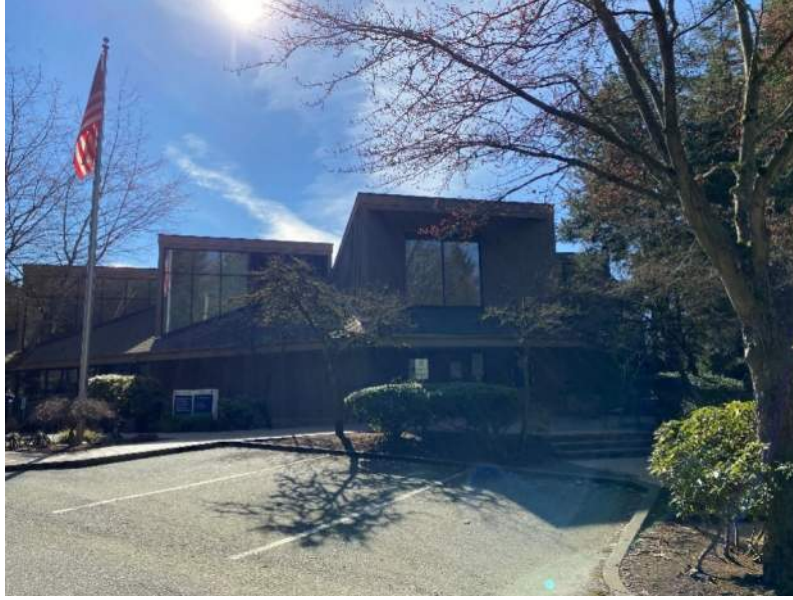
The City Hall is a two-story, concrete- and wood-framed structure located in the central area of Tukwila. The building is approximately 195 feet by 128 feet in plan, 37 feet tall, and has an L-shaped footprint with distinctive saw-tooth wall lines on the southeastern elevations of the structure. The main roof is stepped in 24-foot-wide sections that align with the saw-tooth wall lines and slope monolithically from northwest to southeast. The upper story is wood-framed construction with structural-panel walls and long-span timber roof trusses. The lower story construction consists of concrete walls and columns, steel posts, and wood-framed walls supporting the level above. The building is located on a site that slopes downhill from north to south. The first story is below grade on the north side and portions of the east and west sides. A partial basement level is located below the first story in the southwest corner.

Figure 3.1-1. City Hall, Northwest Corner.

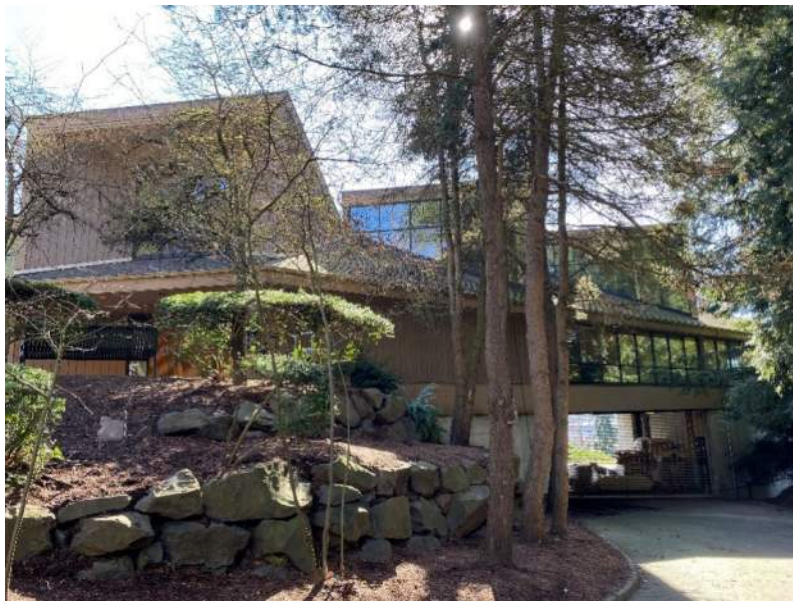
Figure 3.1-2. City Hall, West End (looking south).

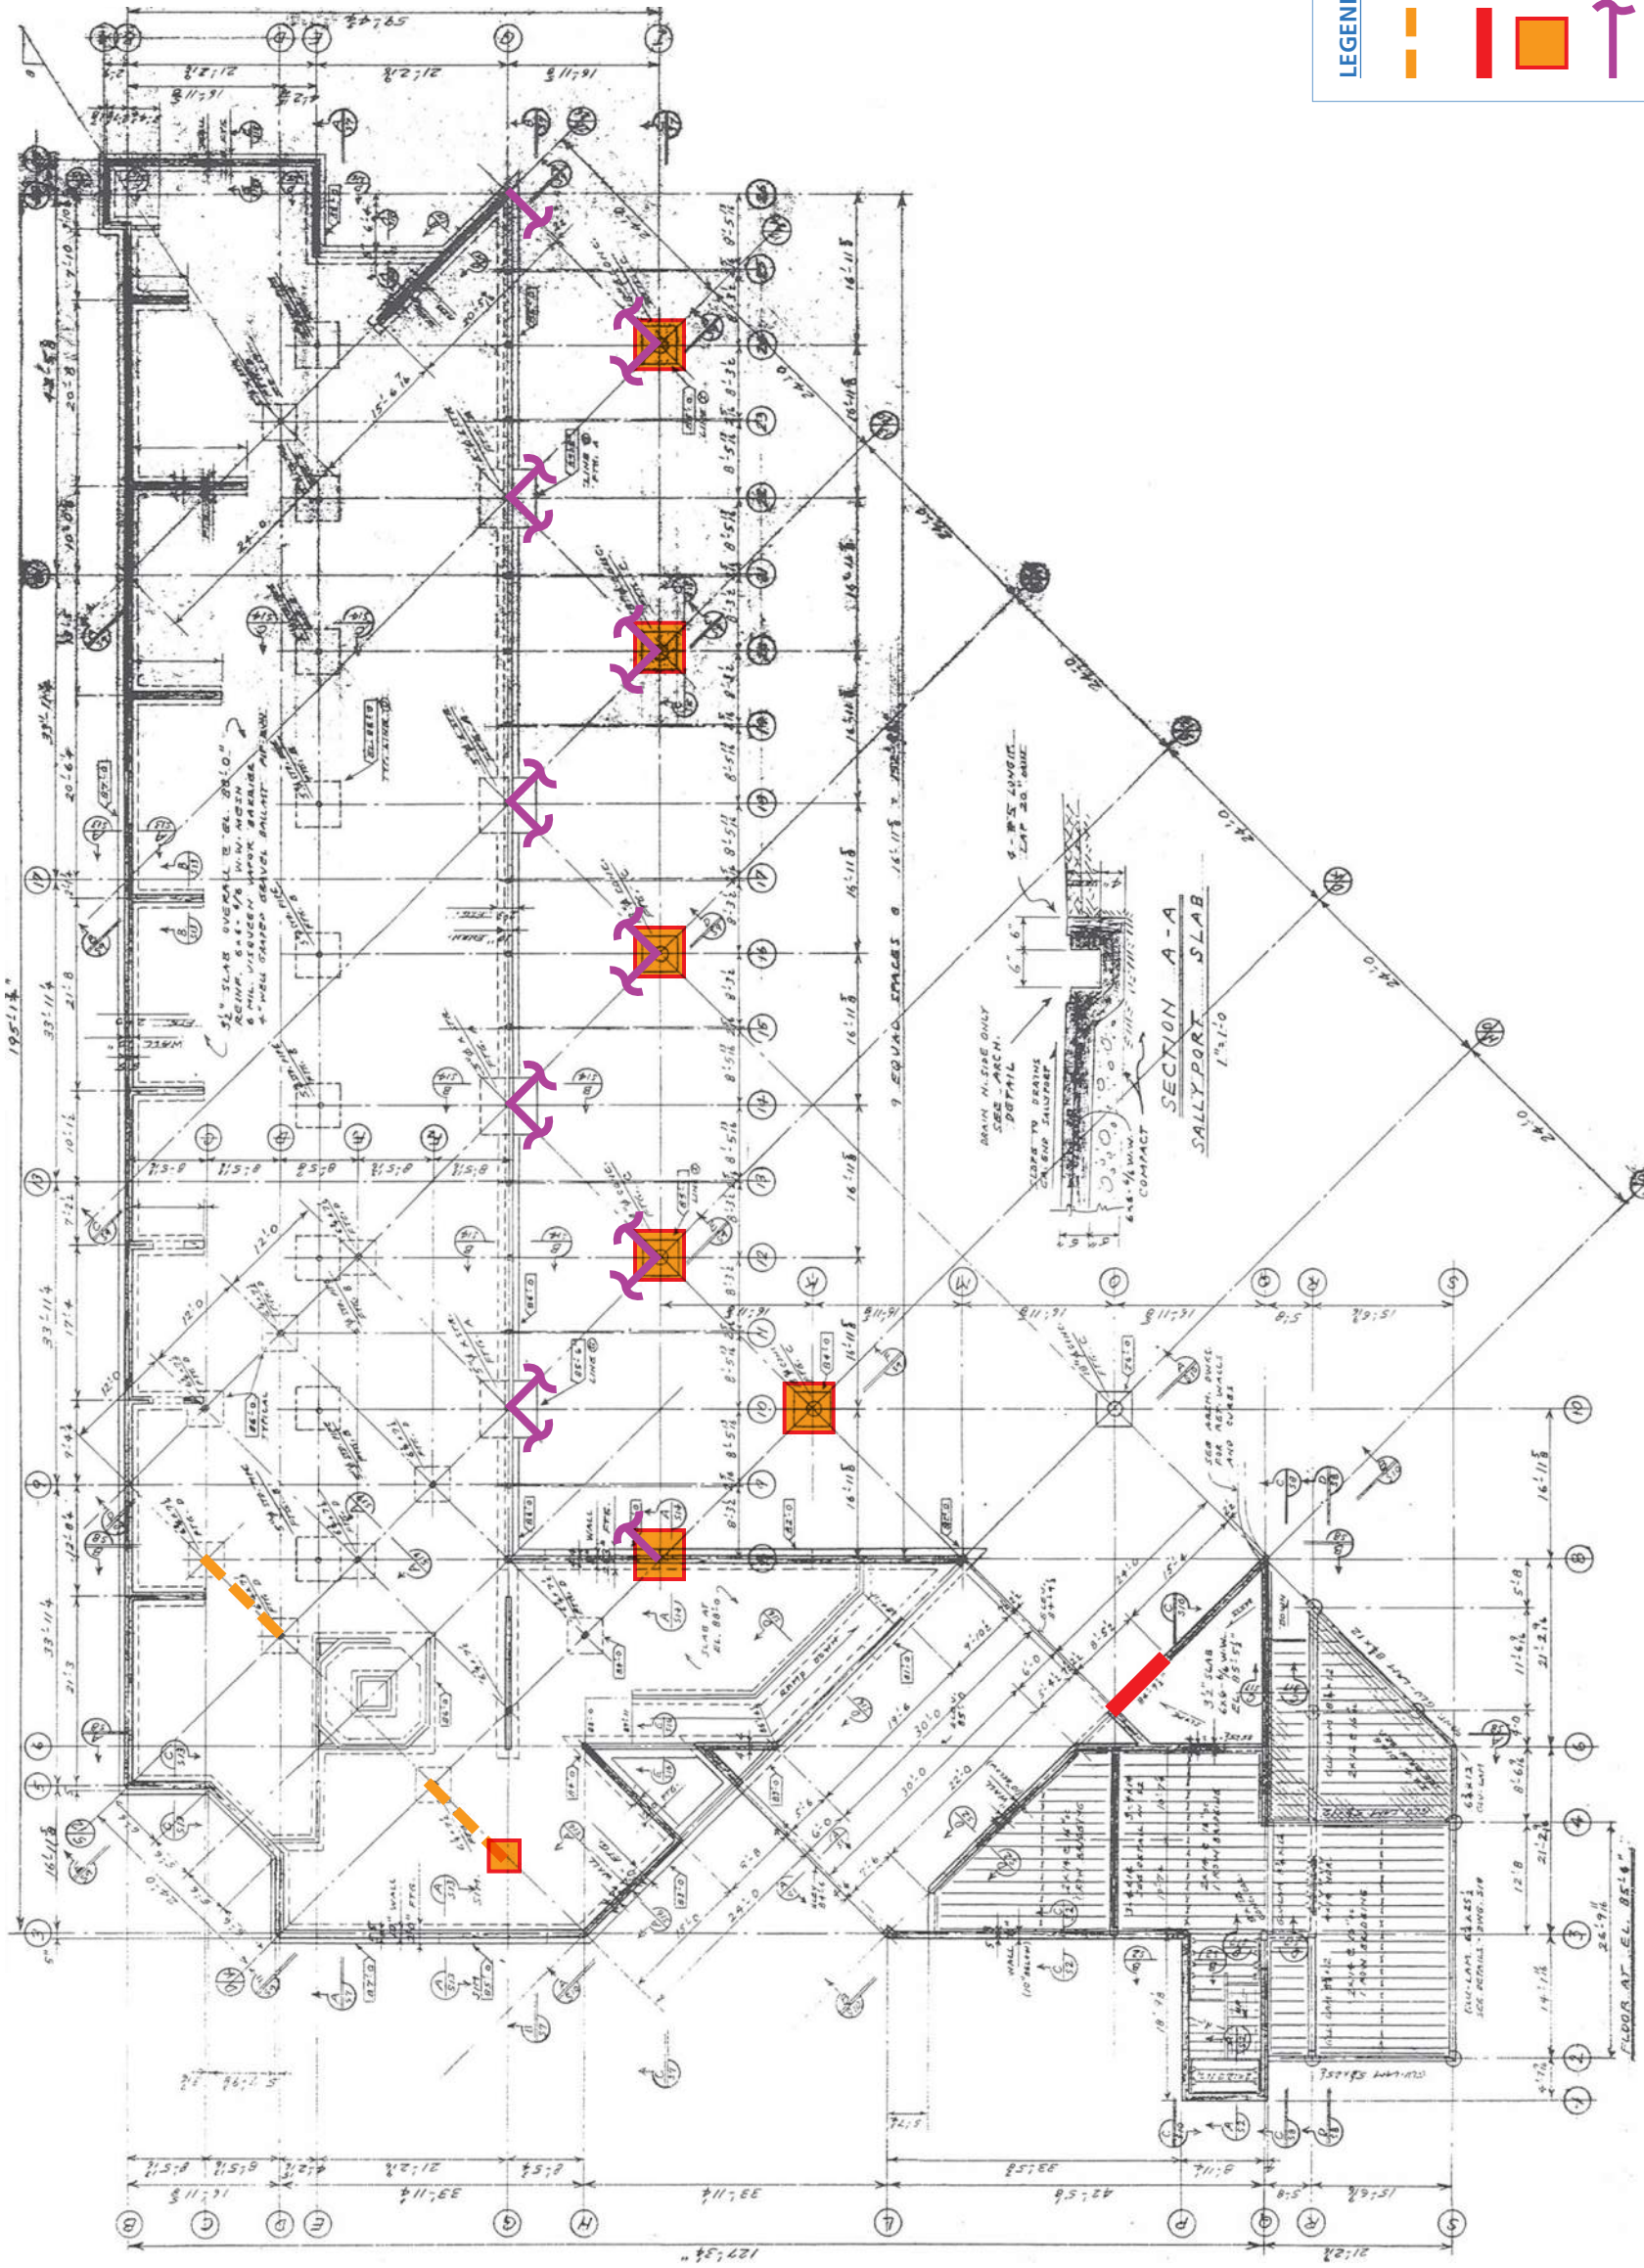
- New Wood Shear Walls & Footings For Continuity of Walls Above
- Strengthen Support Beam For Shear Wall Above
- Enlarge Footings Beneath New Braces
- New Steel Braces For Continuous Load Path For Shear Walls Above

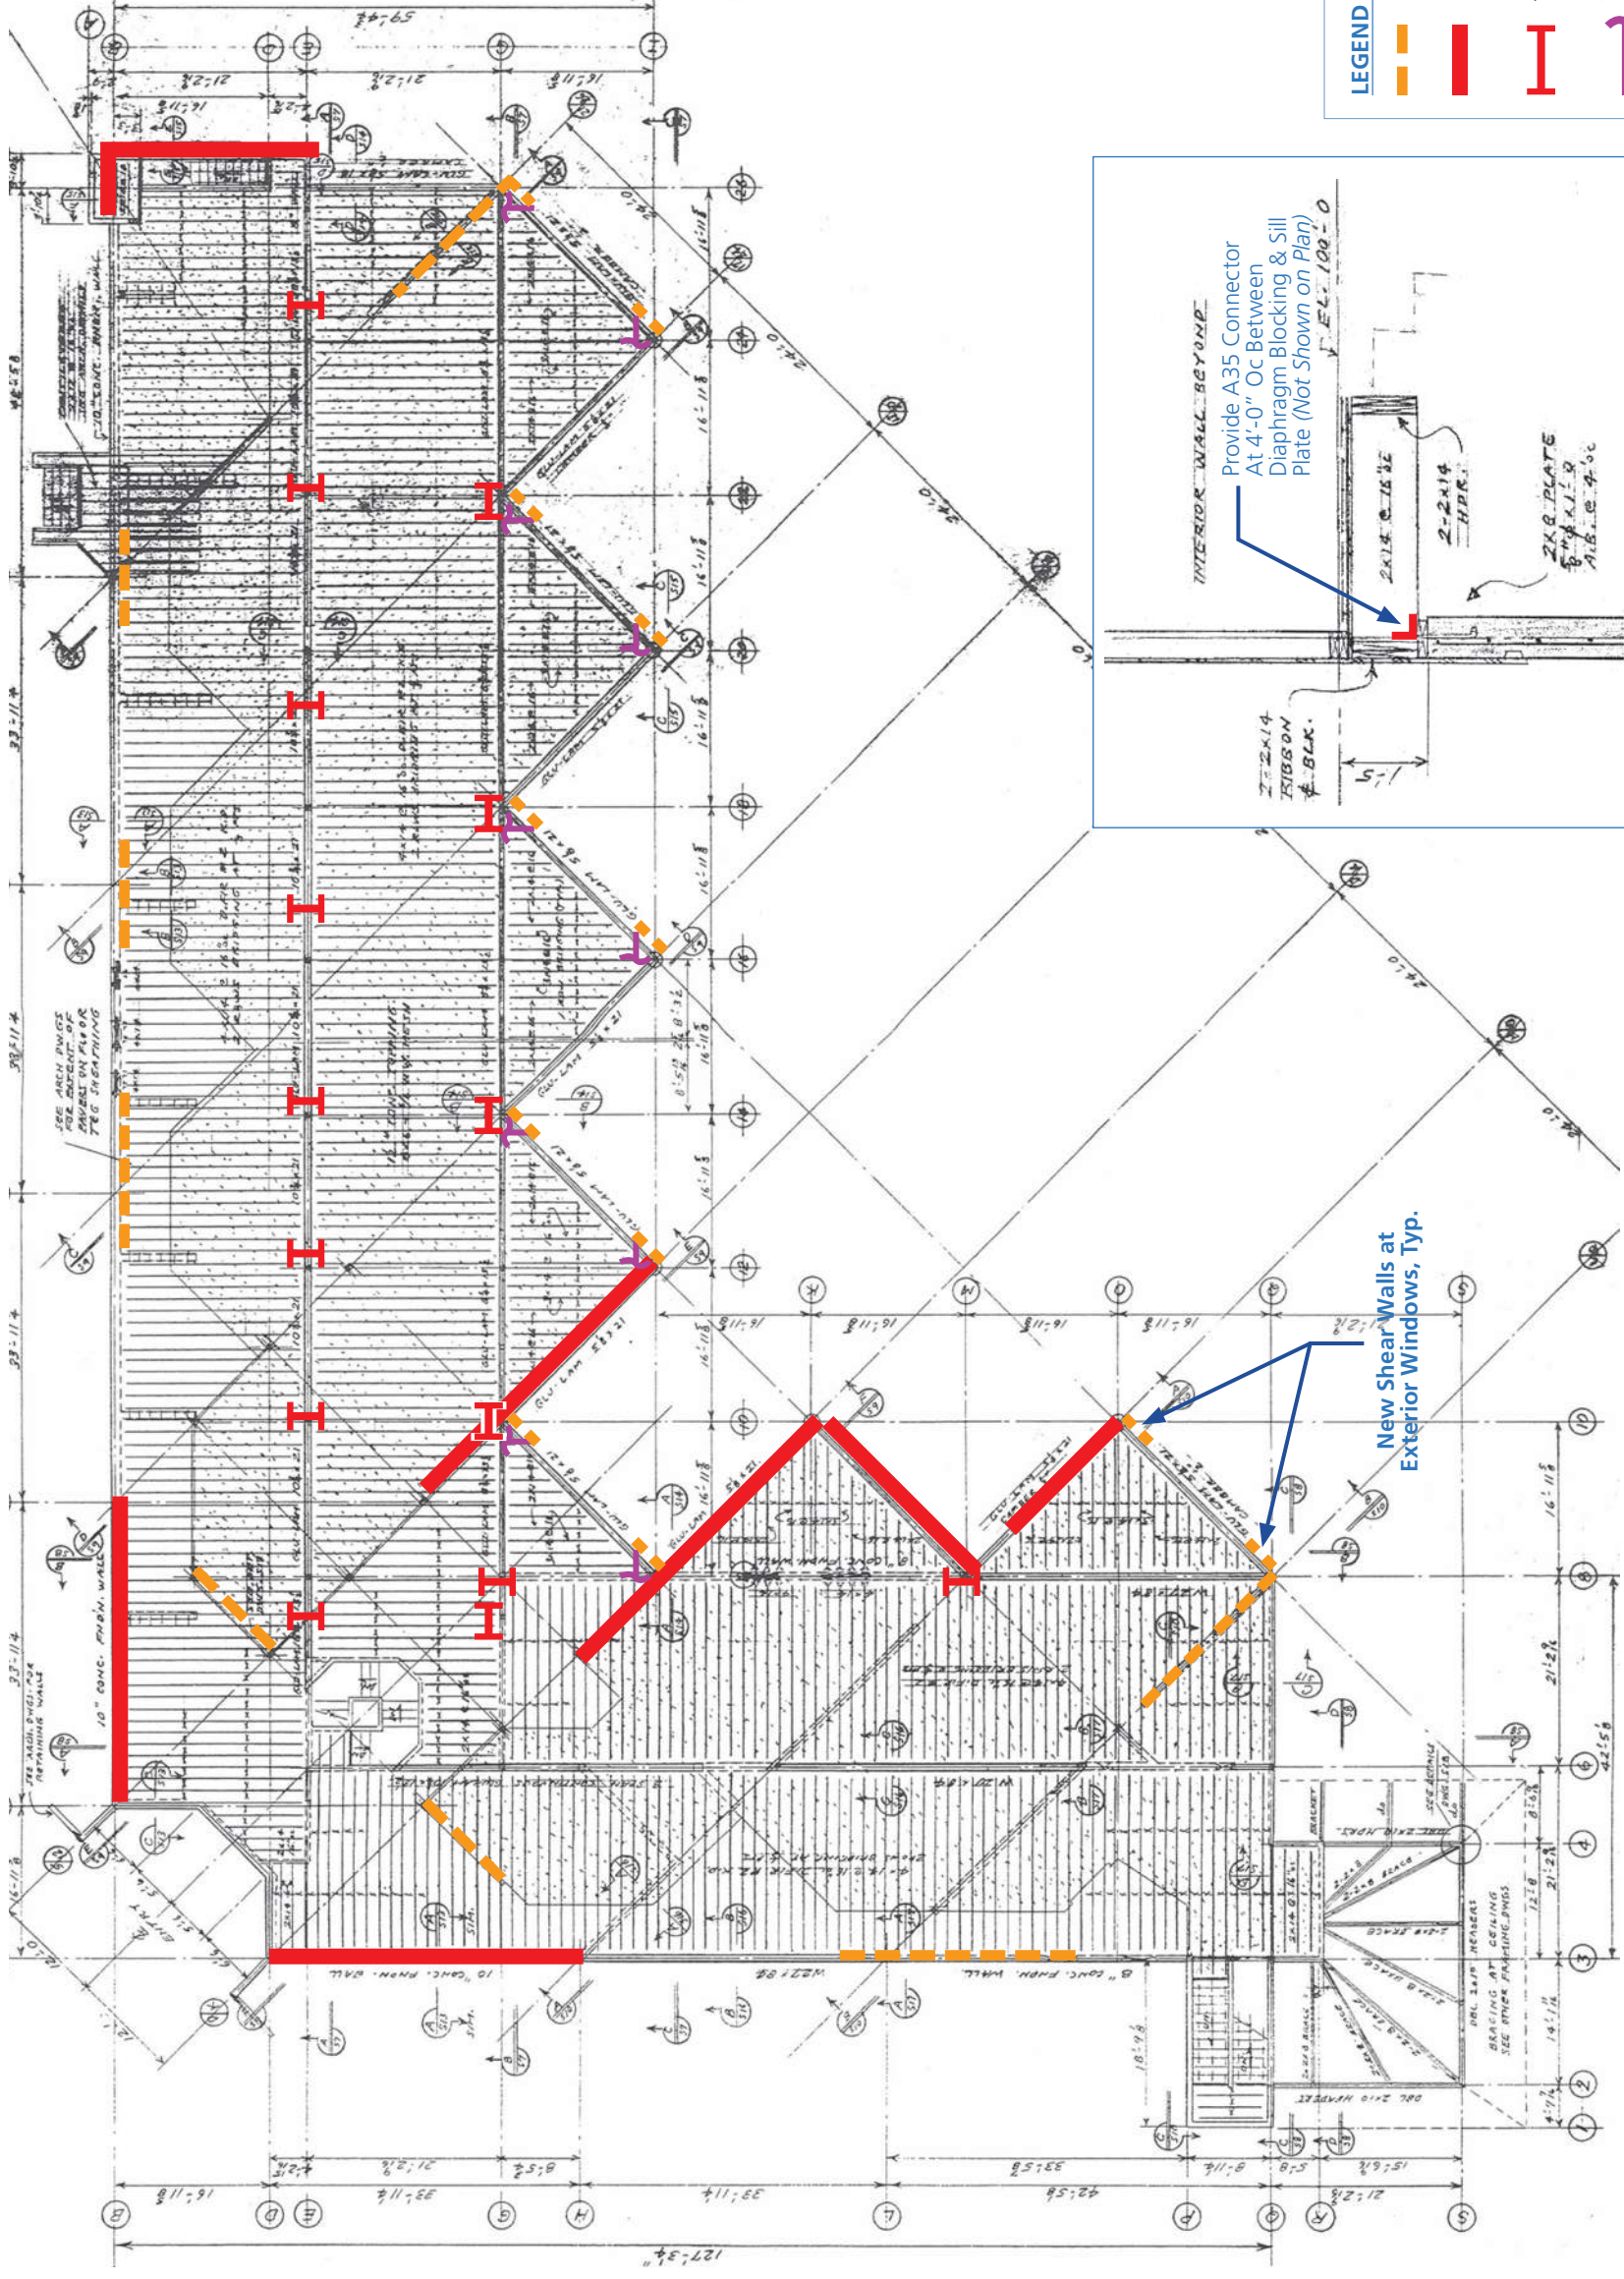
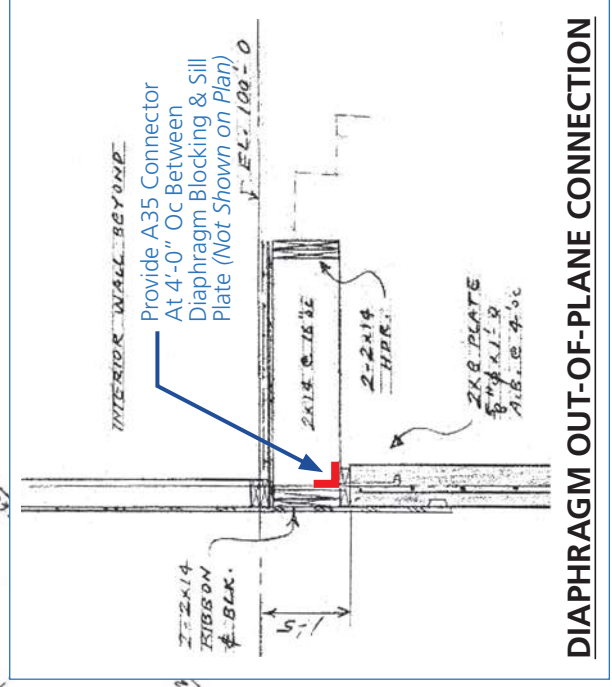
Figure 3.1-7

New Wood Shear Walls
	Retrofit Connection Between Concrete Walls & Wood Framing
	Seismic Strap, Wood-To-Wood or Wood/Steel Beam To Concrete Wall
	New Steel Braces Below Connected to Level 2 Diaphragm

City Hall — First Floor Retrofit Concept
 City of Tukwila Multi-Building Seismic Assessments Update - June 2022

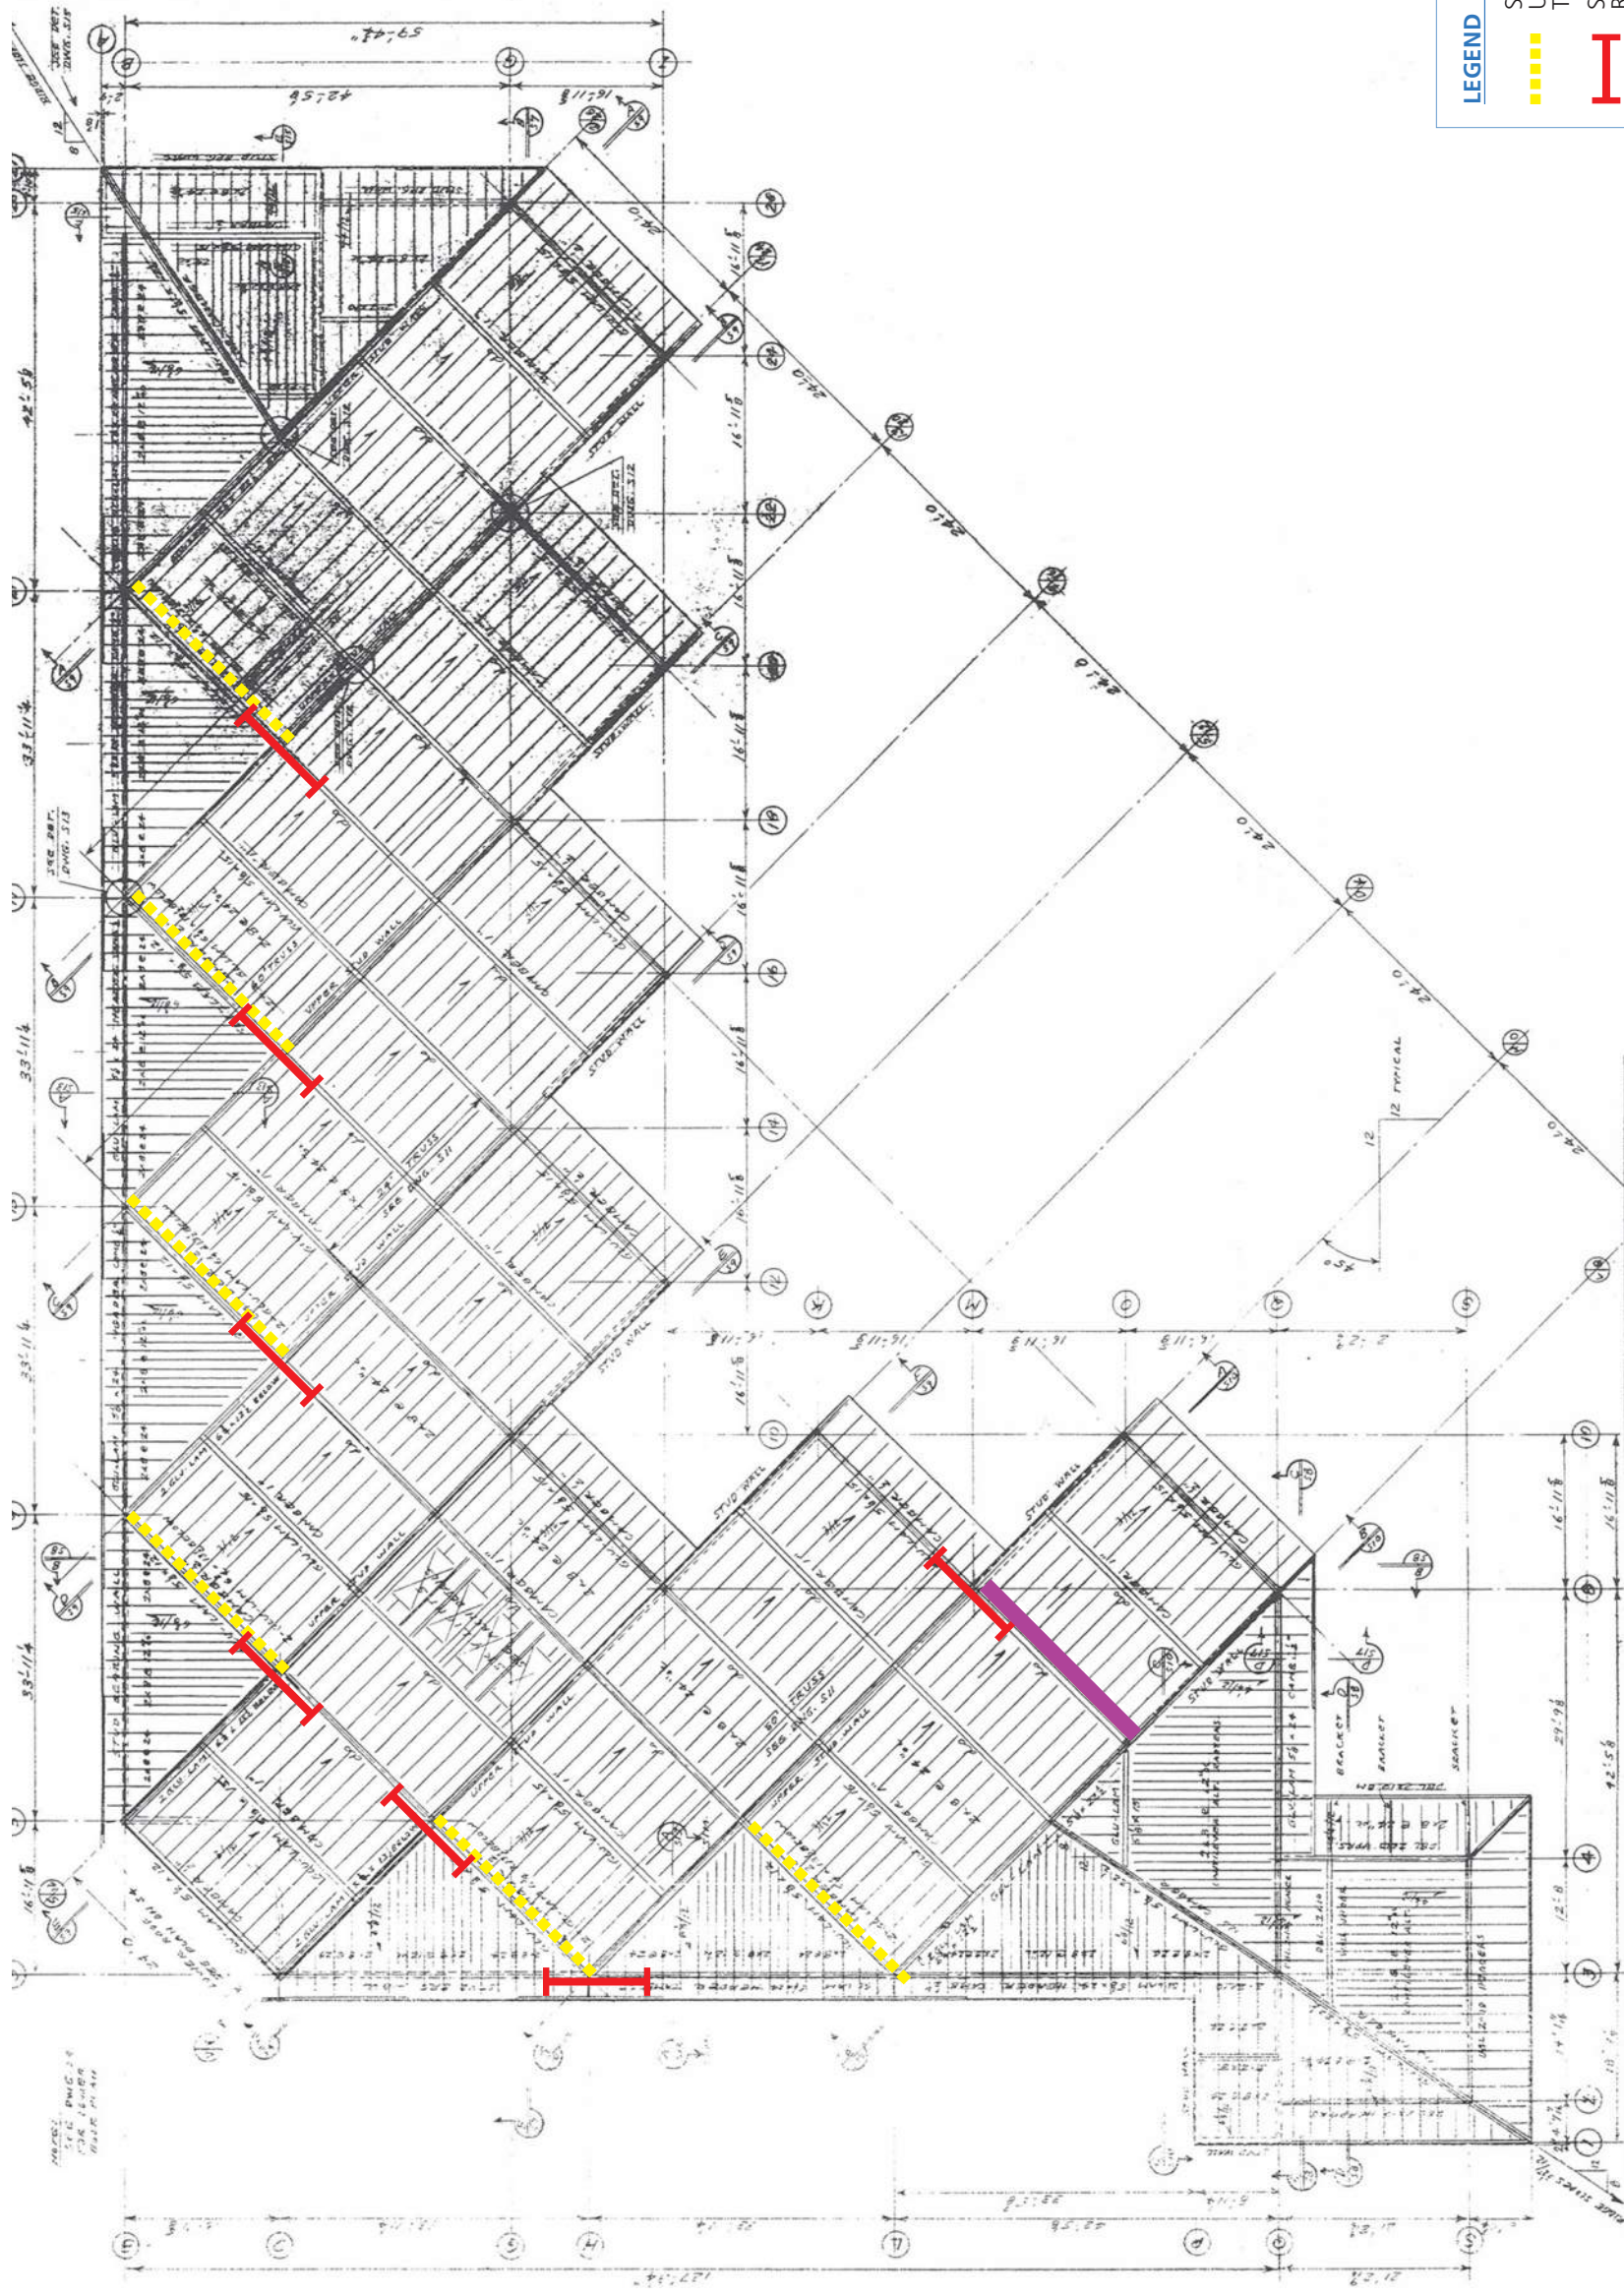
- Steel Bracing Connecting Upper Roof to Lower Roof, Typ (6) Plcs
- Seismic Strap Between Roof Beams
- New Drag Strut

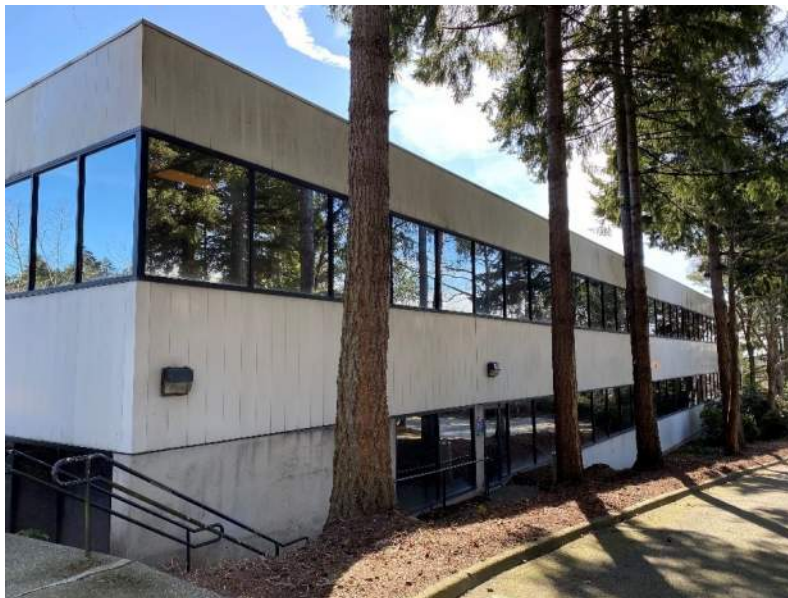
The 6300 Building is a three-story concrete- and wood-framed structure located in the central area of Tukwila, adjacent to City Hall. The rectangular building is 80 feet by 210 feet in plan and 43 feet tall. The first and second stories are primarily wood-framed construction with structural-panel walls and diaphragms. The building has a parking level below the first story. Construction of the parking level consists of concrete walls and columns supporting the levels above. The building is located on a site that slopes downhill from north to south. The north end of the parking level is below grade. Concrete walls in the northern half of the building also act as retaining walls.

Figure 3.2-1. 6300 Building, West Exterior.

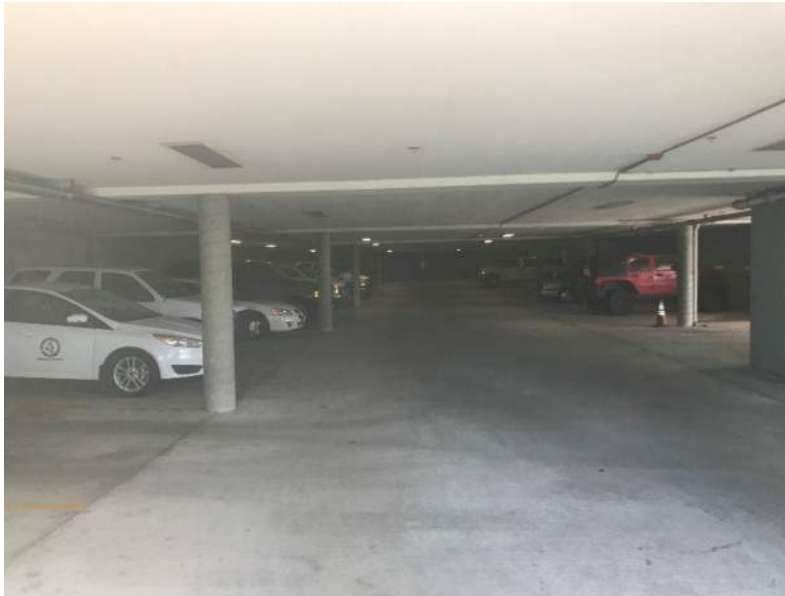
Figure 3.2-2. 6300 Building, Parking Level.

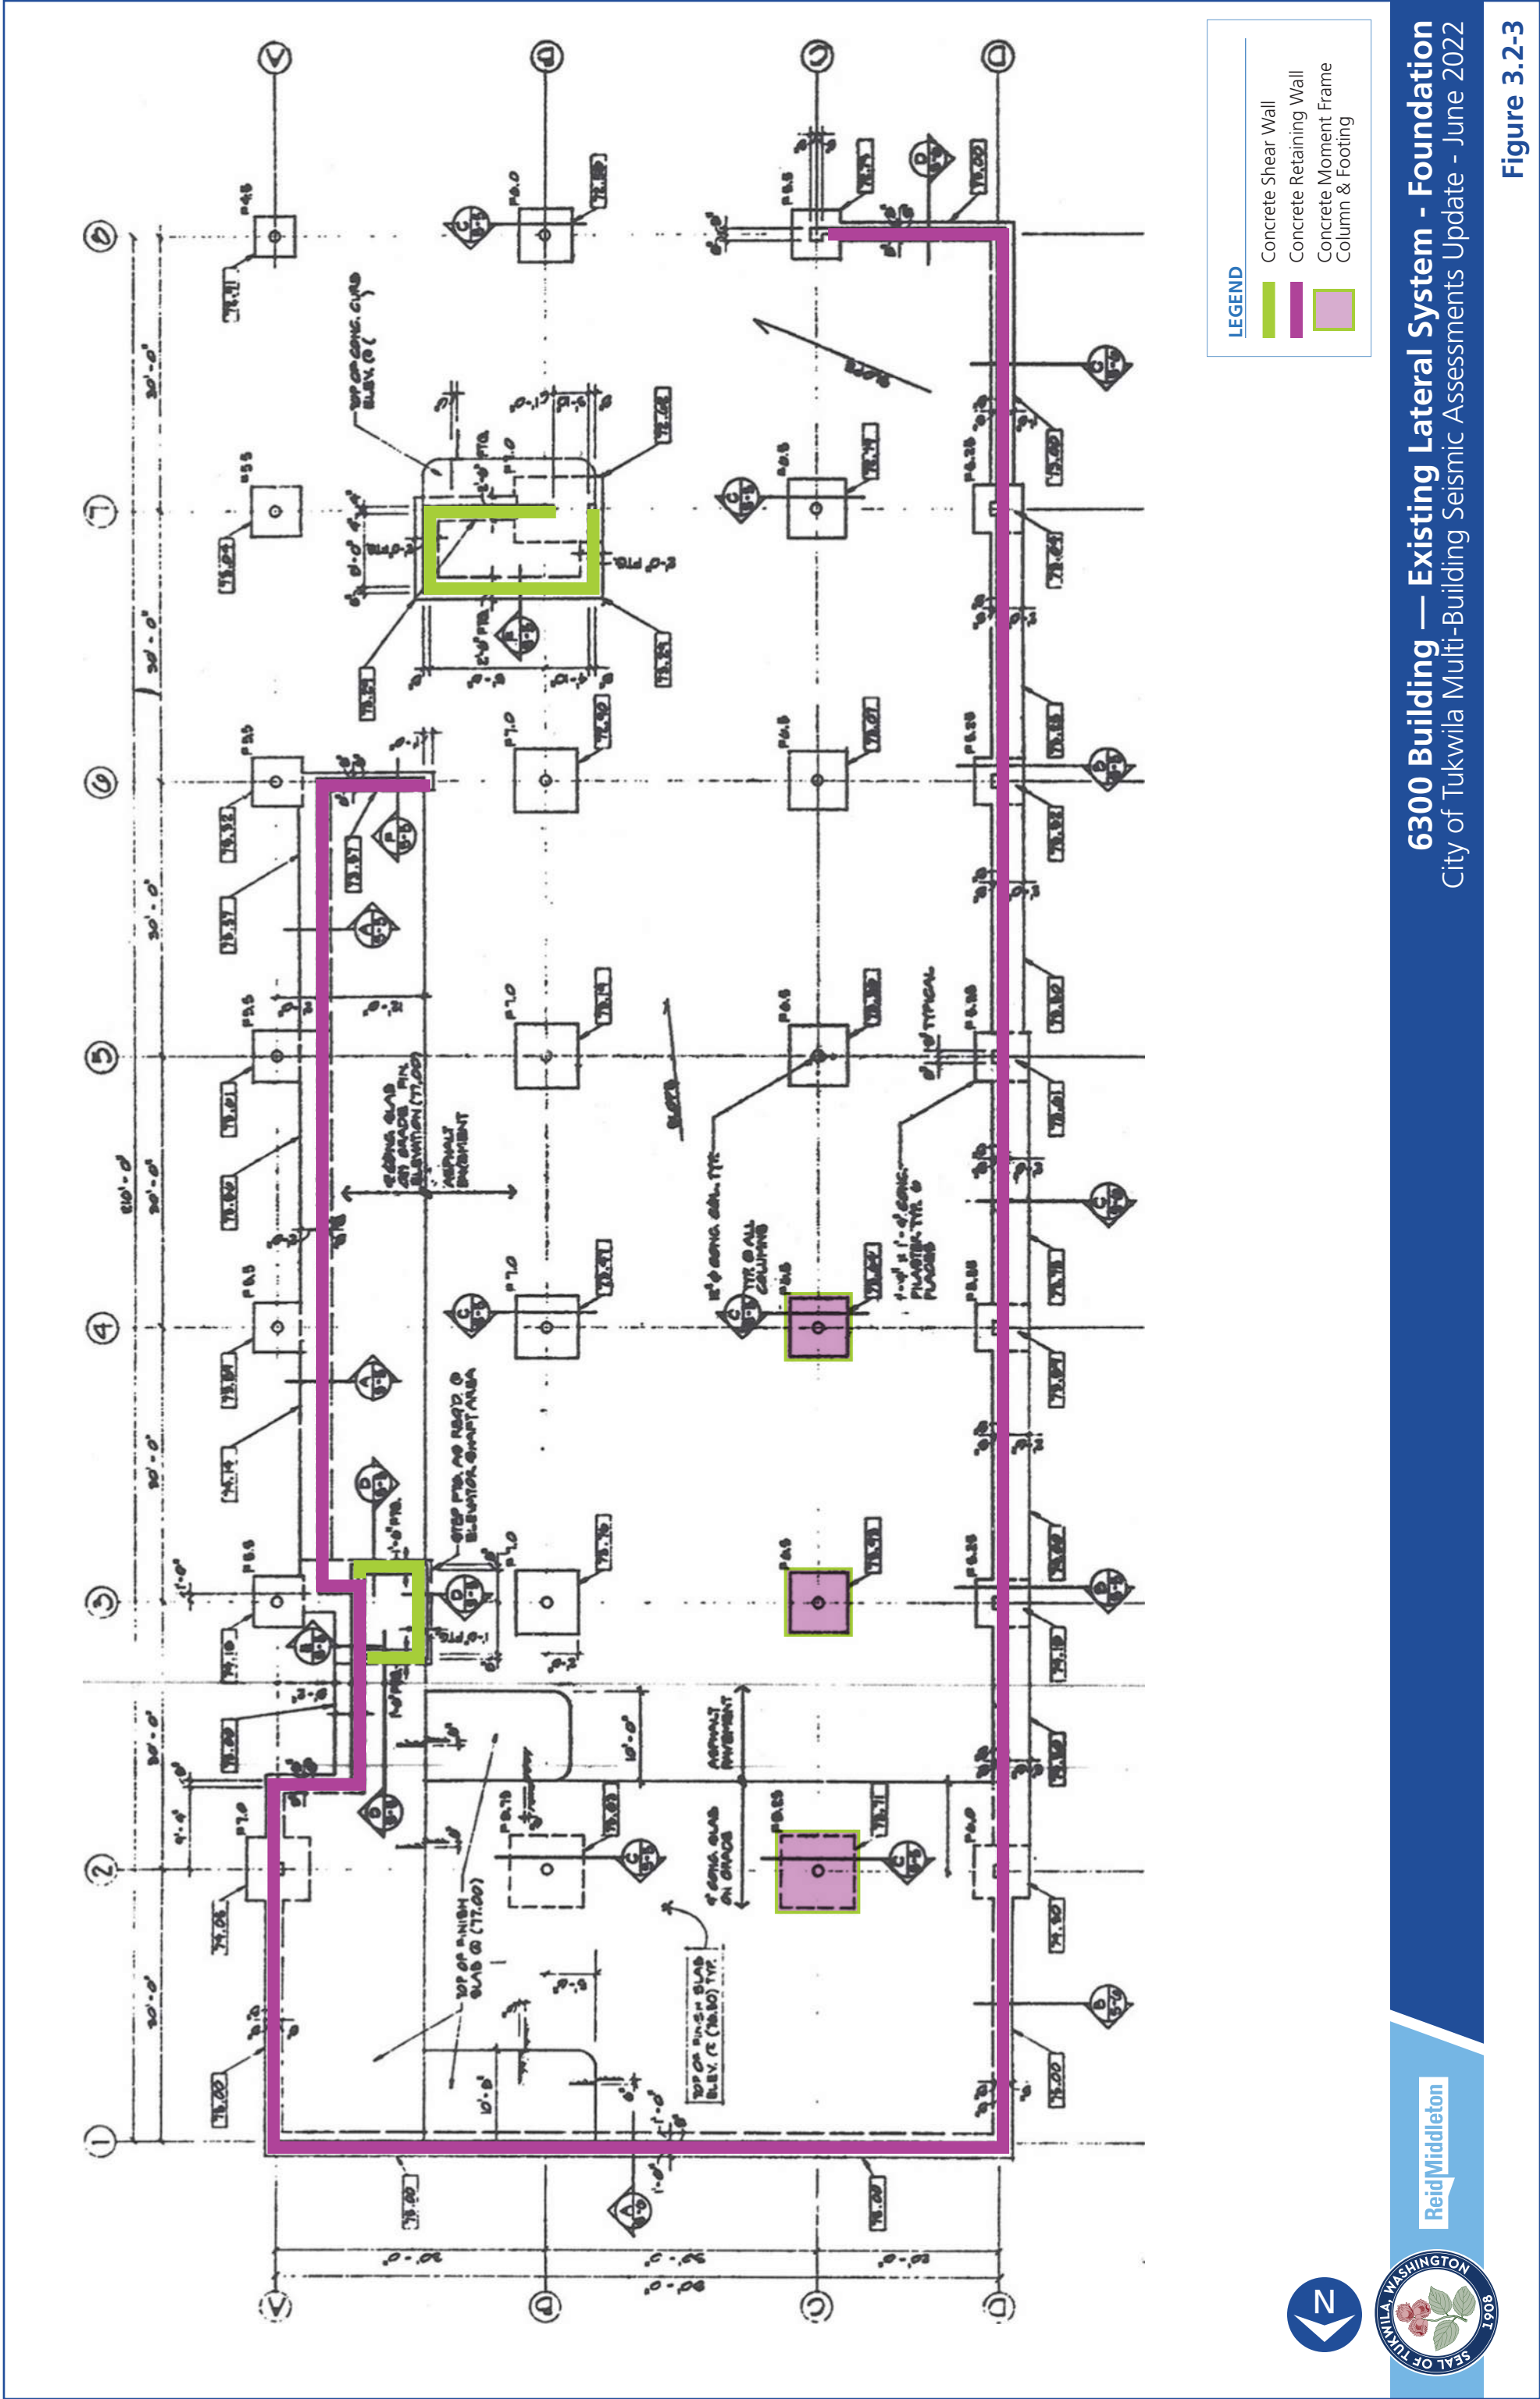
Figure 3.2-3

FEMA 310, and ASCE 31-03). The building is classified in ASCE 41, Table 3-1, as several different building types: a Wood Light Frame structure, **W2**; a Concrete Shear Wall Building with Flexible Diaphragms, **C2a**; and a Steel Moment Frame Building with Flexible Diaphragms, **S1a**. These building types include those buildings that have bearing walls constructed of reinforced concrete and wood, elevated floor and roof framing structural systems consisting of wood or other flexible diaphragms, and steel moment frames.

6300 Building — Existing Lateral System - Foundation
City of Tukwila Multi-Building Seismic Assessments Update - June 2022
