TO: Finance and Governance Committee
FROM: David Cline, City Administrator
BY: Hari Ponnekanti, Public Works Director/ City Engineer
Rachel Bianchi, Deputy City Administrator
CC: Mayor Allan Ekberg
DATE: July 22, 2022
SUBJECT: City Facilities Overview and Seismic Update for City Hall, 6300 building and TCC

MULTI-BUILDING SEISMIC ASSESSMENTS UPDATE

June 2022

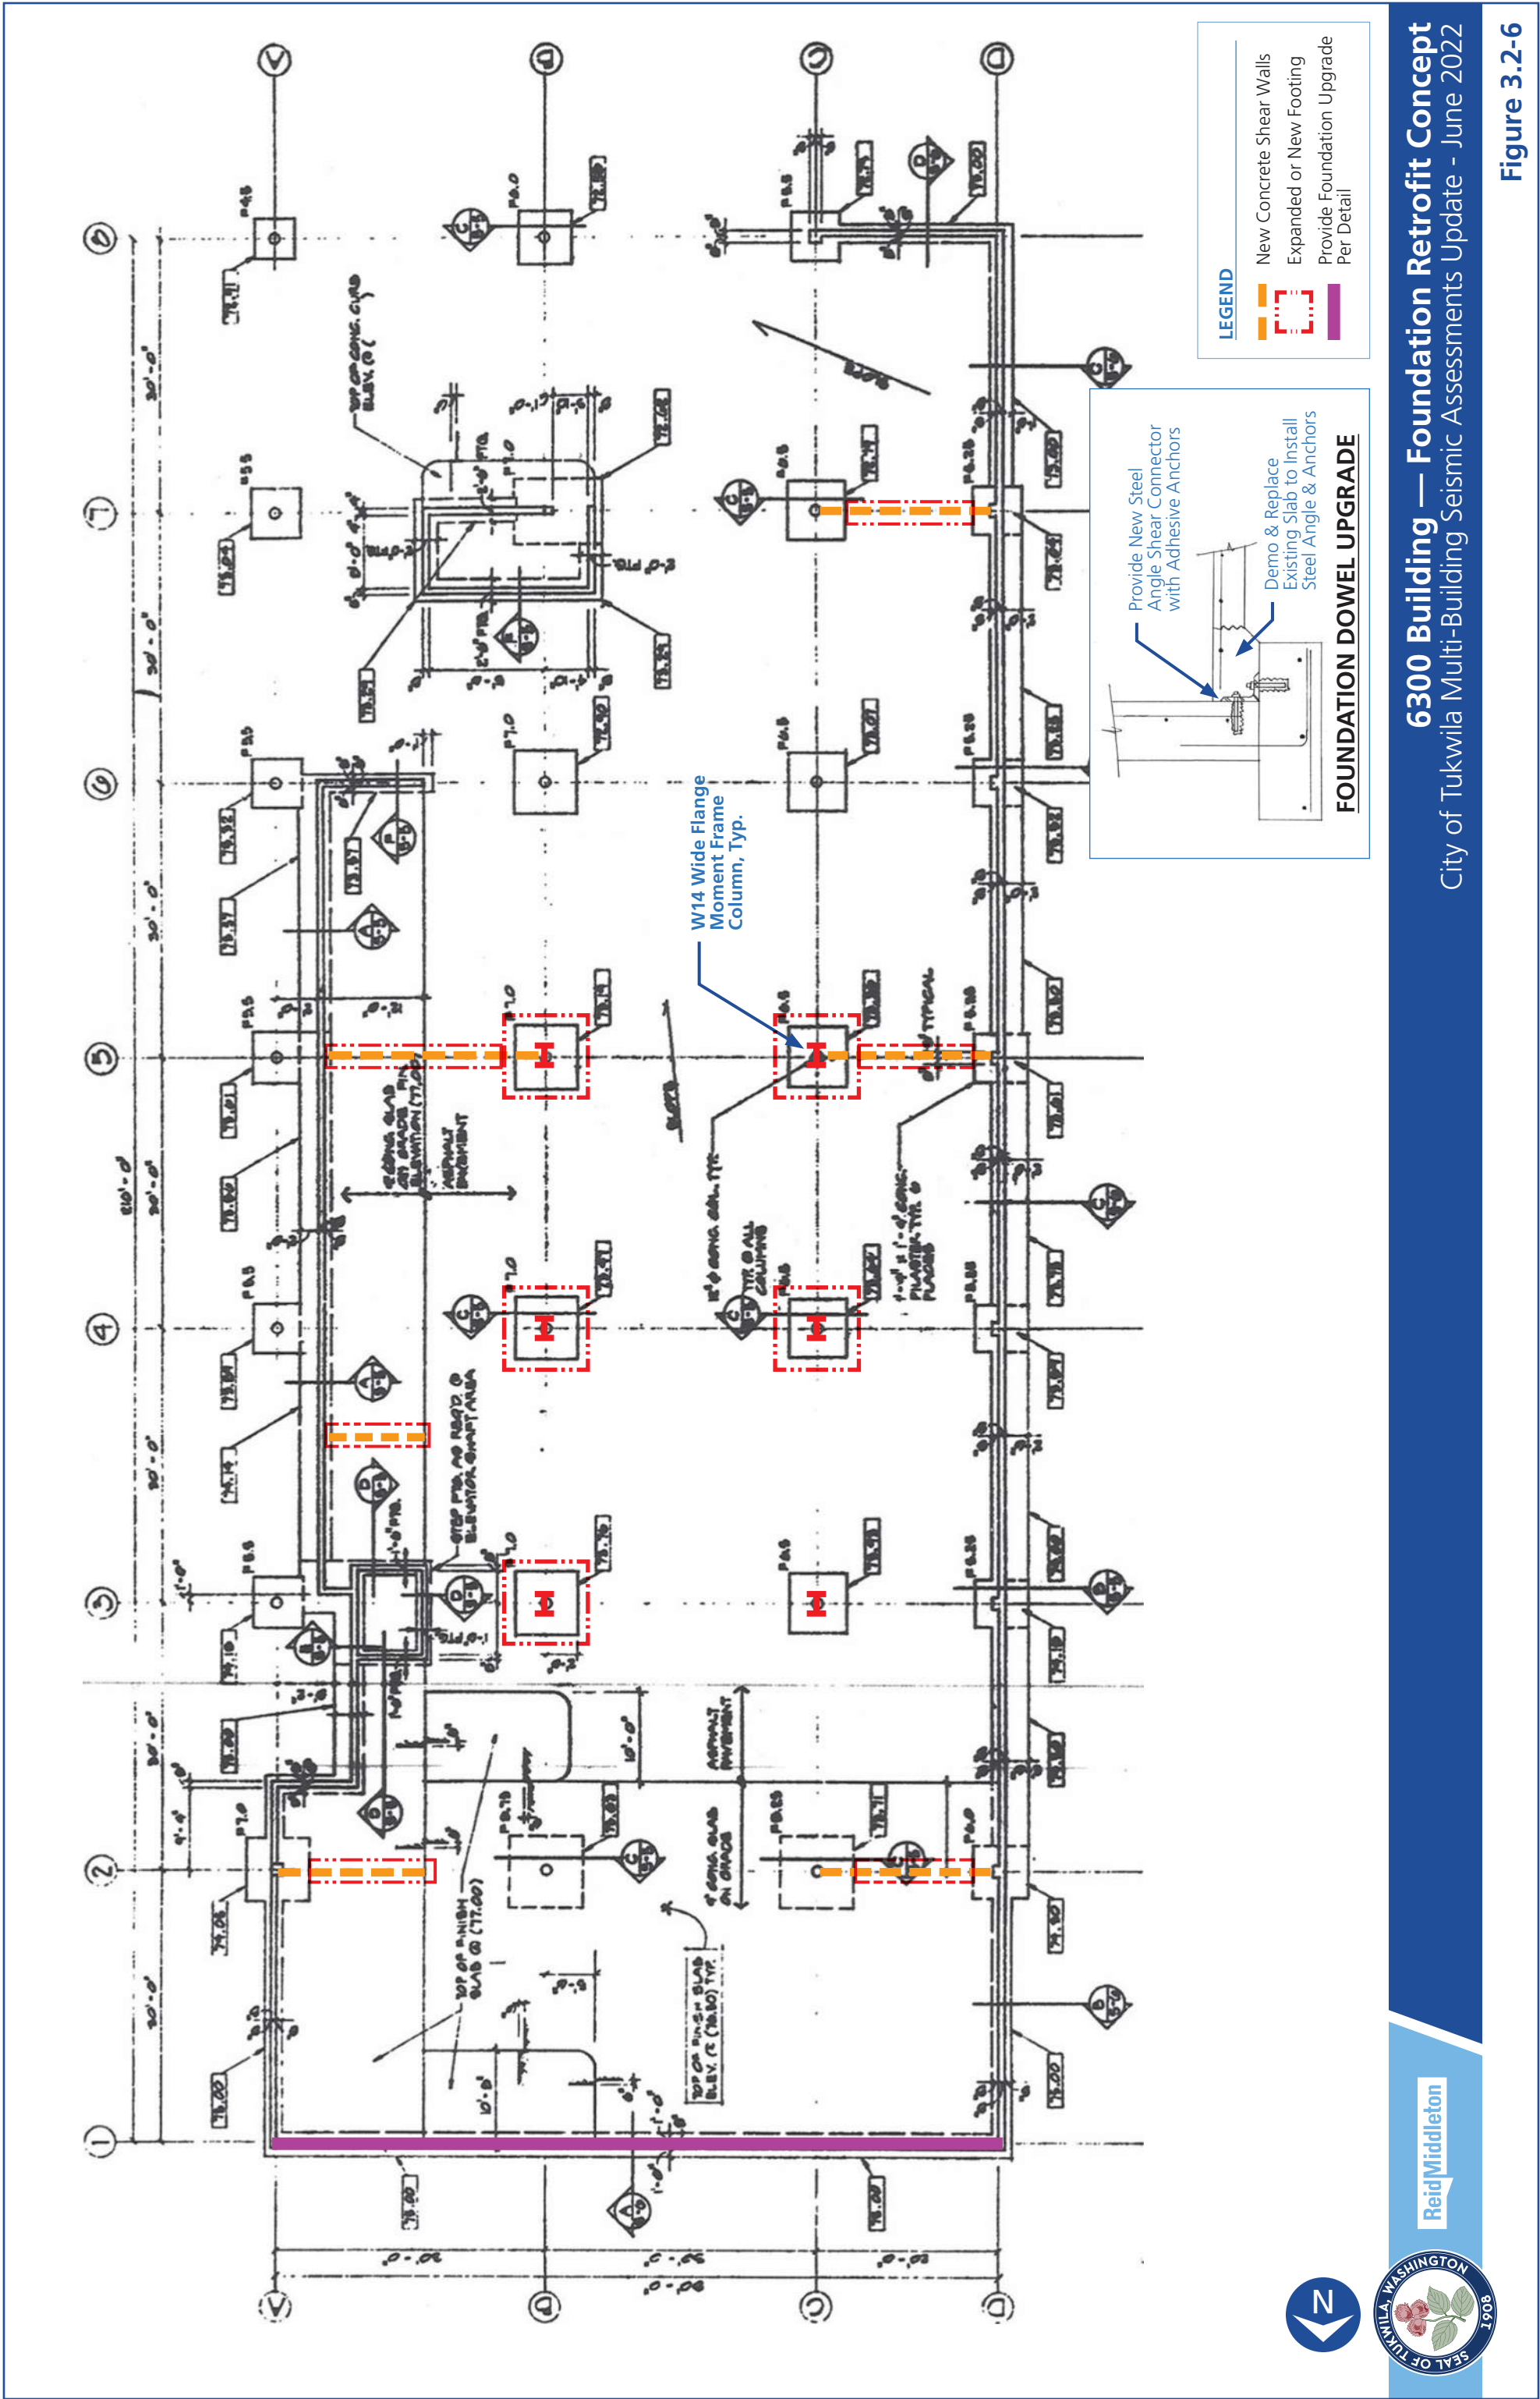
Figure 3.2-6

6300 Building — Foundation Retrofit Concept
 City of Tukwila Multi-Building Seismic Assessments Update - June 2022

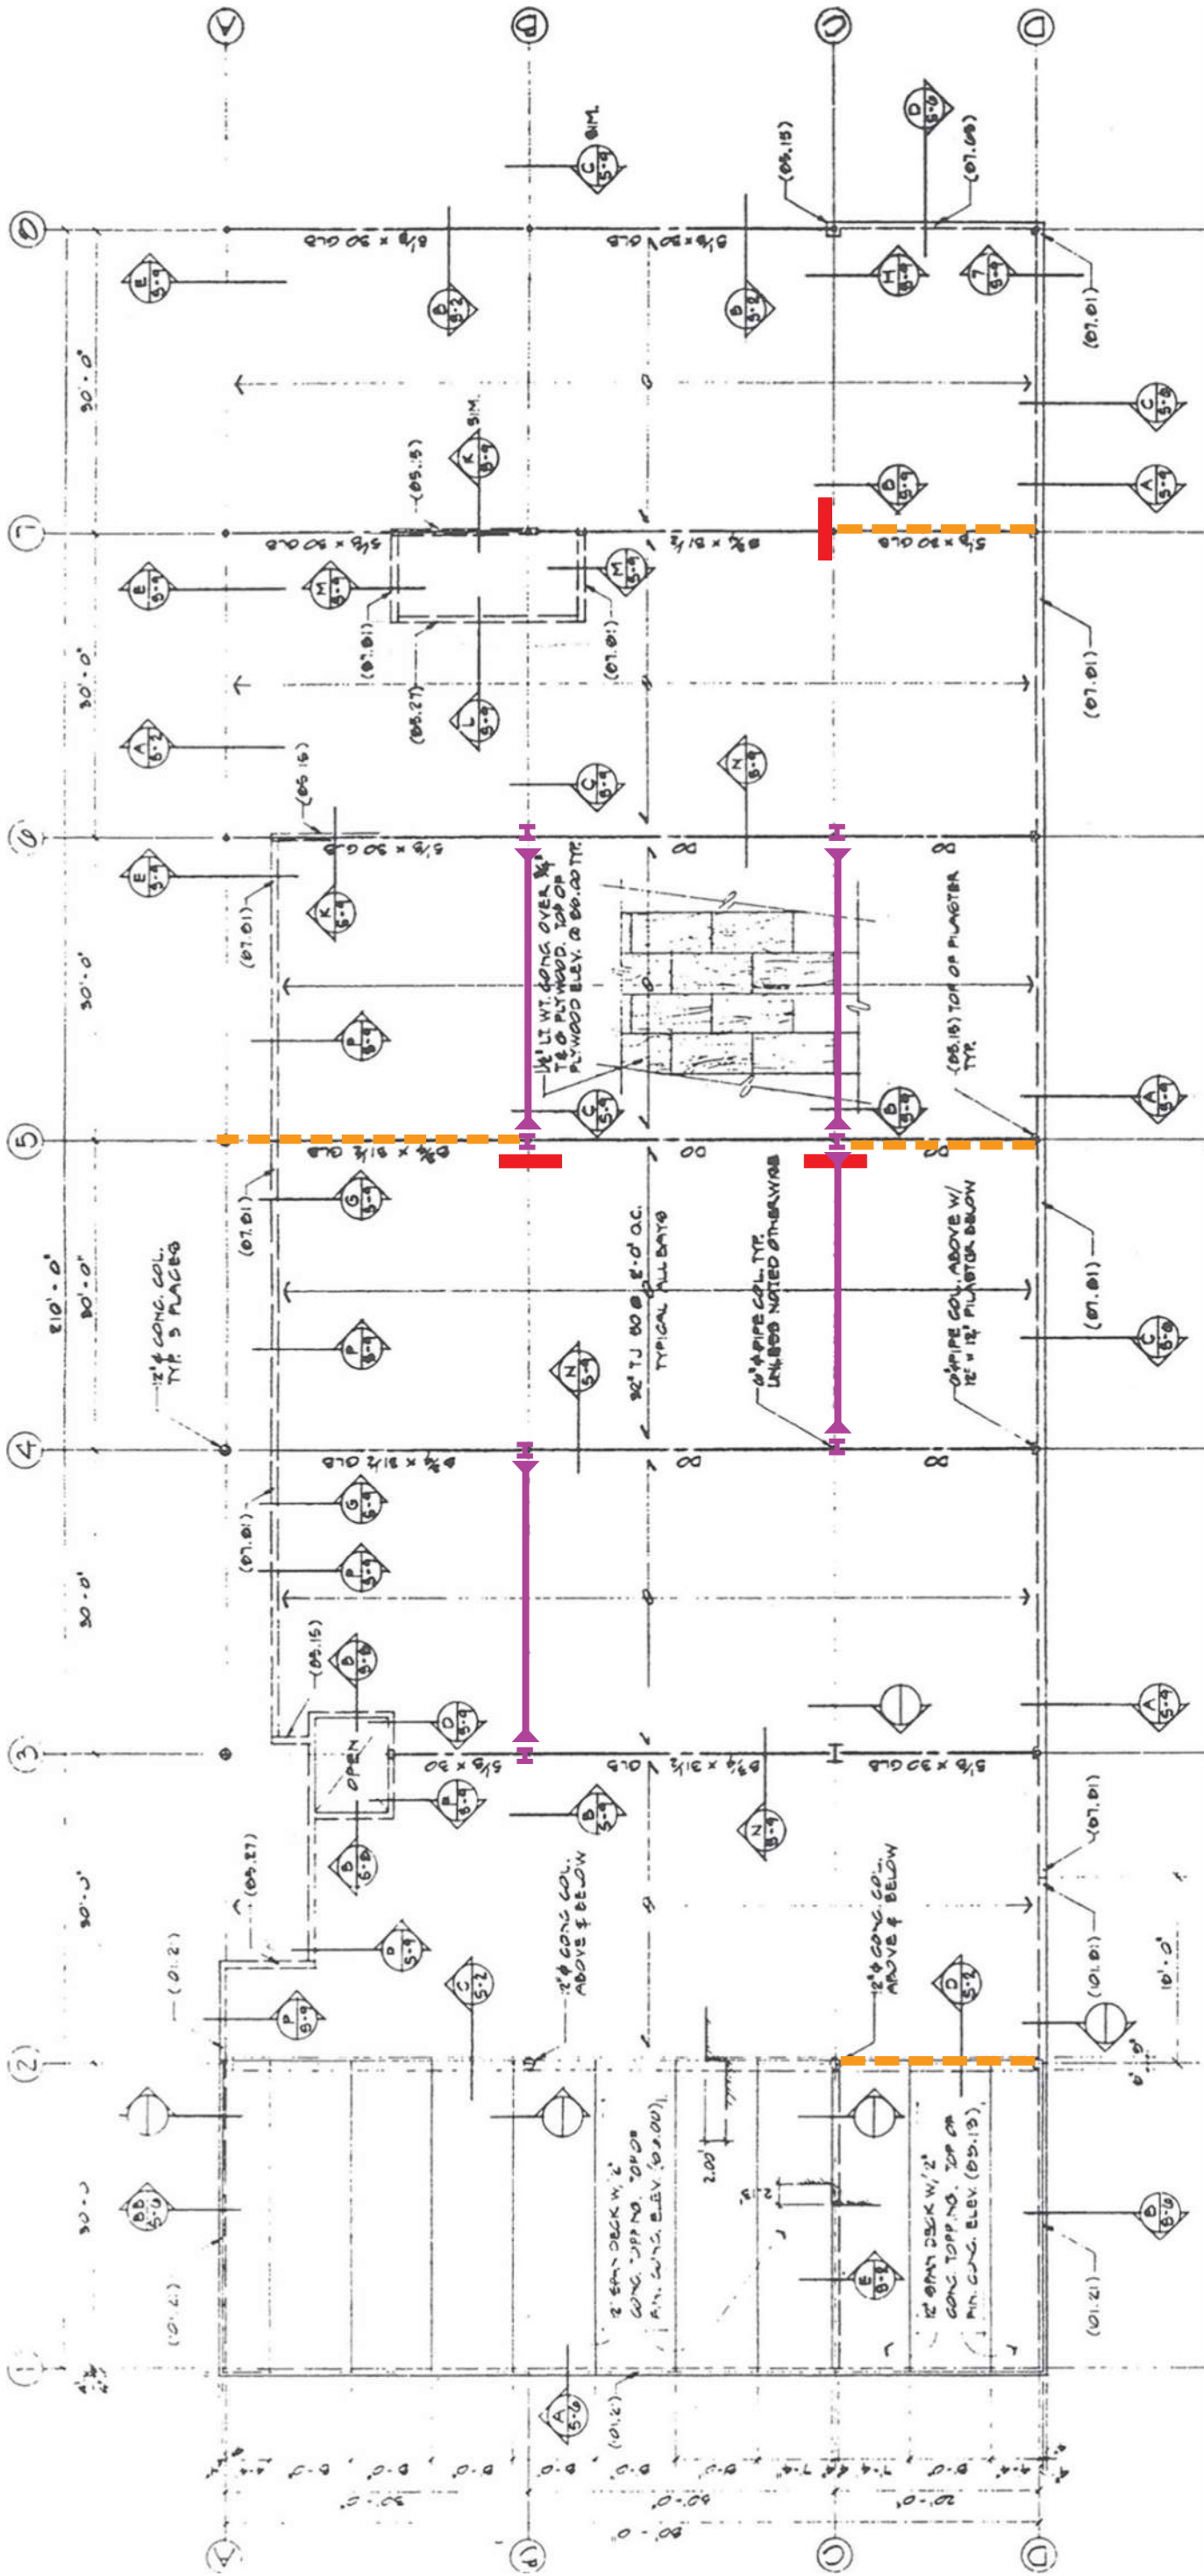
Figure 3.2-7

- New Wood Shear Walls. Provide Connections To Concrete Walls Below
- Cross Tie
- New Steel Moment Frame Beams & Columns

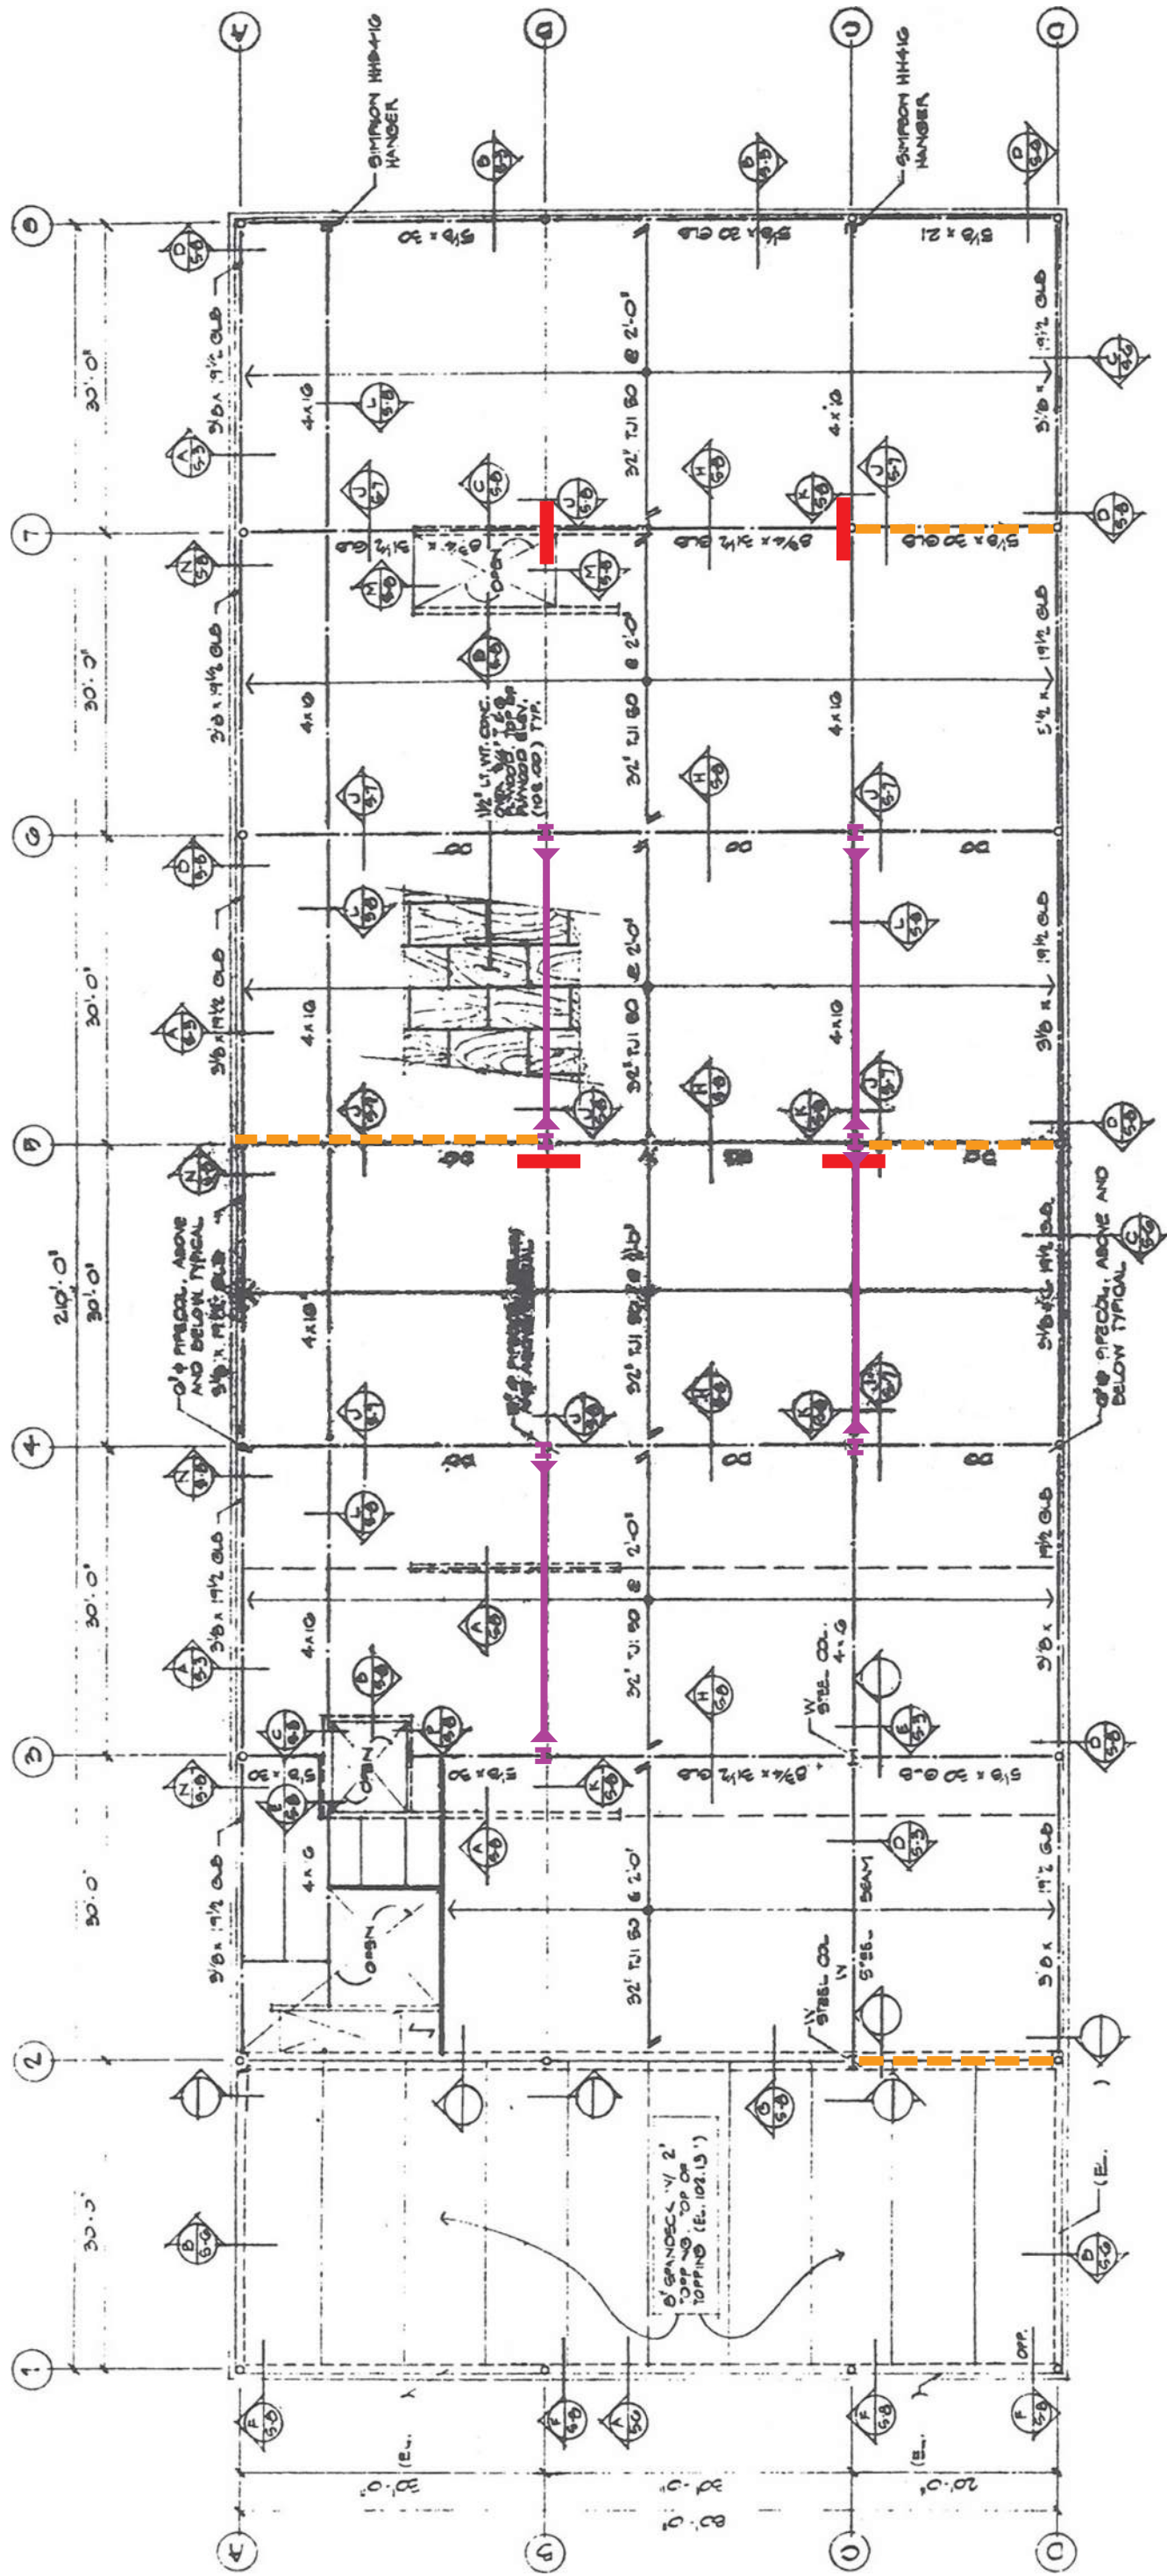
Figure 3.2-8

- New Wood Shear Walls. Provide Connections To Concrete Walls Below
- Cross Tie
- New Steel Moment Frame Beams & Columns

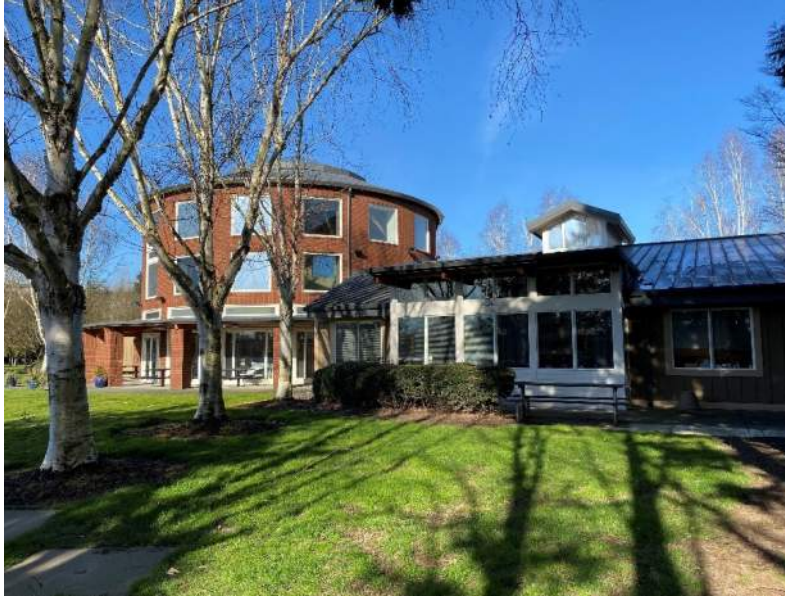
The Tukwila Community Center is a one-story building located in the northern end of Tukwila, along the Green River. The building consists of two low-rise, rectangular wing sections and a 38-foot-tall circular high-roof rotunda between the wings. The east wing also includes a 38-foot-tall high-roof gymnasium. The rotunda construction consists of a wood- and steel-framed roof with a wood structural-panel diaphragm supported by steel, masonry-clad columns. The east and west wings are generally wood- and steel-framed roofs with wood structural-panel diaphragms supported by wood and light-gage steel stud walls with a masonry façade. The gymnasium is constructed of steel roof trusses and metal roof deck supported by concrete masonry unit (CMU) perimeter walls.

Figure 3.3-1. Community Center, Southeast Exterior.

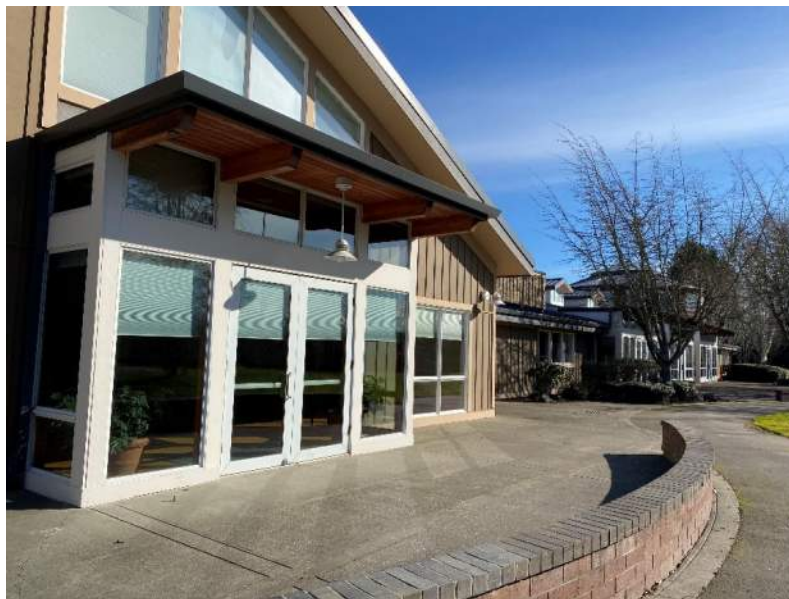
Figure 3.3-2. Community Center, West Exterior.

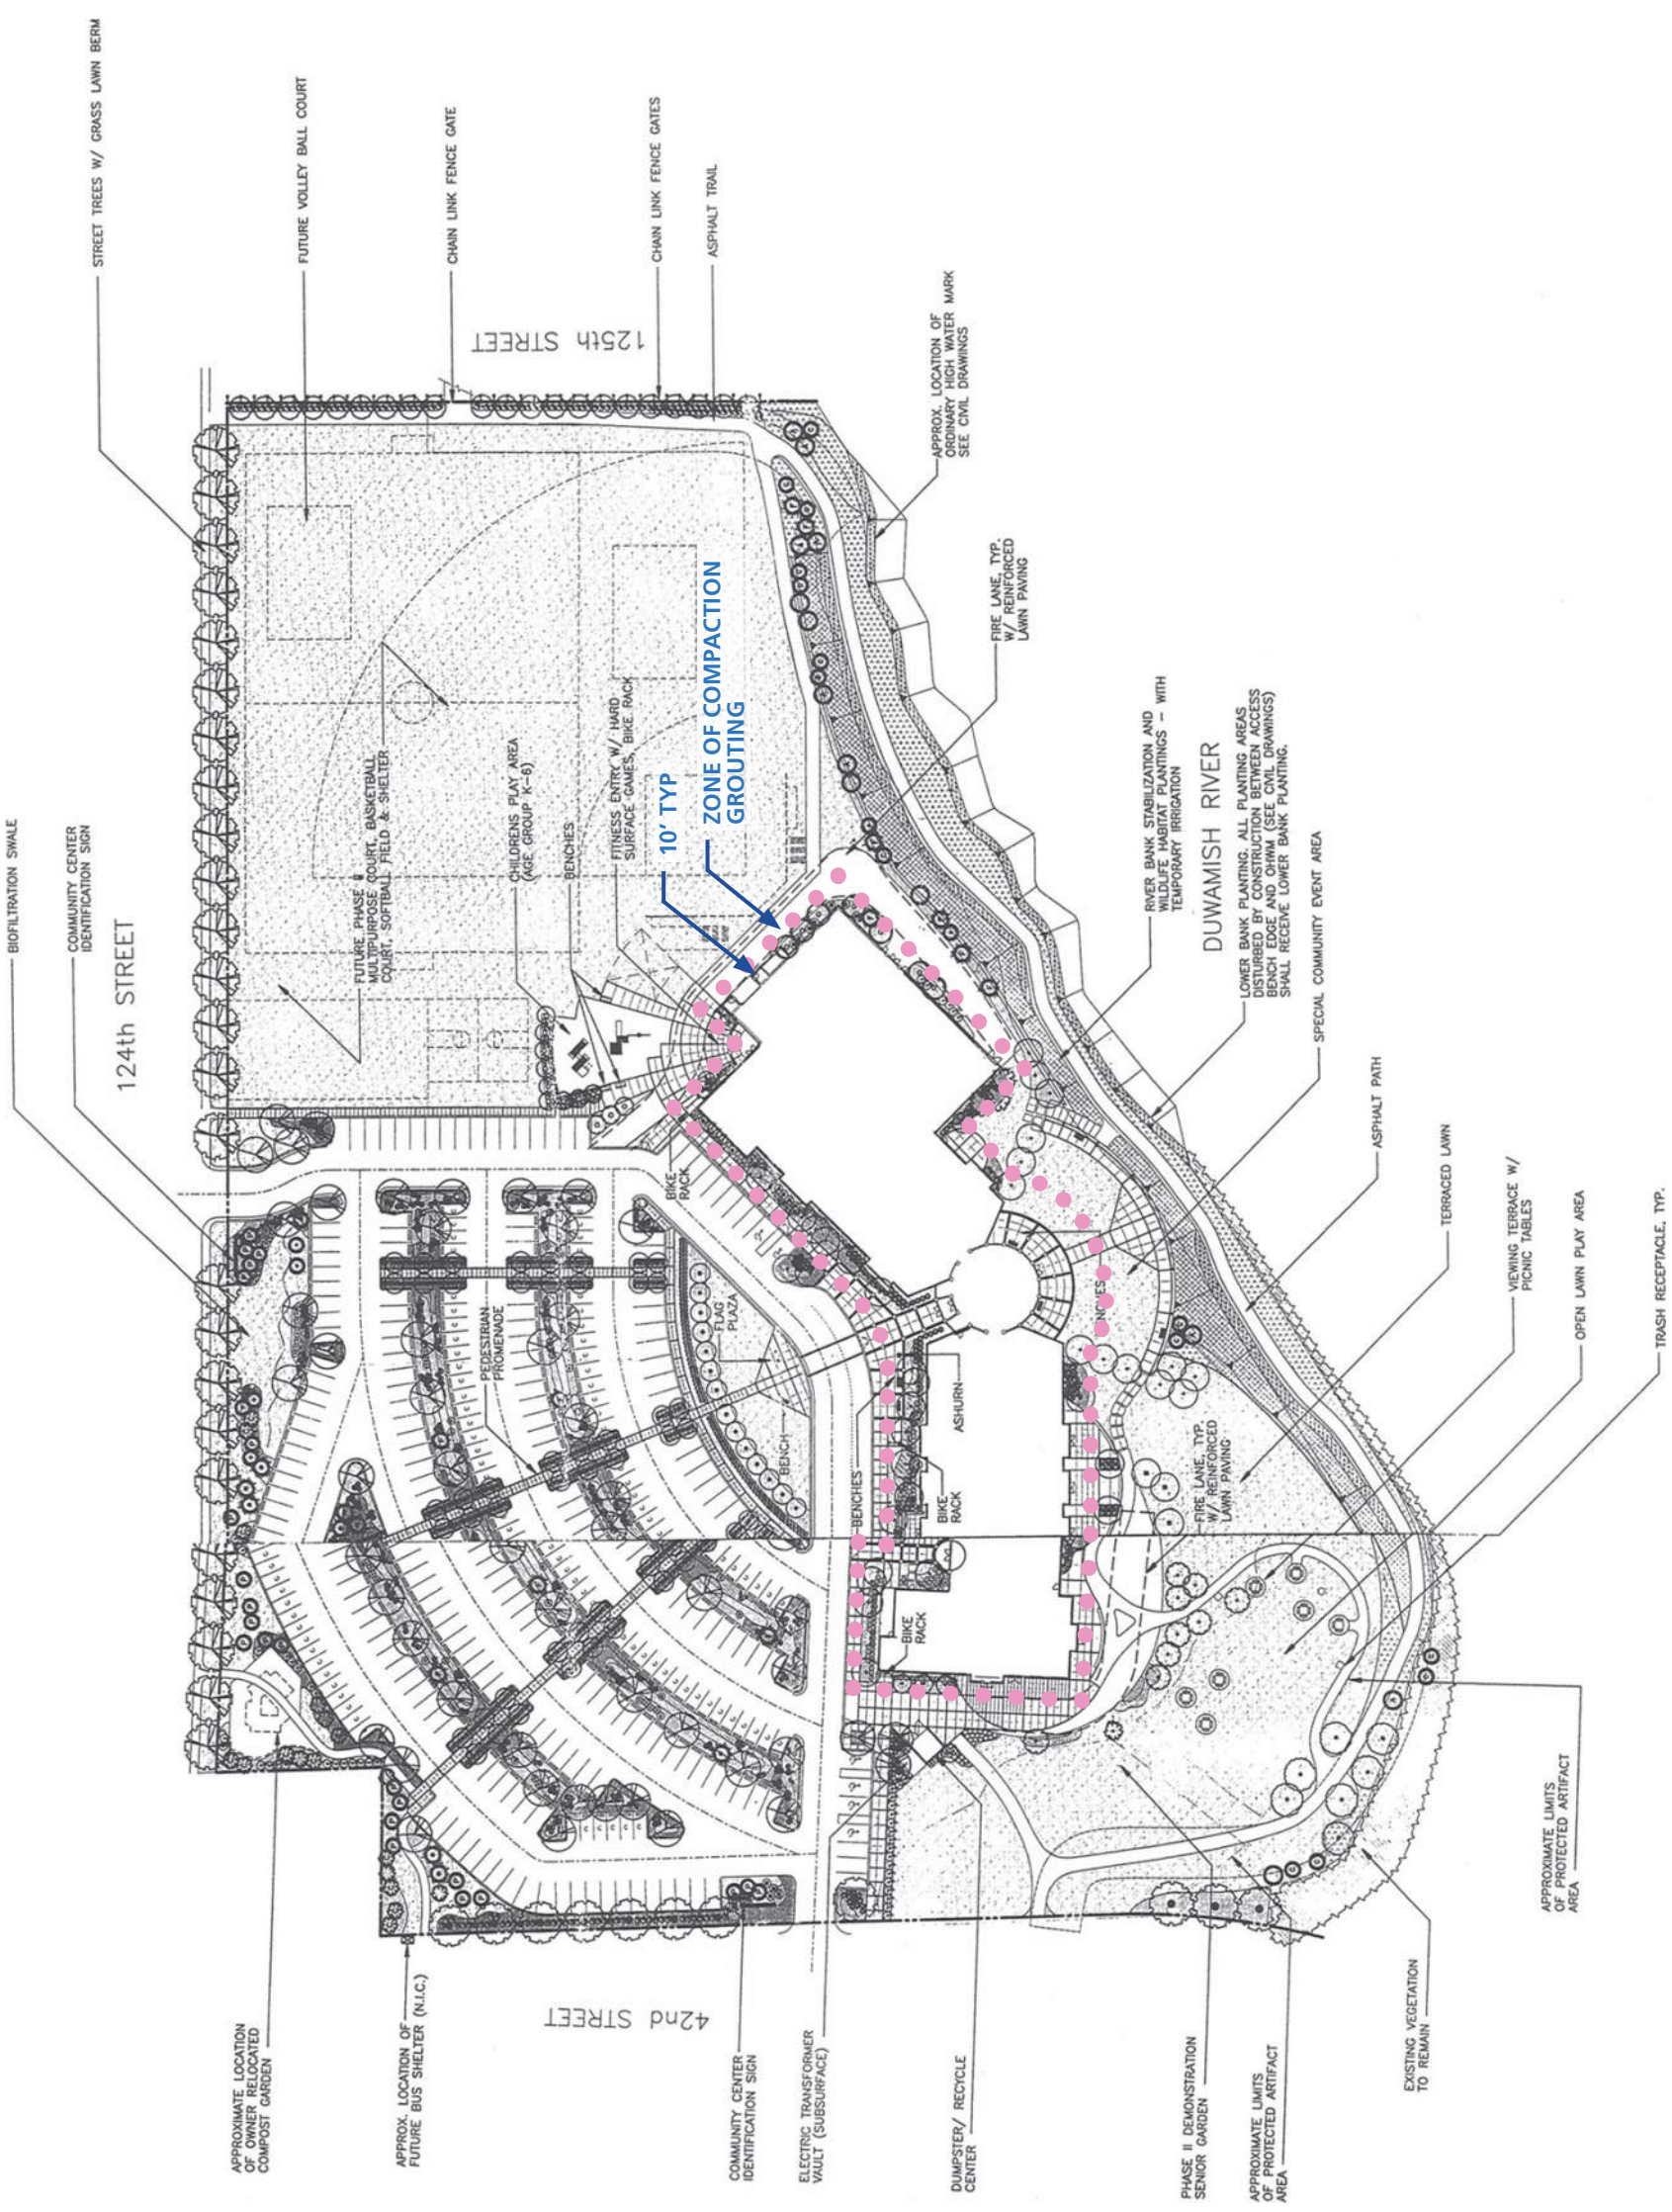
Figure 3.3-7

Community Center — Site Plan Retrofit Concept
 City of Tukwila Multi-Building Seismic Assessments Update - June 2022

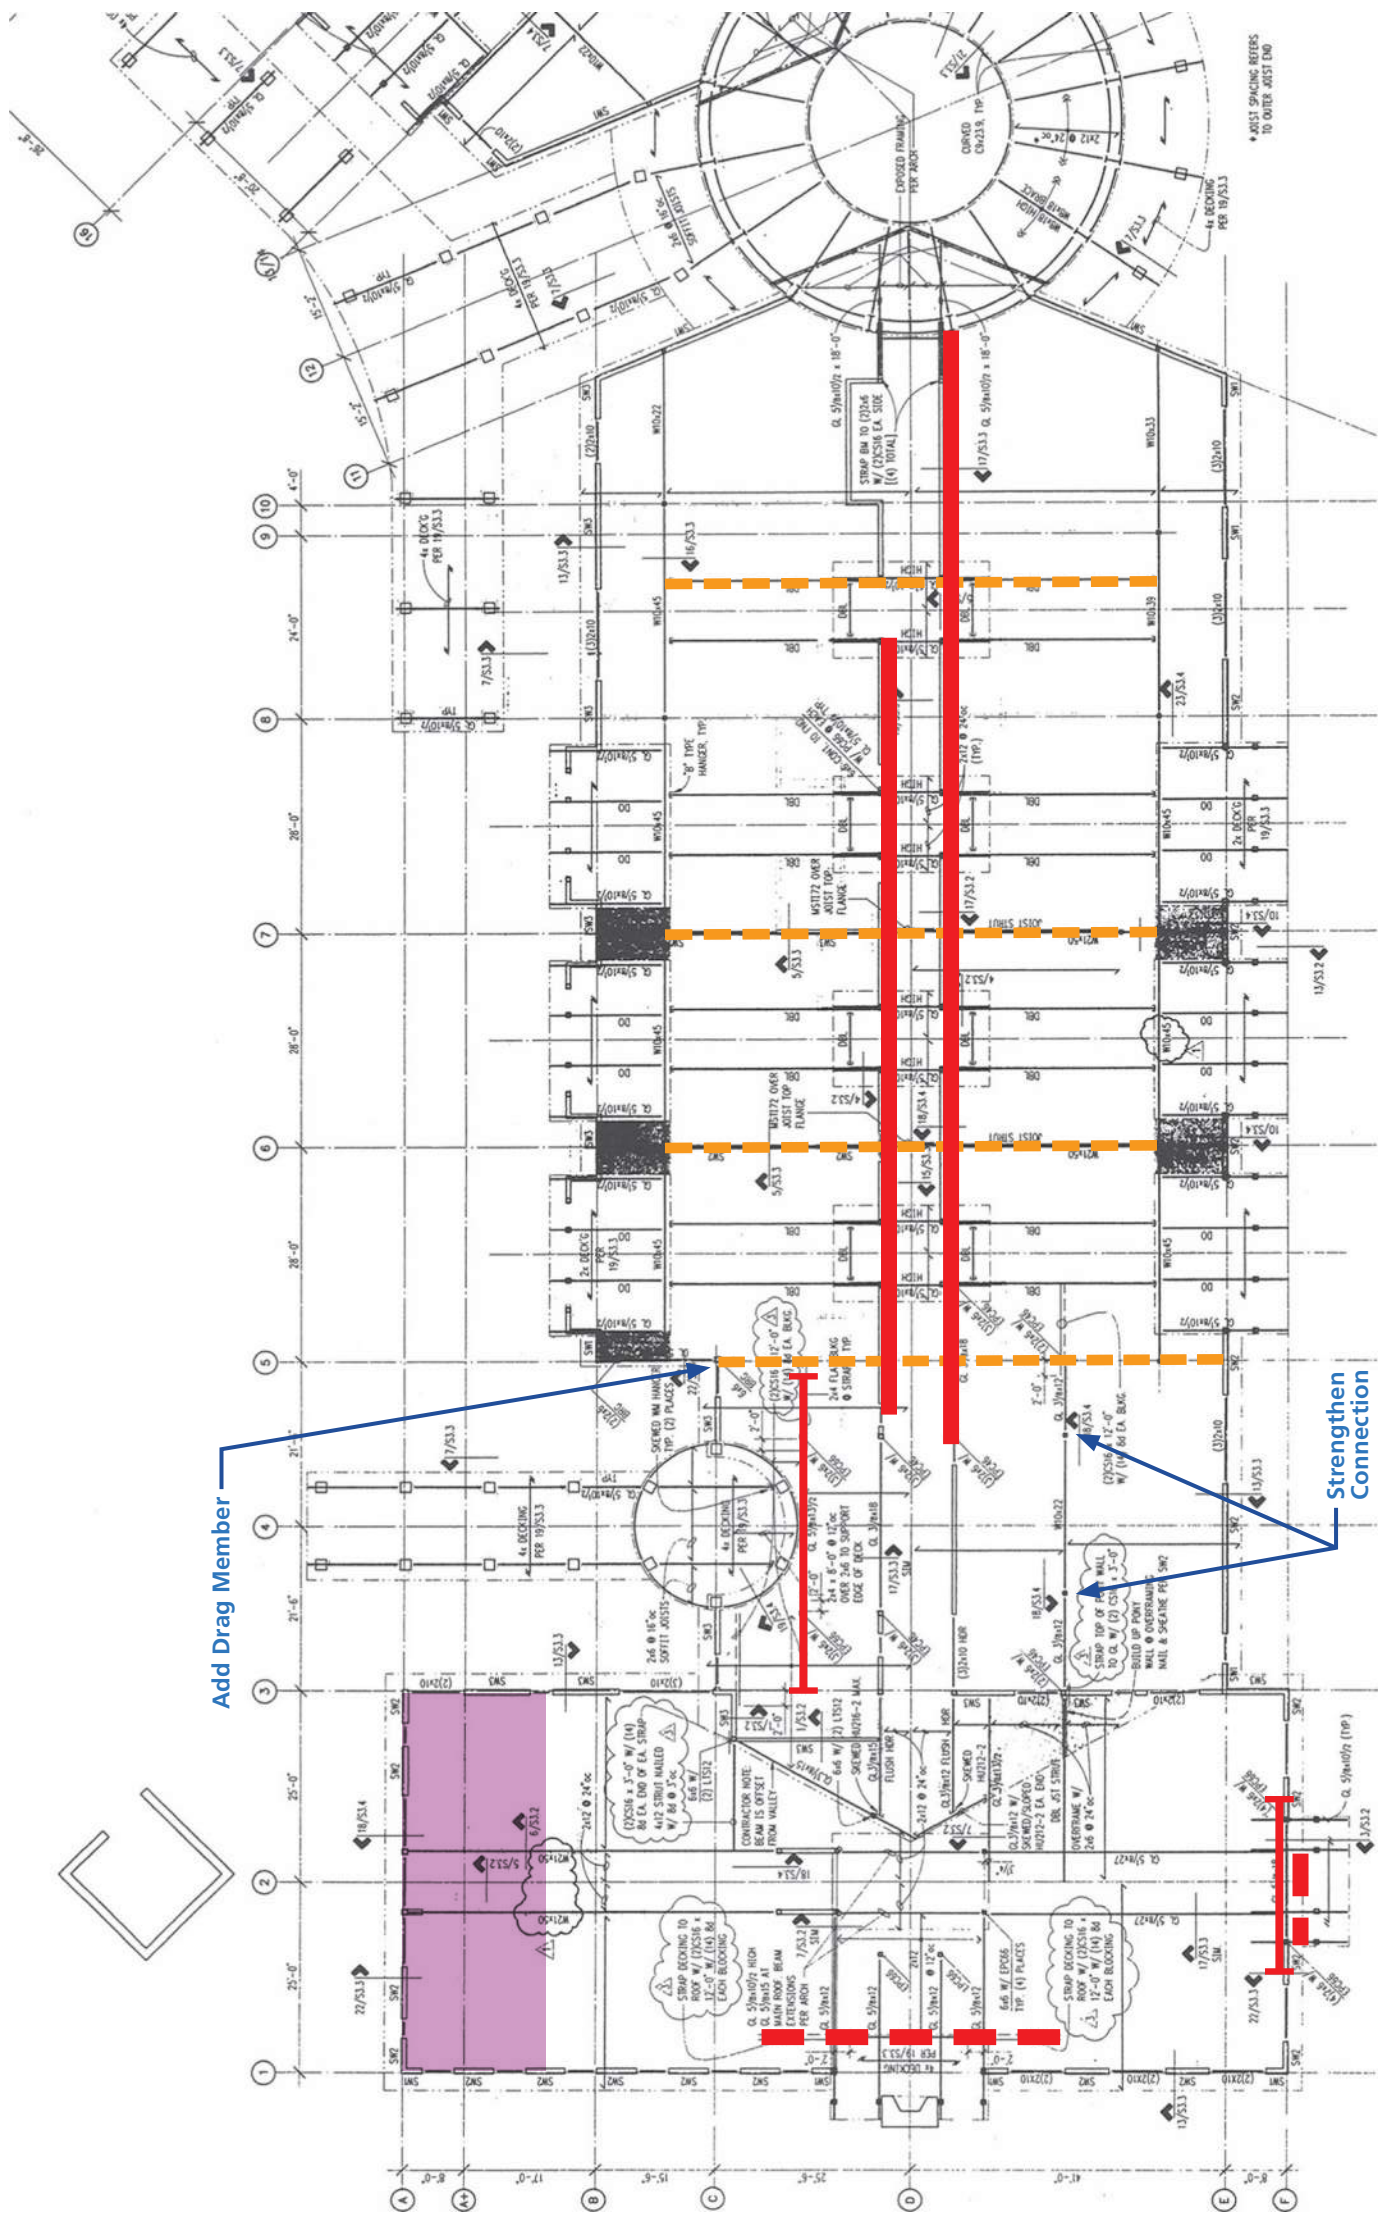
- Reinforce Drag Member
- Add Blocking & 12GA Coil Strap Along Corridor Walls
- Block Existing Diaphragm, Increase Nailing
- Add Blocking & 12GA Coil Strap
- 12GA Coil Strap

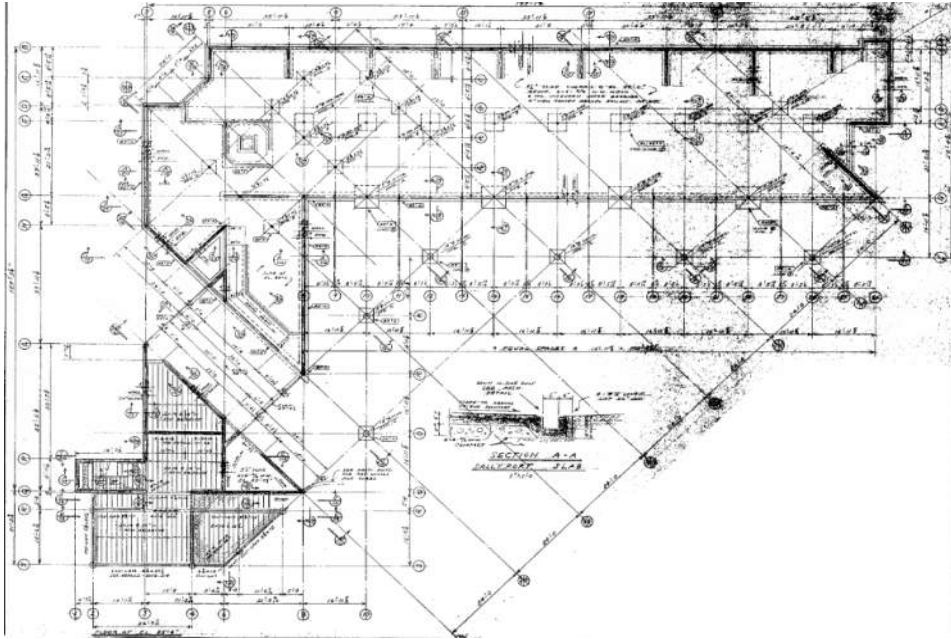
Figure 1: City Hall Foundation Plan

Building Weight Summary	
Roof	139 kip
Level 1	643 kip
Σ	782 kip

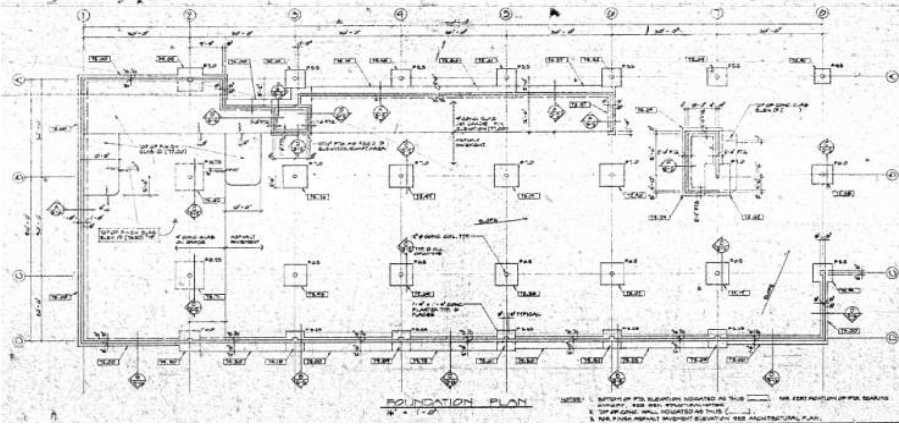
Figure 1: Building 6300 Foundation Plan

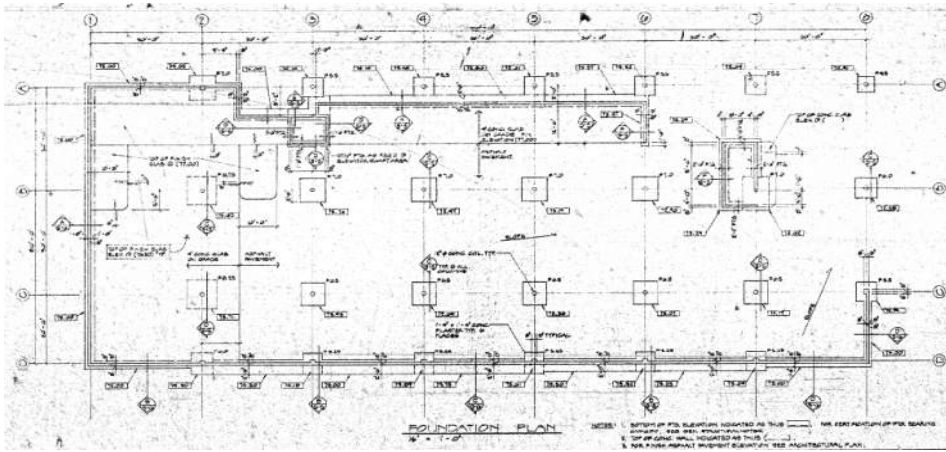
Figure 1: 6300 Building Foundation Plan

Building Weight Summary	
Roof	209 kip
Level 2	695 kip
Level 1	1,136 kip
Σ	2,040 kip
