SUBJECT: Annual Bridge Inspections and Repairs Update

Project No. 70010402

2023 Presentation on the State of the City's Bridges

CITY ENGINEER'S BRIDGE INSPECTION REPORT October 2023

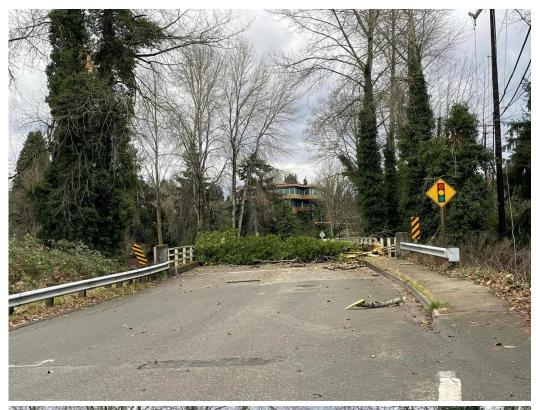
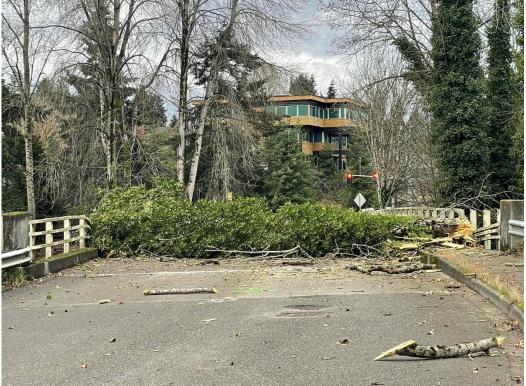
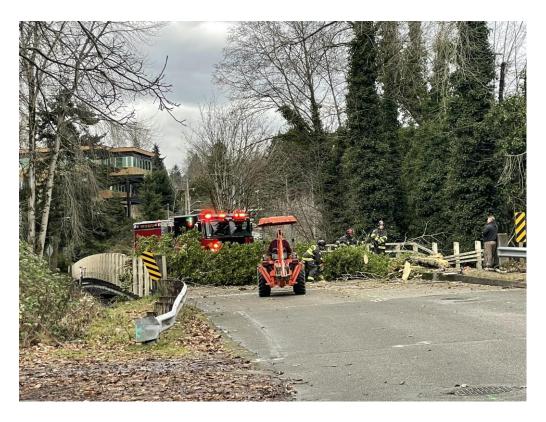
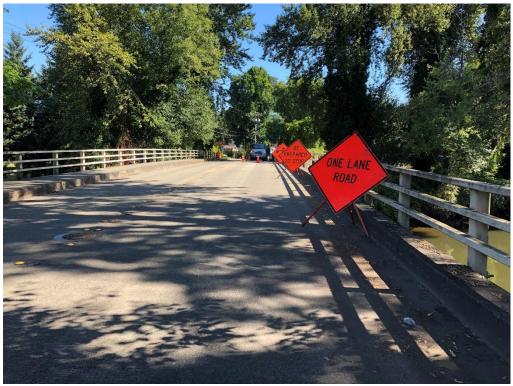
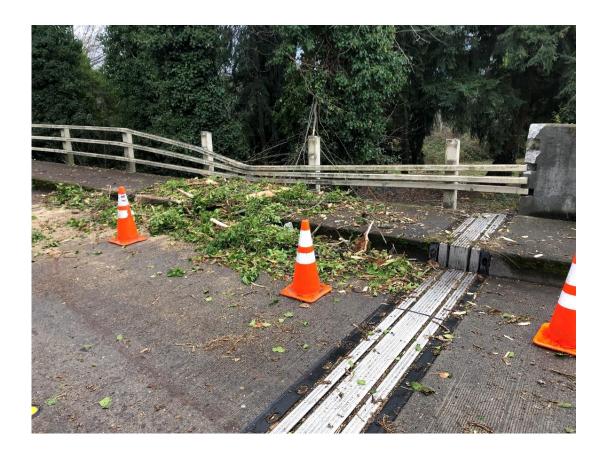
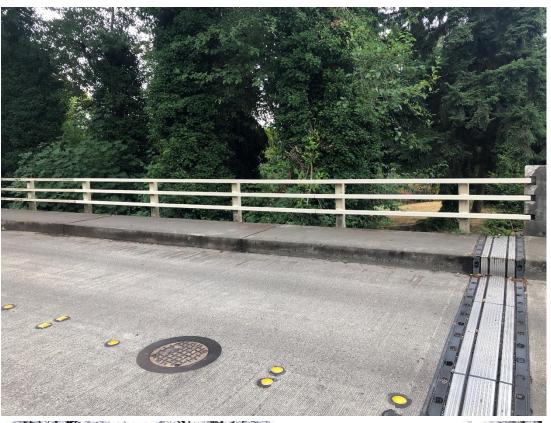
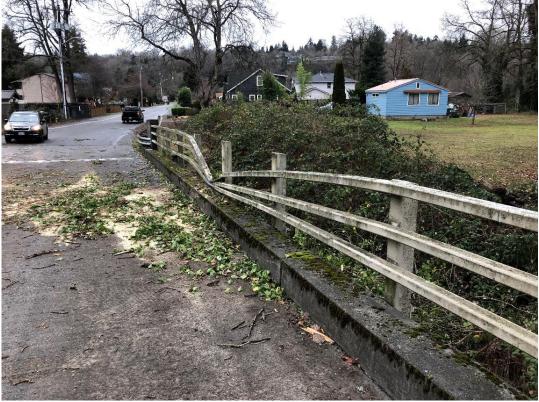
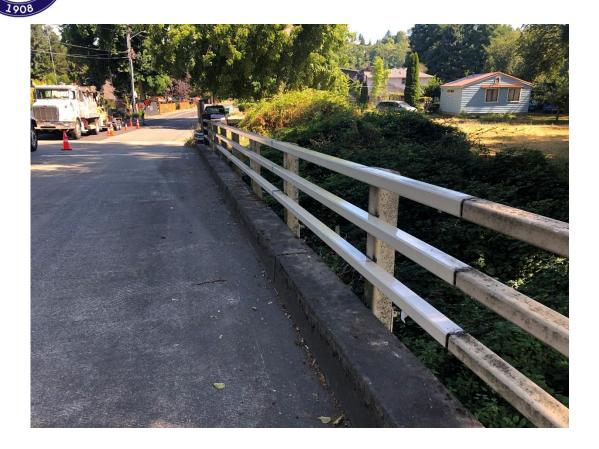
Foster Point Bridge Rail Pictures

On January 9, 2023 the City experienced a wind storm that knocked over a number of trees throughout the City. One tree fell on the east side of the Foster Point Bridge which resulted in the top of the tree falling across the structure damaging both the east and west bridge rail. It was determined that the tree did not cause any structural damage which allowed Fire and the Public Works Streets Department to remove the downed tree. A mobile welding company teamed with a transportation group who provided traffic control and delivery of the materials and both the east and west bridge rail was replaced. Please see the attached photographs for before and after photos.
